Exmoor National Park  
Historic Environment Report Series No 12

# THE BOUNDARY OF THE ROYAL FOREST OF EXMOOR: AN ARCHAEOLOGICAL SURVEY

Author: Peter Bonvoisin (student placement, University of Cardiff)  
Edited by Faye Balmond  
September 2013

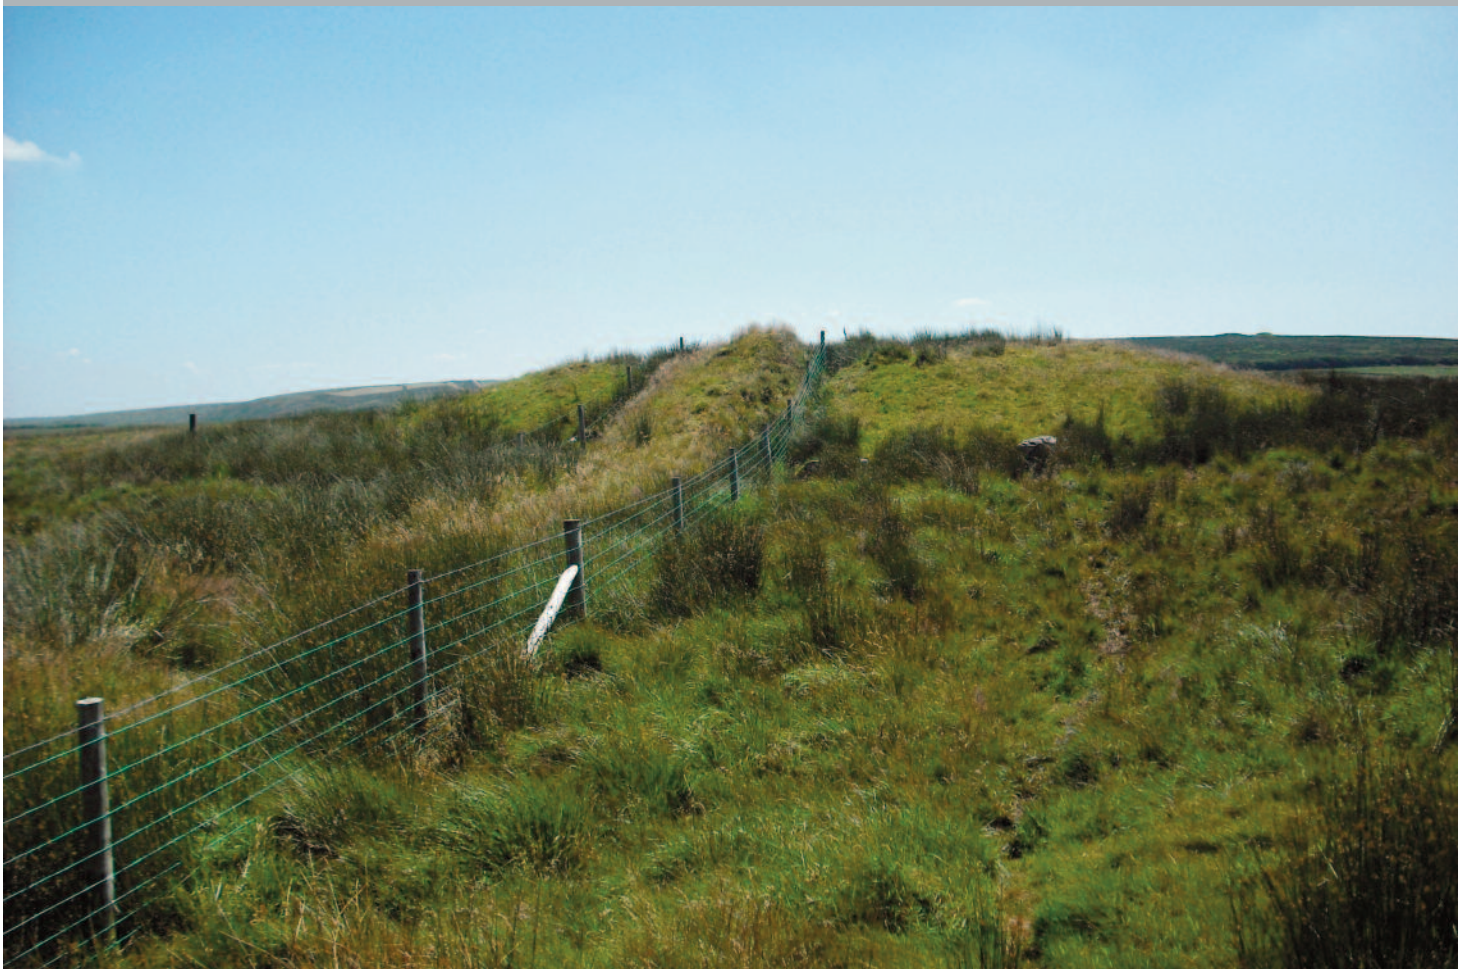
## **FRONT COVER:**

**Section 6 of The Royal Forest Boundary showing a bank running over the top of Setta Barrow.**

The next identifiable boundary stone is Hore Stone. The boundary between here and Edgerley Stone consists of open field and a bank, and is in relatively good condition. After Sloley Stone a road runs south along the boundary. The bank follows this road for approximately 800 m. The bank is low and does show signs of previous erosion, but it has no recent evidence of deterioration. It is protected from livestock damage with a fence, and in one place cuts through Setta barrow, which may well have marked the boundary before the construction of the bank. The kerbstones of the barrow are evident.

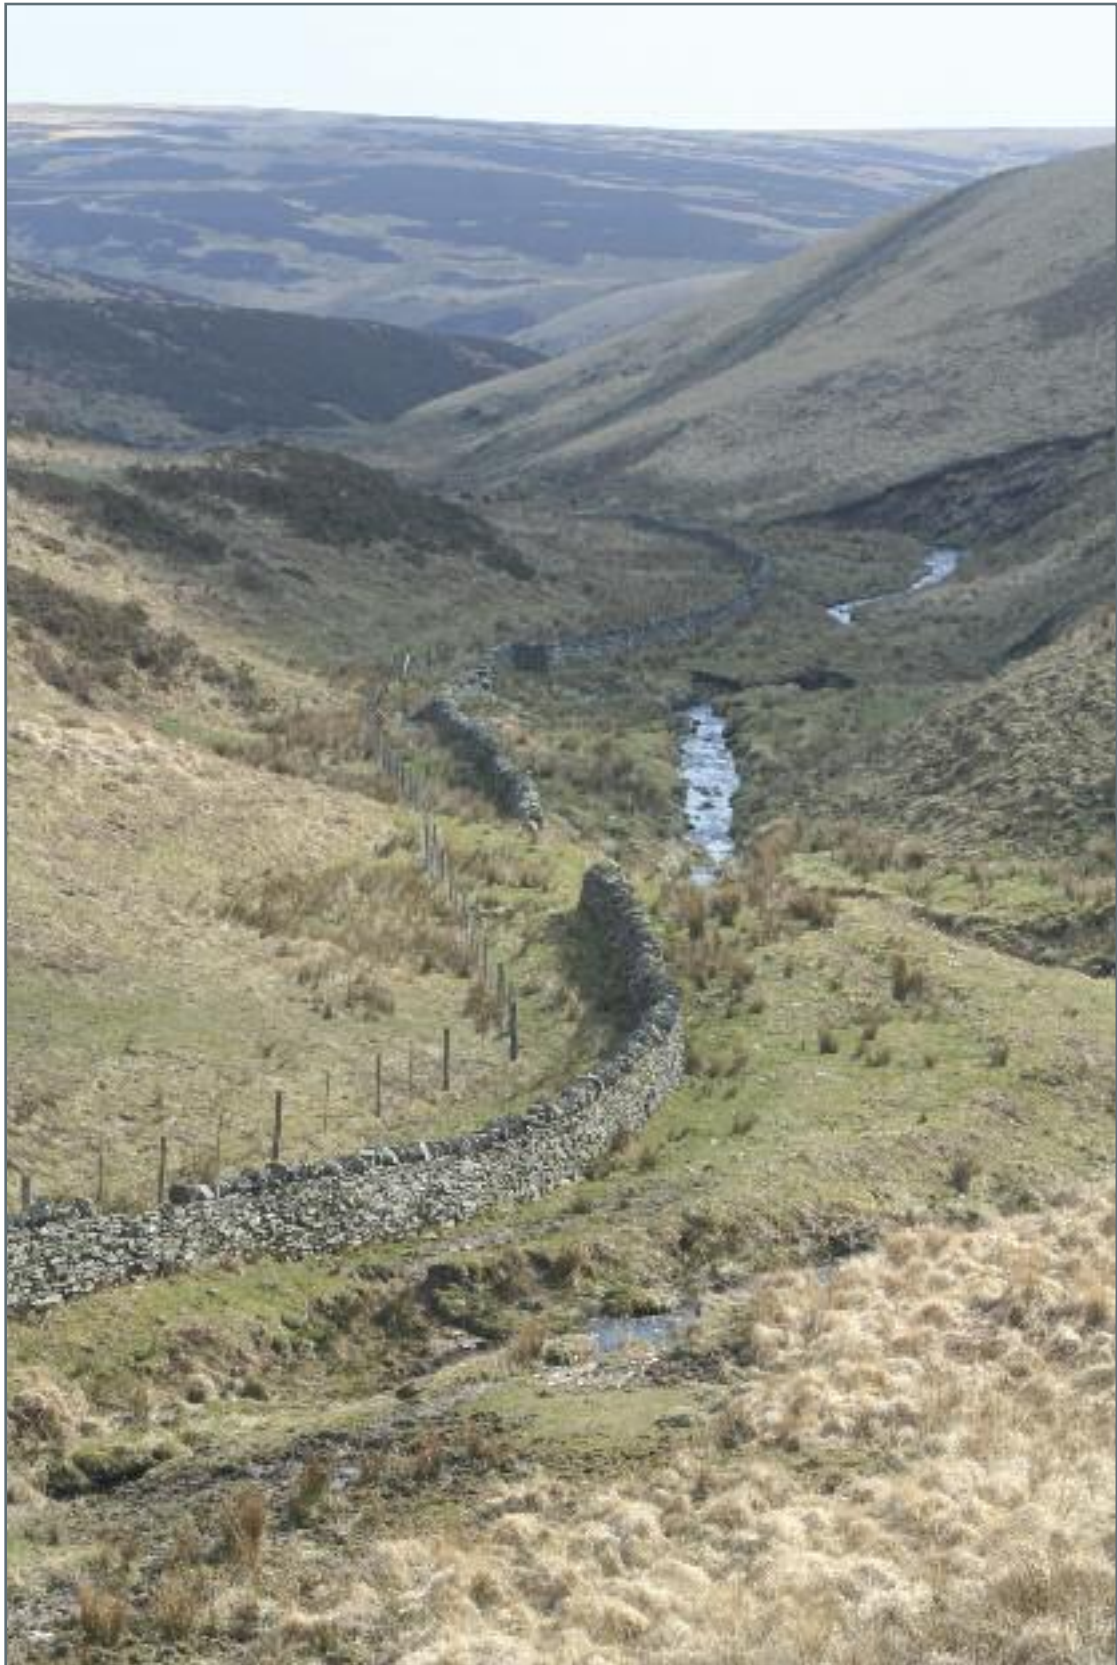
The majority of the dry stone wall boundary is collapsed, due to natural weathering and livestock erosion, or it is in a fragile condition. There are a few areas where the dry stone wall has collapsed into the stream and disappeared.

Areas of the Royal Forest boundary are built of dry stone wall in varying condition

Section 3 in particular was noted as having a large amount of collapsed dry stone walling. While there is clearly a restoration scheme underway, there remains a very large amount of work to be done. The restored wall is very obviously a different structure being thicker and more stable, but only when constructed in small sections, contrasting with the historic wall. There are parts of reconstructed wall where the capping stones have been lost, a serious structural issue. Specification of the wall restoration work could be reviewed. The work of rebuilding this section of the wall should be maintained if possible, but it is important that it is done in a way that ensures that it does not need major ongoing repairs. Regular monitoring and small scale 'running repairs' should be considered.

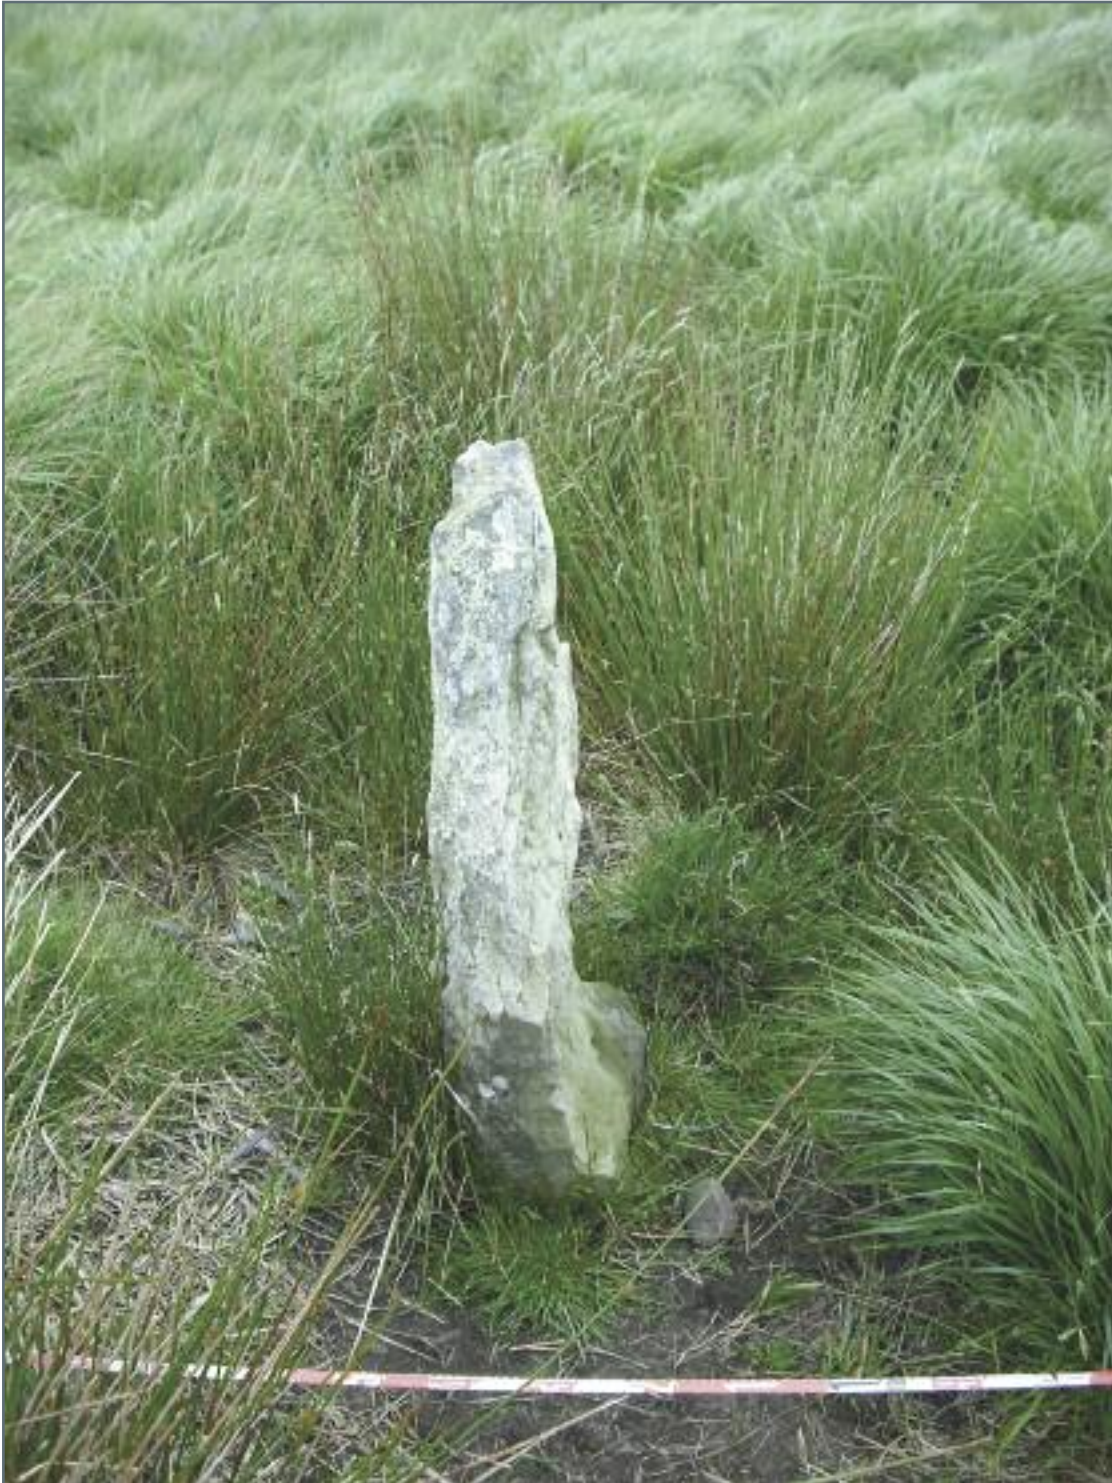
Many of the boundary stones along this section are leaning or recumbent. The ground is rather waterlogged, though this may have been exacerbated by the wet summer of 2012. Whilst most of the stones appear to be stable the ground around them does not, and the stones may be at risk of being lost within the peat.

Boundary stones still mark part of the Royal Forest boundary. It is likely that there were many more of these stones marking the medieval boundary of the Forest.

The boundary stones that make up the Royal Forest boundary are the hardest parts to conserve, and yet they, more than any other part of the boundary, evoke a sense of the medieval Forest boundary. The majority of these are in the most remote parts of the boundary, usually in areas with the least access paths, for example the boggy and wet area between Alderman's Barrow and Black Barrow (section 1). It is recommended that these should be formally monitored every five years.

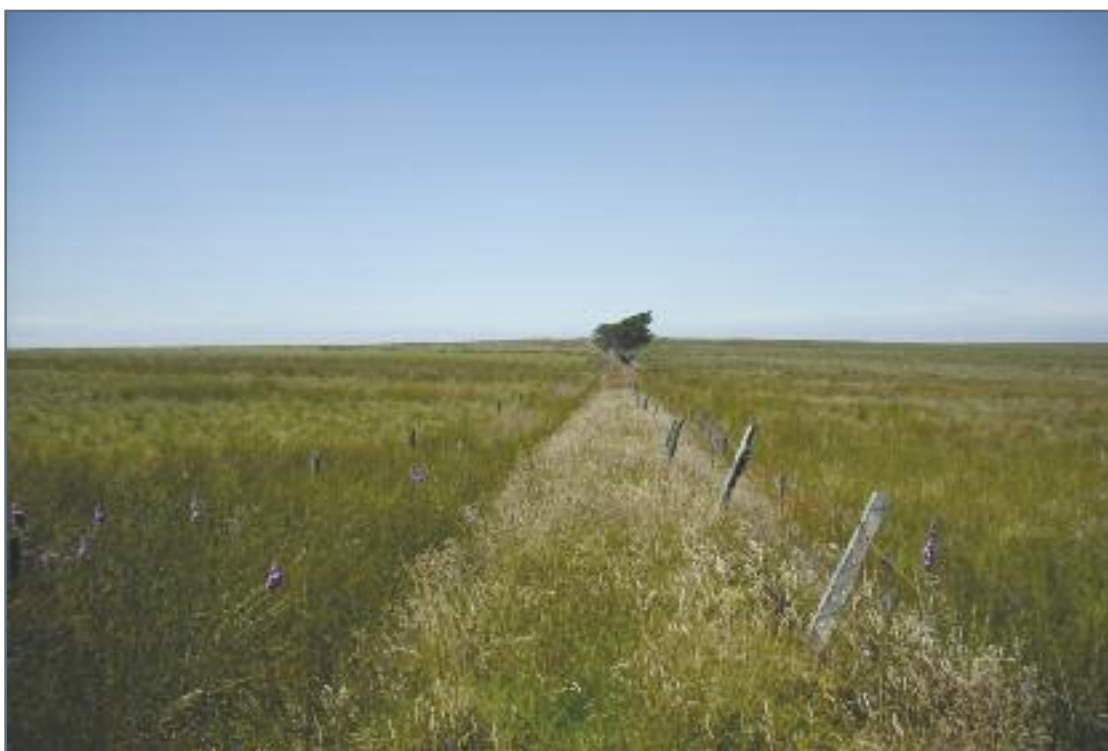
Significant areas of the Royal Forest boundary are formed of earth bank, sometimes with a beech hedge.

Where stone faced banks making up the Royal Forest boundary have been used as modern field boundaries they are generally found to be in a sustainable condition. Some areas of damage were noted but the majority appear to be maintained by the landowner or tenant. Most banks in use as field boundaries have fences on either side of them further protecting them from damage by livestock. It is therefore important that fencing and bank protection is sustained. Efforts should be made, where possible, to prioritise the consolidation of boundaries which form part of the Forest boundary.

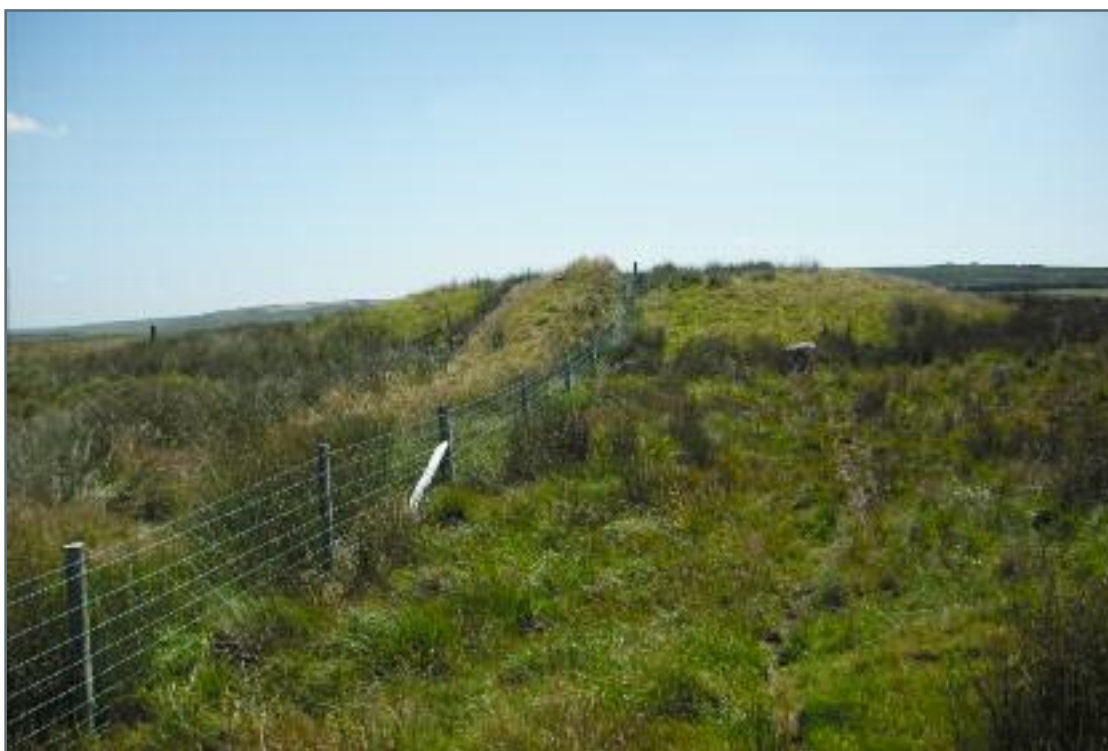
Prehistoric barrows were used as boundary markers in the original perambulations of the Forest. Setta Barrow (pictured here) is notable for the earth bank boundary constructed over the middle.

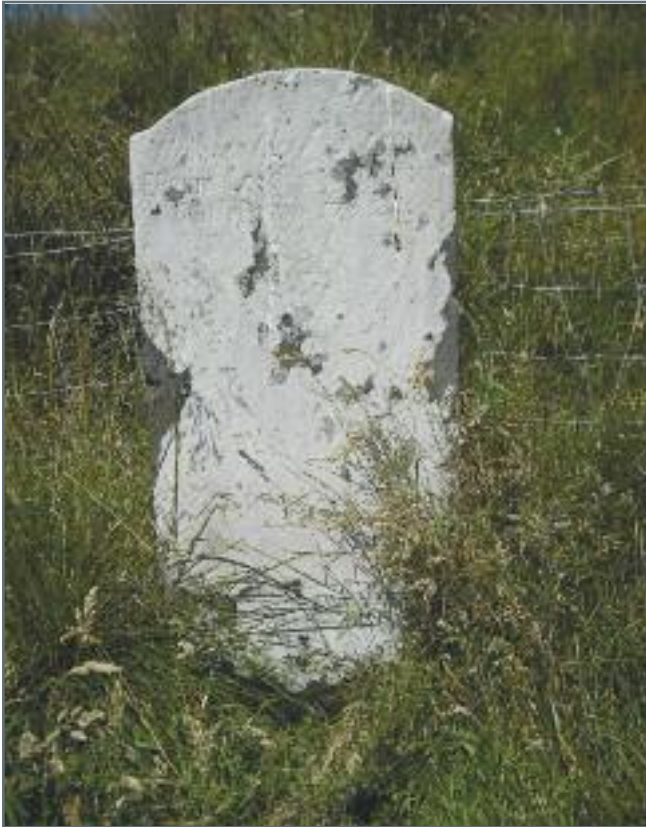
A few of the Royal Forest boundary stones are identified by name, such as Sloley Stone. This stone is unusual in featuring an inscription.

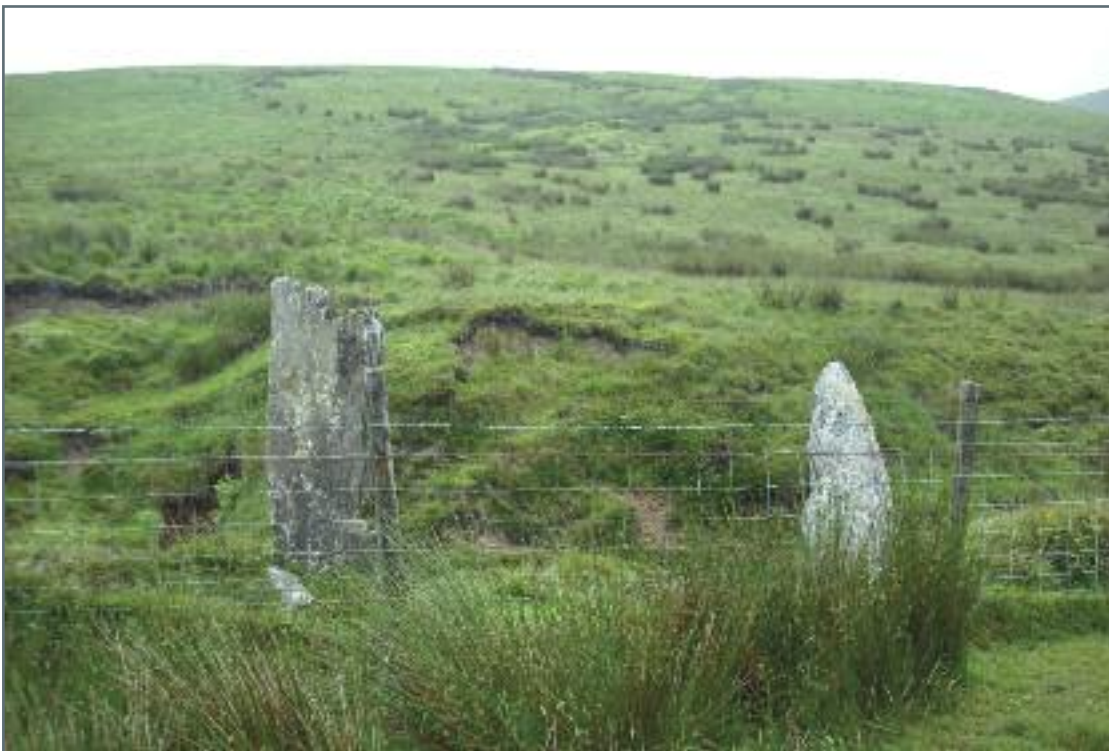
From Brendon Two Gates to Hoarok the boundary is a stone faced earth bank (with small sections of dry stone wall in the valley down to Hoarok). However, there are two large stones (4.4, 4.5), the origin and date of which are unknown, but they appear to be gateposts marking a former gateway through the boundary; they are now perched on the edge of a rapidly eroding gully forming on the south side of the boundary.

Situated along the Forest Boundary, these gateposts are now precariously placed over an eroding gully. Most likely placed under the Knight family, they serve as a reminder of the dynamic nature of the Forest boundary.
