Exmoor National Park
Historic Environment Report Series No 28

WINSFORD CONSERVATION AREA: APPRAISAL DOCUMENT

CONSULTATION DRAFT

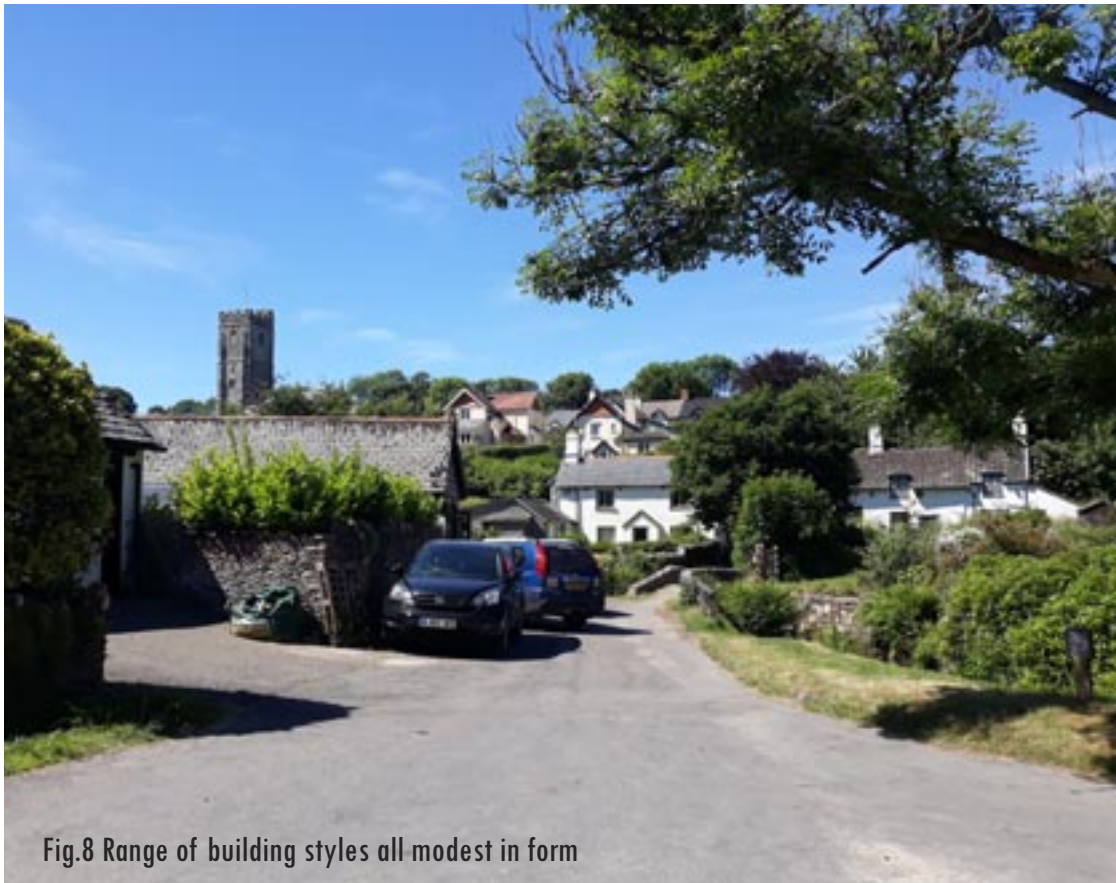
Fig.8 Range of building styles all modest in form

There is little uniformity evident in the buildings, which have evolved according to their particular purpose given at the time. The contrast between Karslake House with its uniformed façade following refacing in the early C19 and the simple form of the former Weslyn Chapel demonstrates this clearly. There are no buildings above two stories in height in Winsford other than the Church Tower.

All the early traditional cottages are modestly proportioned with little in the way of uniformity to their facades. Later C19-early C20 buildings such as Exe Vale House and The Close are larger in scale and well-proportioned but quite in keeping.

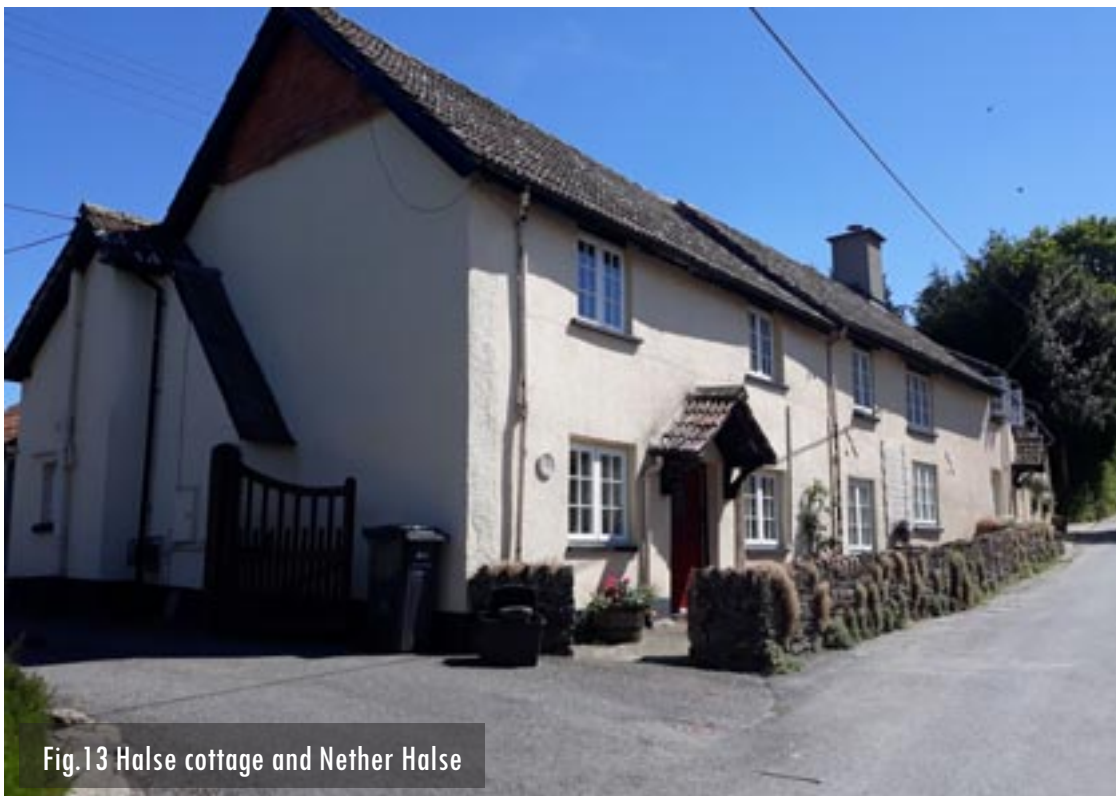
Fig.13 Halse cottage and Nether Halse

On Halse Lane, **Halse Cottage** and **Nether Halse**, although not listed, are reputedly quite early. Their long narrow profile, large rendered axial stack and lowered dormers with pent roof (as elsewhere, an indication of former swept thatch eaves), are probably of 17th-18th century origin.

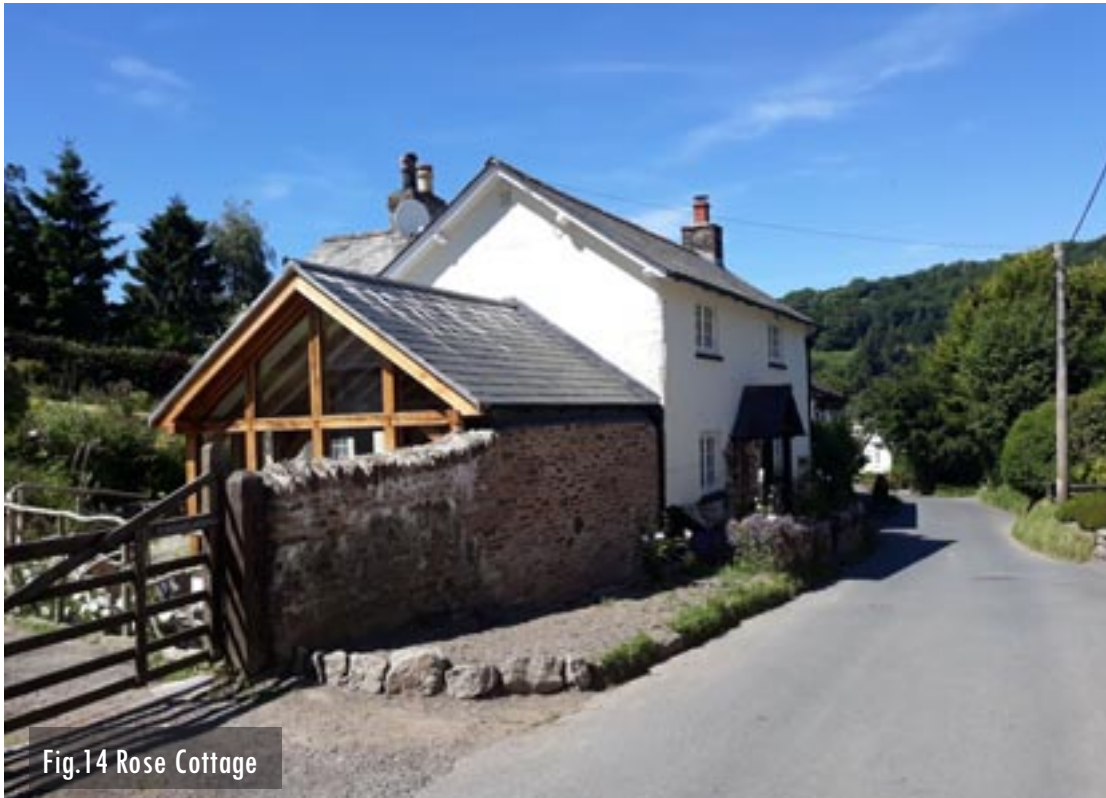
Fig.14 Rose Cottage

Almost opposite, **Rose Cottage** is 19th century or earlier and has a late 19th century porch and a recent side extension with a timber framed, glazed gable end.

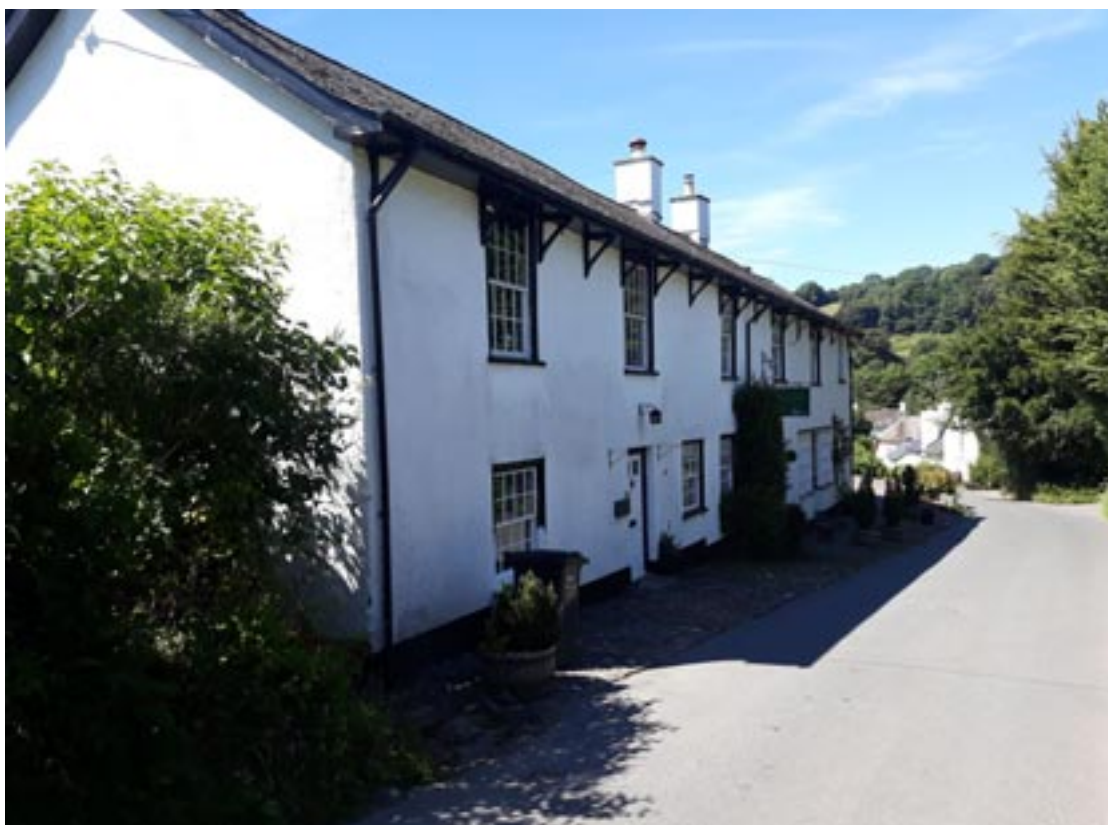
Karslake House, one of the largest buildings in the village, rendered over rubble, with slate roof and front overhanging eaves on timber brackets, was previously a farmhouse and malthouse dating from the 16th-17th century. The six bay frontage has early 19th century 16-pane sash windows mainly at first floor level and in raised surrounds. The long rear outbuilding is mainly 18th century with subsequent alterations made, mainly in the late 20th century. The listing details mention that the name derives from Sir John Karslake, Attorney General 1867-1868 and that it was a shop in the early 20th century with double shopfront with smallpaned windows surviving.

Fig.15 Karlake House has 16th century origins, but most frontage detail is 19th and 20th century, including a former shop-front added in the early 20th century.

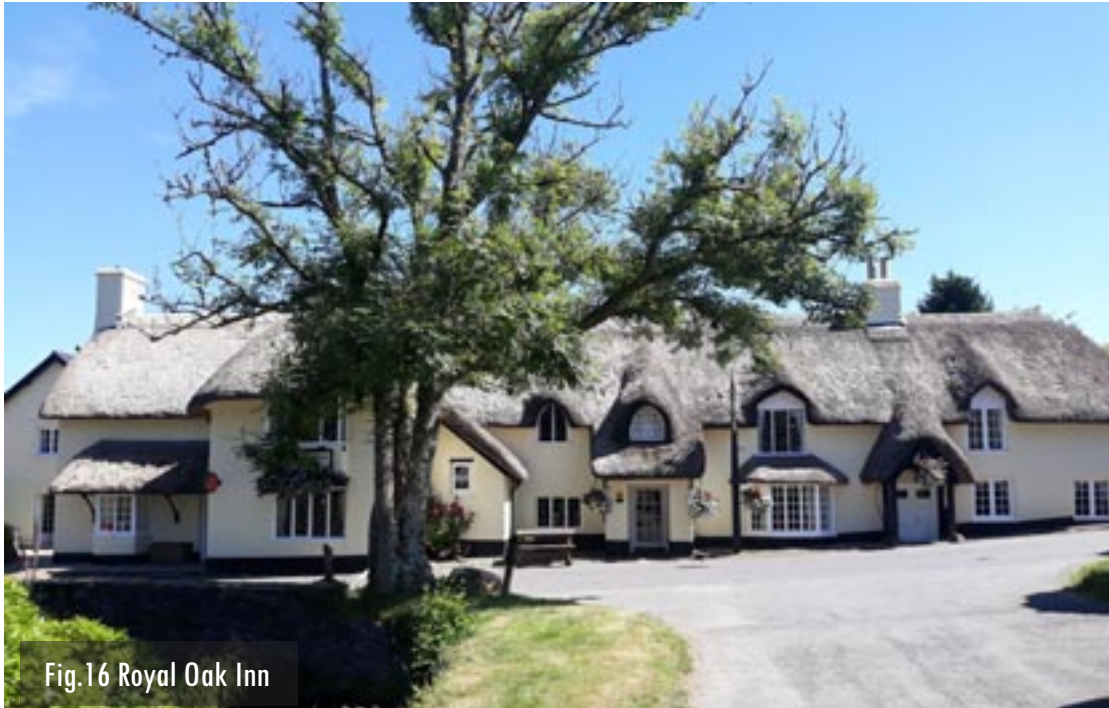
Fig.16 Royal Oak Inn

Of the most prominent secular buildings, **The Royal Oak Inn**, has pride of place in the village. Thatched and rendered, it was formerly a farmhouse before becoming an inn, and with annexes to the side and rear is now also a hotel. The original building, probably three-cell and cross-passage, dates from the 16th-17th century, with a cross-wing extension at the second bay to the left. It has been much altered and enlarged since the 19th century and most of the distinctive fenestration, including timber casement windows, some with astragal glazing bars, is 19th-20th century. The projecting cross-wing, dormer window set in adjoining catslide extension, prominent swept eaves and gabled porch, all thatched, contribute to a frontage of exceptionally picturesque character. Pevsner describes the building as having thatch undulating over dormers and of being mostly late Georgian too with an older core

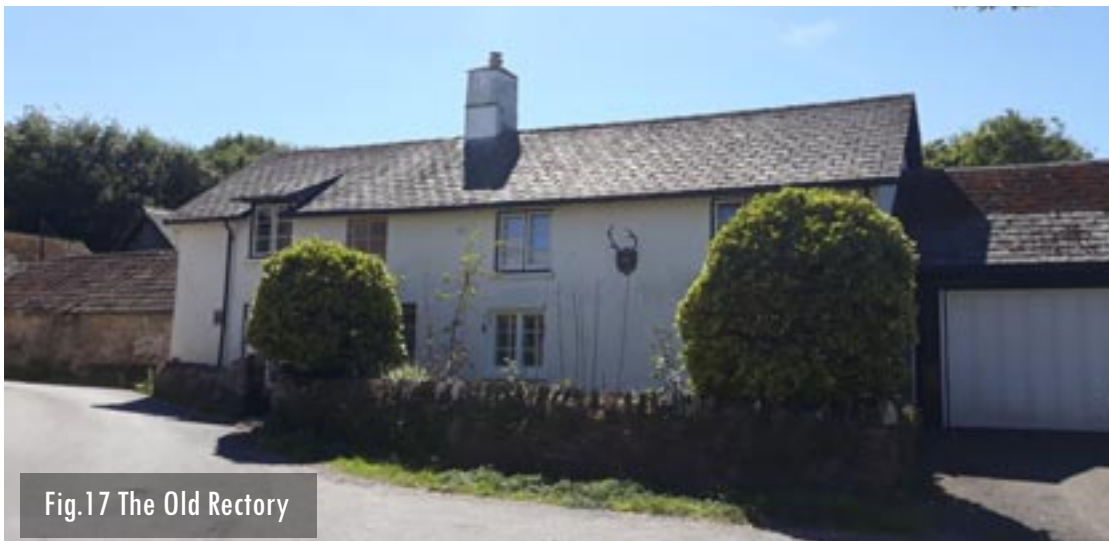
Fig.17 The Old Rectory

The Old Rectory is a former farmhouse, originally thought to be known as "Incladons Hay", and thought to date from the 18th century, though with possible medieval origins. It has an early-mid 19th century panelled door, with the top four glazed. There is a 19th century wrought iron entrance gate similar to Royal Oak Cottage. To the south and west are extensive **farm outbuildings**, including a long barn with two sets of double doors to probable former threshing floors. Facing a yard to the rear is a former cart-shed and a shippon, the latter with round-section stone piers, a typical local vernacular feature, usually of c.18th century date.

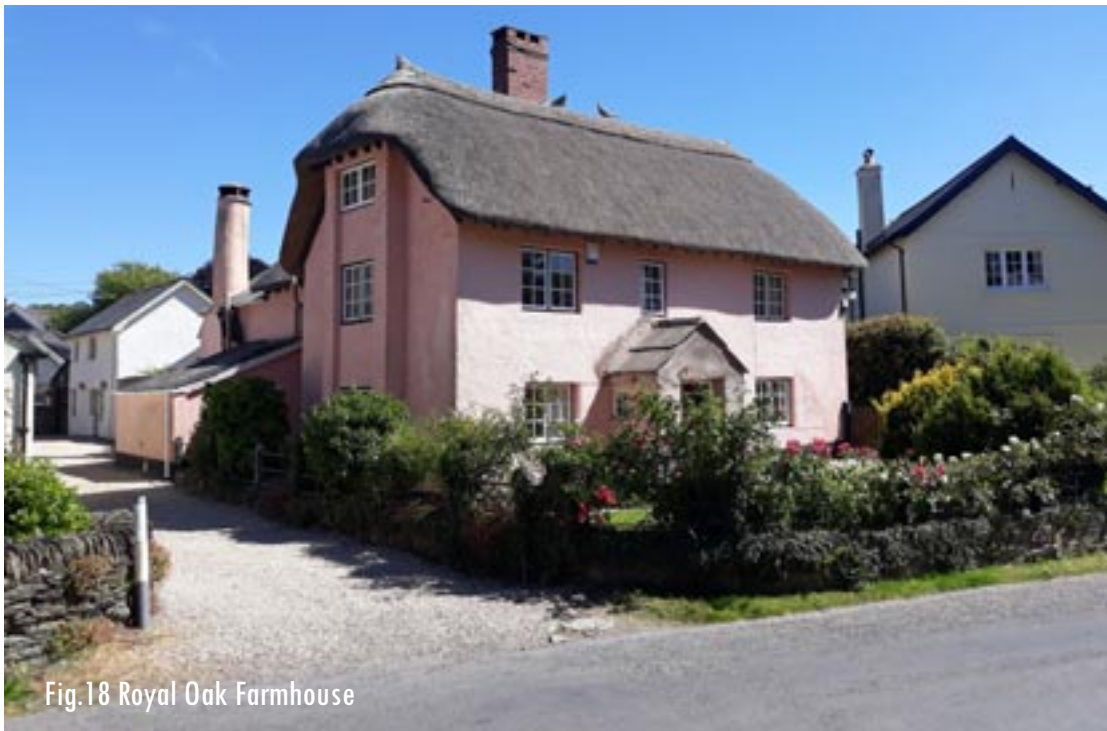
Fig.18 Royal Oak Farmhouse

Close by and much plainer is the **Royal Oak Farmhouse**, also thatched and rendered and dating from the 16th-17th century and now a dwelling. Originally of two-cell and cross-passage plan on an east-west axis, a further two-cell and cross-passage addition was added at the west end. This has half-hipped gables giving light to attic level. The tall central lateral stack to the rear of the added west frontage appears typical of the 17th century. It was re-fronted in the 19th century with a gabled porch likely added at this time.

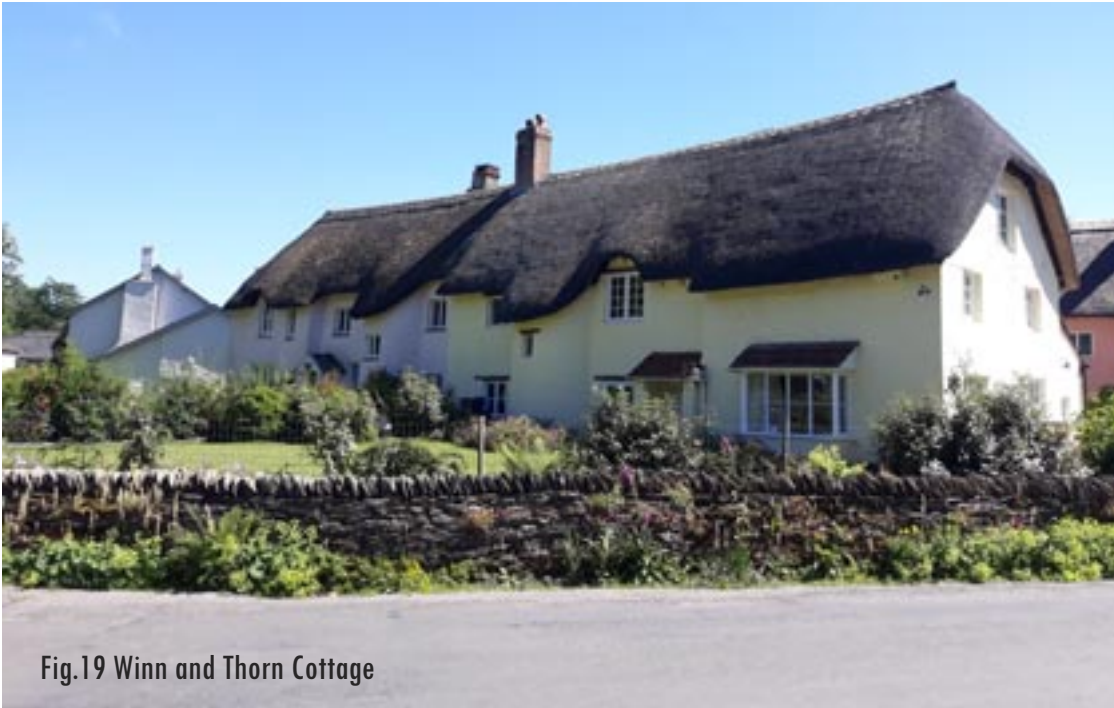
Fig.19 Winn and Thorn Cottage

Completing this picturesque group at the centre of the village where the lane curves, and set well back is a semi-detached cottage pair, **Winn Cottage** and **Thorn Cottage**. Both are also thatched and rendered over stone rubble and possible cob, and are indicated in the listing details as late 18th century/early 19th century but appear earlier. Both have long irregular frontages with swept eaves and projecting circular stone turrets on the façade. There is an attic storey light set in the half-hipped gable as at Royal Oak Farmhouse. There is evidence of 19th and 20th century alterations in fenestration, mainly timber casement windows below timber lintels. Thorn Cottage has a small enclosed porch with gabled roof, and 19th century half-glazed door with marginal glazing bars. Winn Cottage has an added porch and square bay, both probably early 20th century with Bridgwater tiled pentice roof. The listing details note that this pair; “forms a picturesque group with an unusual plan for a pair of semidetached cottages in West Somerset.” Pevsner describes the buildings as being late Georgian in date with rounded stair turrets to the front.

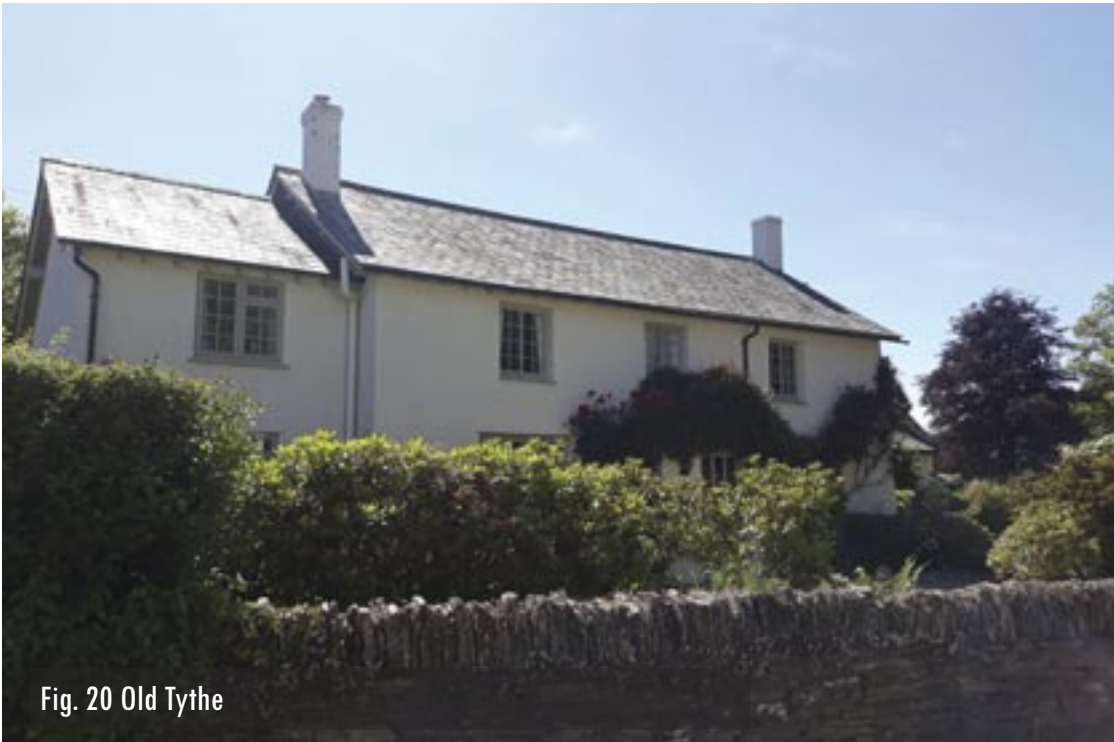
Fig. 20 Old Tythe

Heading south down Edbrooke Road **Old Tythe** has 8- pane casements with narrow glazing bars was formerly the village bakery, and appears to have 18th century or earlier origins.

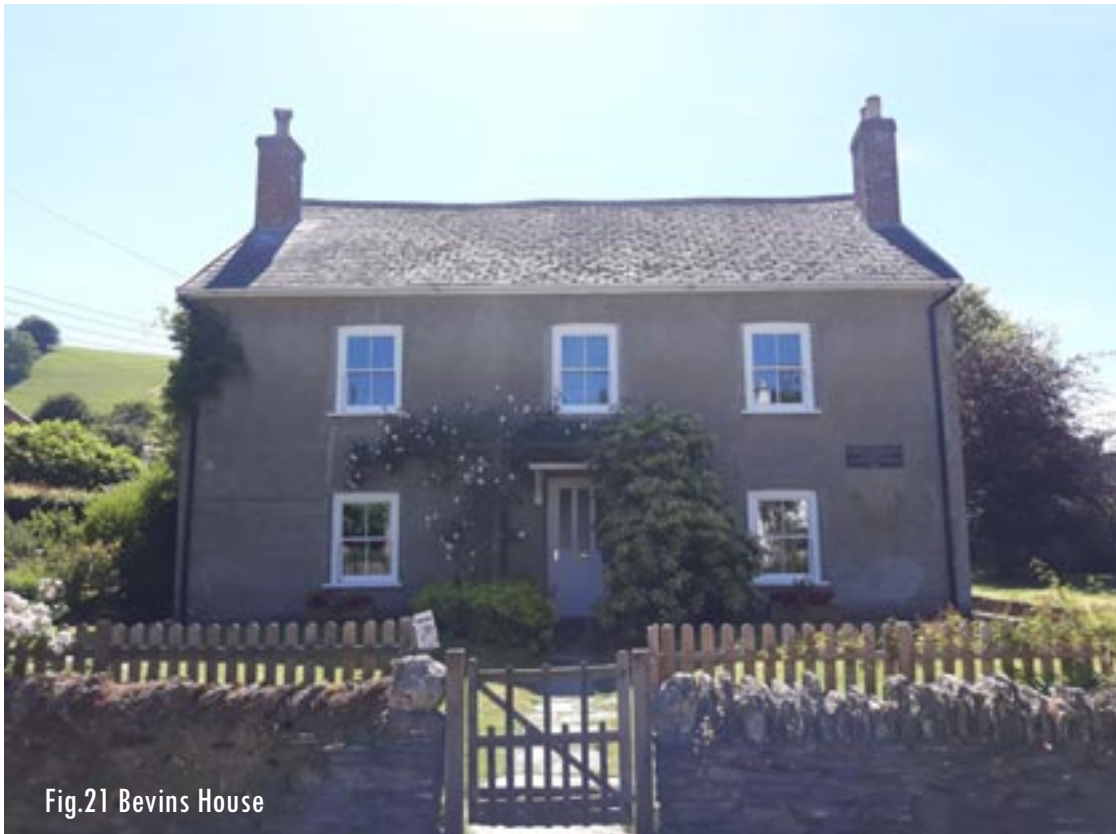
Fig.21 Bevins House

Of particular historic importance is **Bevins Cottage** with a late 19th century frontage, probably originally a two-cell cottage with cross-passage but with the roof raised subsequently. The three-bay frontage has sash windows with single vertical glazing bar, central half-glazed door with two lights. This was the birthplace and home for his first eight years of Ernest Bevin 1881-1951, statesman and trades union leader who also attended the village school.

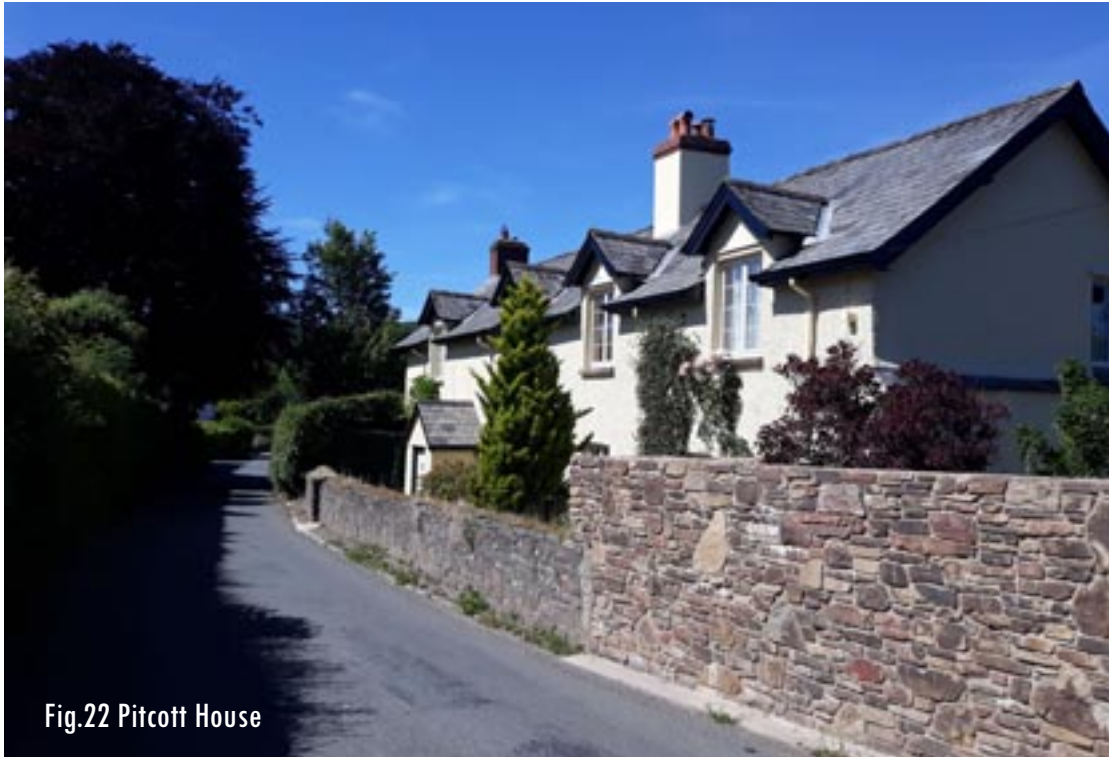
Fig.22 Pitcott House

Returning towards the village on the Edbrooke Road on the opposite site is the former Corn Mill at Pitcott, probably dates from the late 18th – early 19th century and is now a private house. **Pitcott House** a large house dominant in the street scene, is difficult to date, but probably a former farmhouse of early origin. The small-pane metal casement windows and plank doors are probably early 19th century.

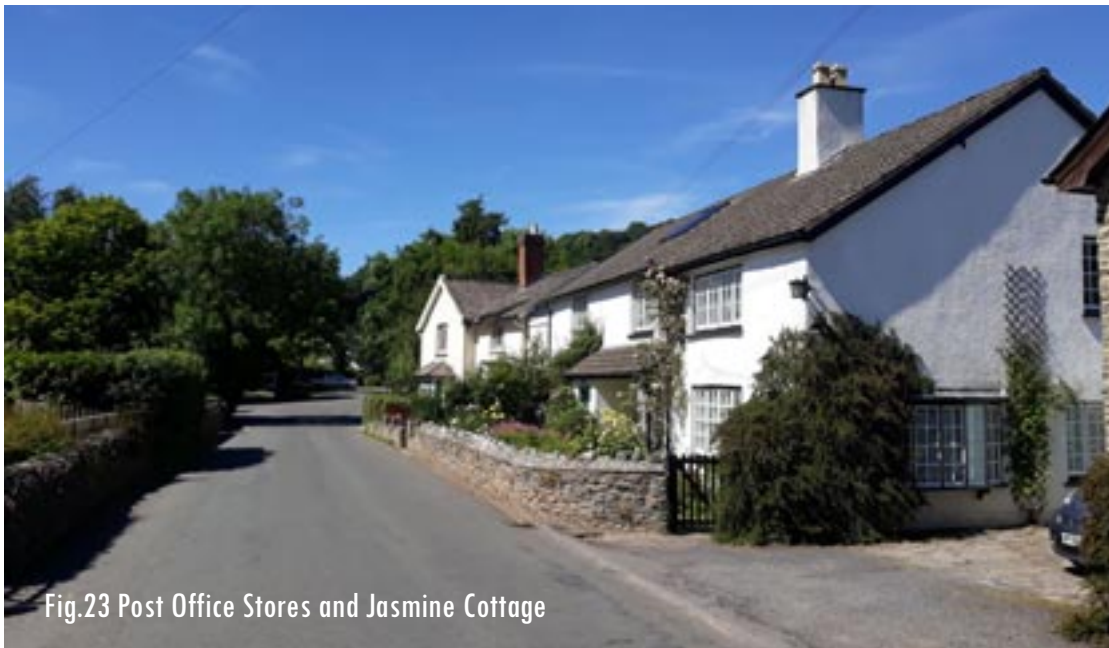
Fig.23 Post Office Stores and Jasmine Cottage

The group consisting of **Post Office Stores** and **Jasmine Cottage** date from the 19th century. The latter is recorded as built in 1866 on Sir Thomas Dyke Acland's land by Joseph Steer a local building contractor who set up the adjoining carpenters' workshop, now called **The Old Timber Store. Weirside** was formally a Methodist chapel but was poorly converted in the 1980s, little evidence of its former use or appearance remains.

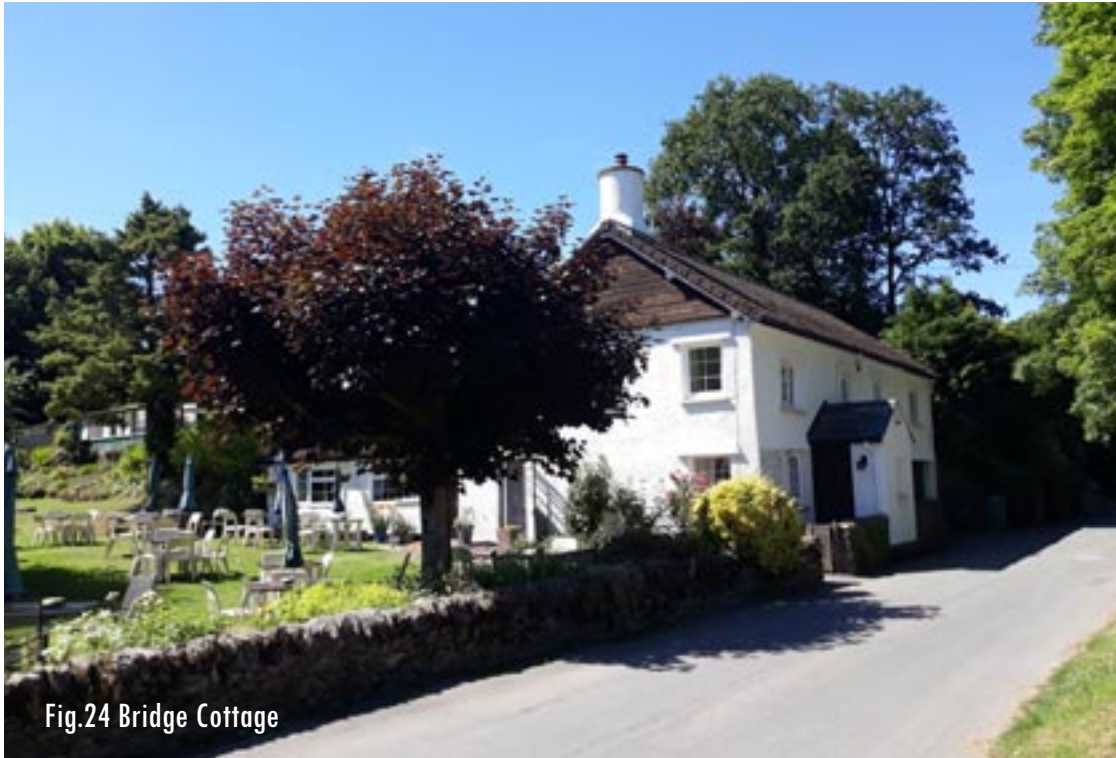
Fig.24 Bridge Cottage

Returning to the village centre, **Bridge Cottage**, a tea room since c.1950, is thought to date from c.1780. It was originally thatched, and bears the typical Acland estate feature of triple ogee-arched windows with drip-mould above, and round-section stack, probably added in the early-mid 19th century.

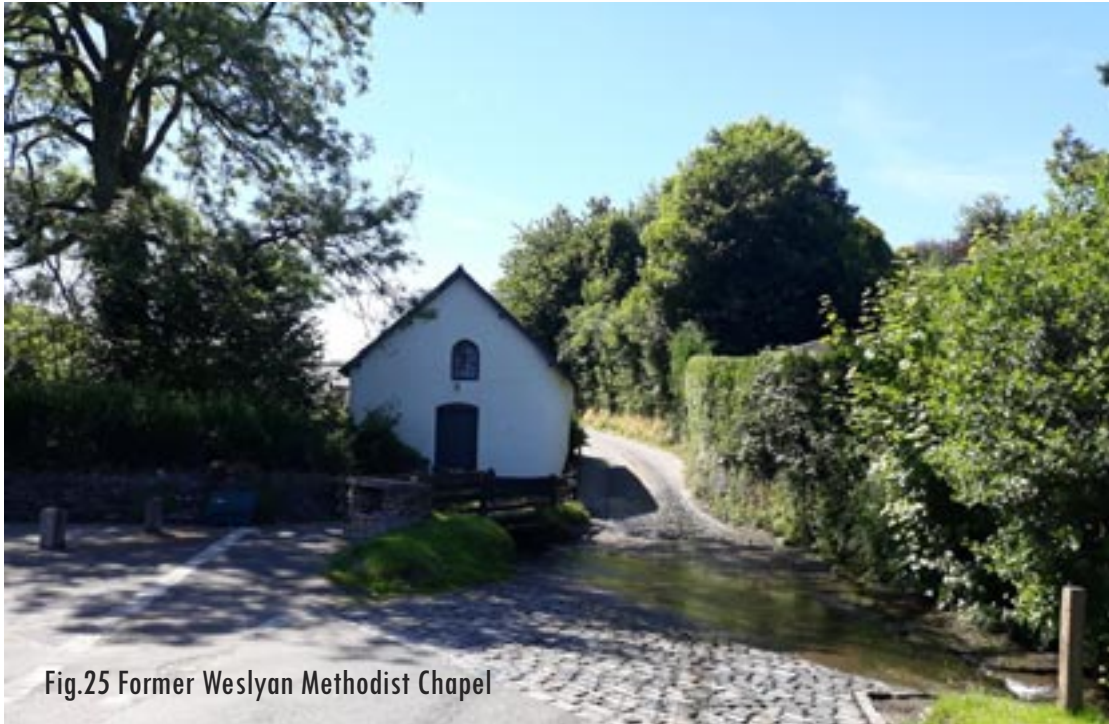
Fig.25 Former Wesleyan Methodist Chapel

Other significant buildings, some of more historic than architectural interest, all lie close to the River Winn. These are the former **Forge** mentioned in a record of 1870 but converted to a dwelling and lock-up shop in the 1930s and an **early Wesleyan Methodist Chapel**, adjoining the ford. This dates from the late 18th century and was formerly thatched. It became the village hall from 1884 when the new Methodist Chapel was built, until the new hall was built in 1952.

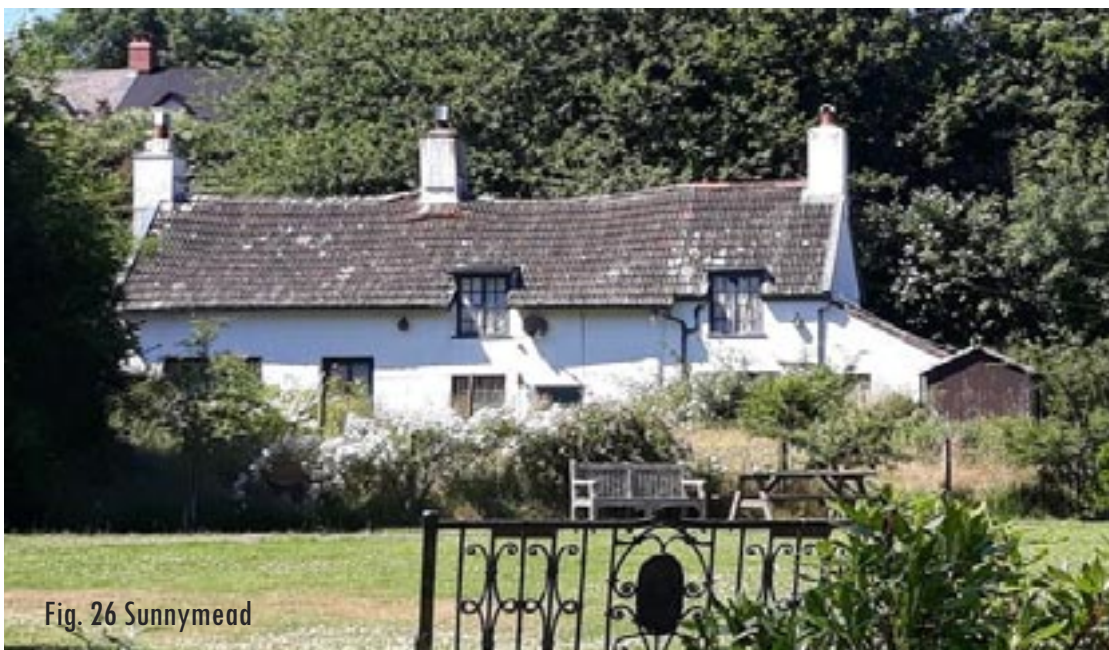
Fig. 26 Sunnymead

Another detached cottage is **Sunnymead**, originally 17th century but extended and re-fronted in the early 20th century. Probably originally a three cell and cross-passage plan, but since altered internally. Rendered over rubble and possibly some cob, there are three rendered stacks. The below eaves first floor windows indicate a former thatched roof with swept eaves, and there is an early 19th century iron-frame casement window with leaded-lights. The listing details mention that this cottage is "principally listed for its contribution to the picturesque village scene, overlooking village green."

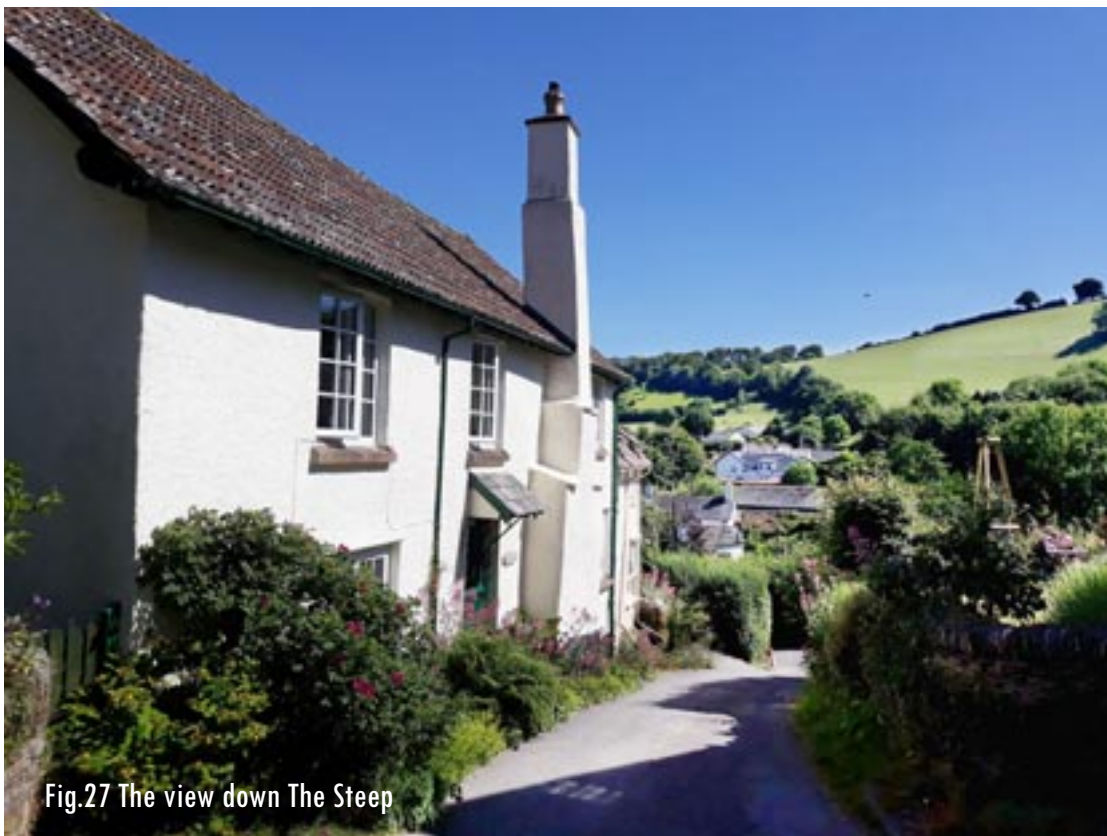
Fig.27 The view down The Steep

A compact group to the east of the church consists of **Church Cottage**, **Gallifords**, **Steep Cottage** and **Gay's Cottage**. Each retains some vernacular features, indicating an 18th century or earlier date, for example shouldered front lateral or gable end stacks with square-section rendered uppers and six-panel door with steps up at Church Cottage. The plain timber casement windows, some small paned and plank doors are probably of 19th century origin.

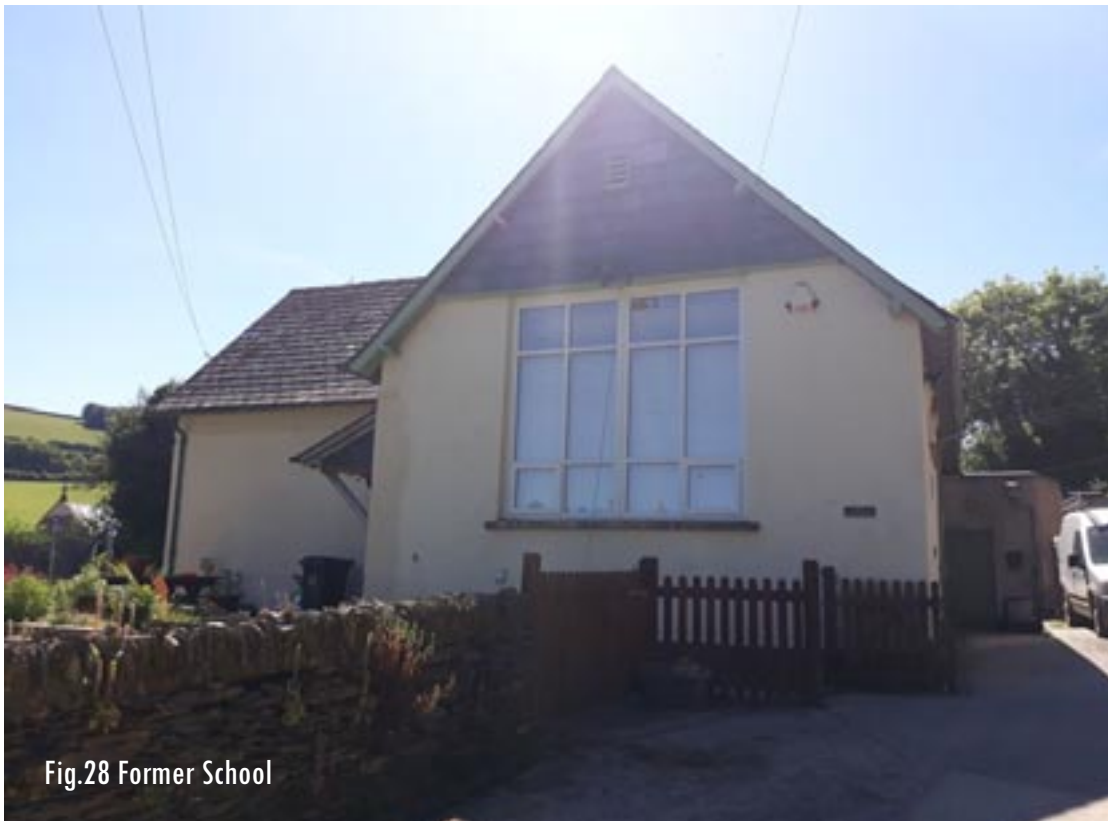
Fig.28 Former School

The **former school** building was built by the Acland family in 1881 who had expressly wished that the building should always be used for educational purposes. During the Second World War, there were over 100 pupils in the school. It was closed forcibly in 1995. Rather than convert the property to a house, a charity was formed to keep the building for community use operating as a community computing centre, doctor's surgery and a complementary health care centre. This use ended in 2012 and it is now local needs affordable housing.

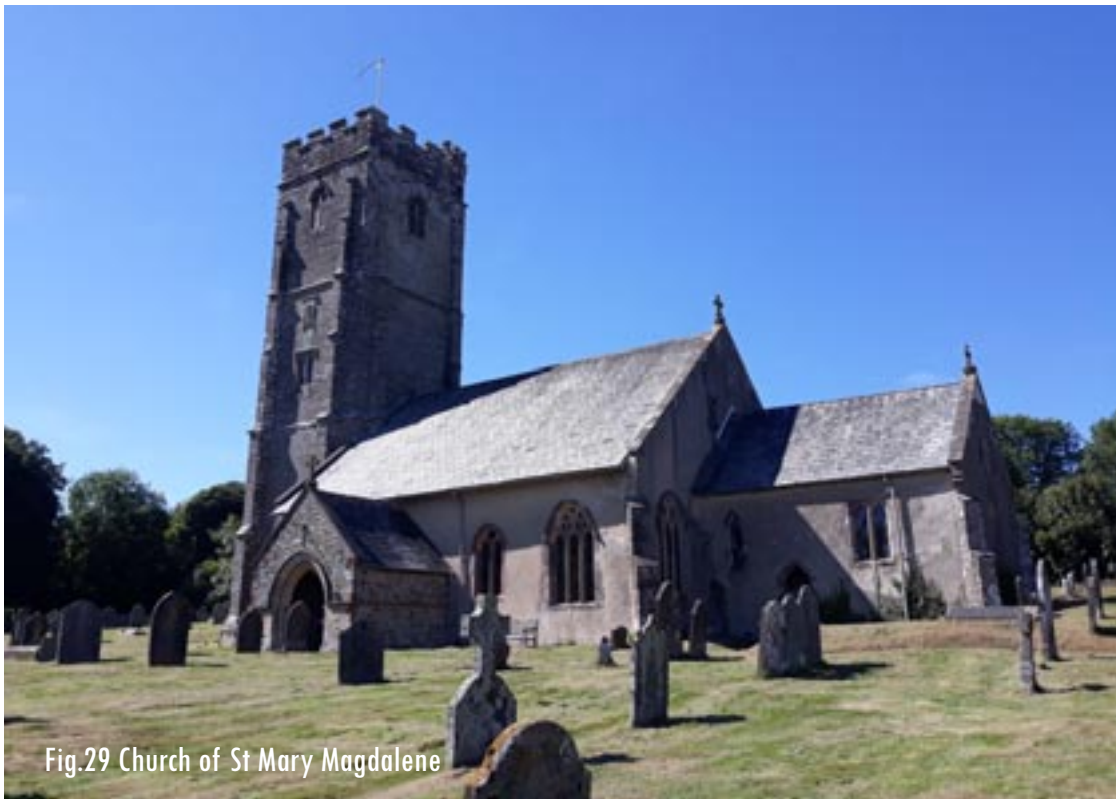
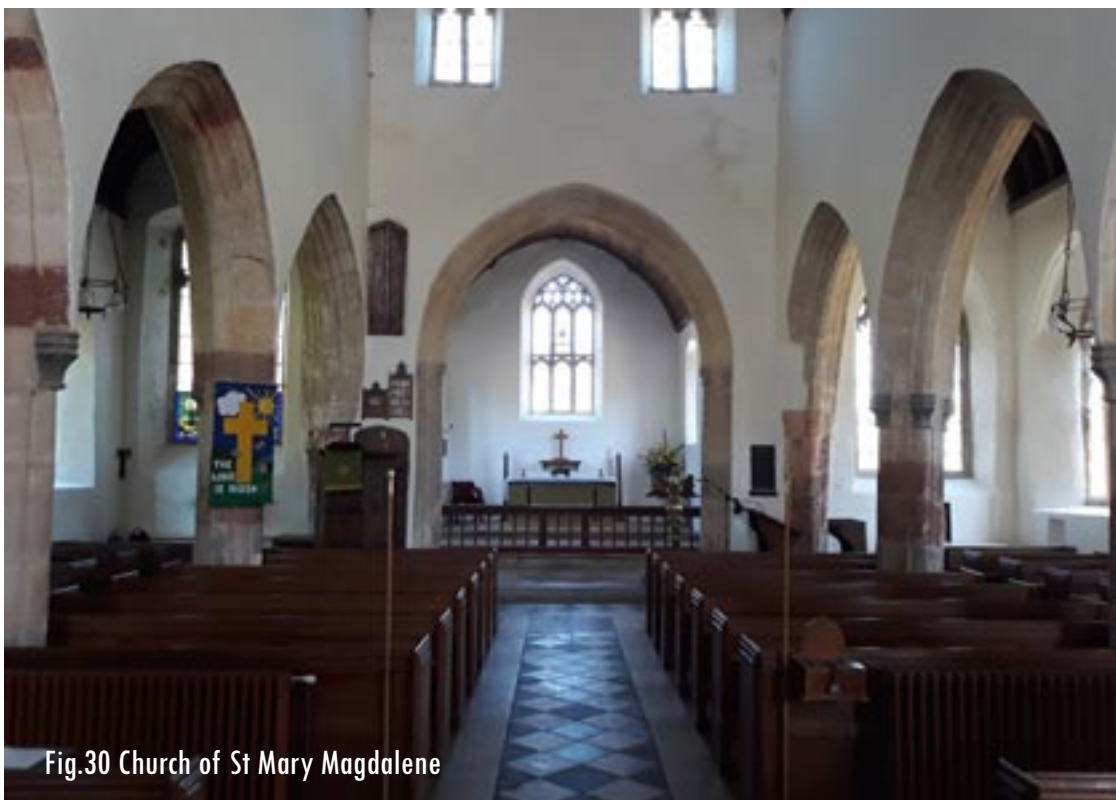
Fig.29 Church of St Mary Magdalene

Fig.30 Church of St Mary Magdalene

The Parish Church recorded in the listing details as formerly dedicated to St. Peter The Apostle, has been dedicated to St. Mary Magdalene since the late 19th century. There is some Norman work, for example the carved font. The chancel is 13th century, as is a rare survival of iron work to the early medieval door which was reportedly removed from nearby Barlynch Priory. The nave aisles and tower are in typical Perpendicular style of c. 1450. The crenellated three-stage tower with set back buttresses and crenellated north-east stair turret is unusually tall by Exmoor standards, and the listing details state "it is very rare in the west Country to find the nave wall lit at the chancel end." Other distinctive features are the Jacobean pulpit, a piece of 14th century stained glass in the East window, and open wagon roofs, restored in the 19th century, but with original bosses and wall plate. The listing details also note that a "painted panel of the Royal Coat of Arms of James I dated 1609, (is) said to be one of only 4 extant."

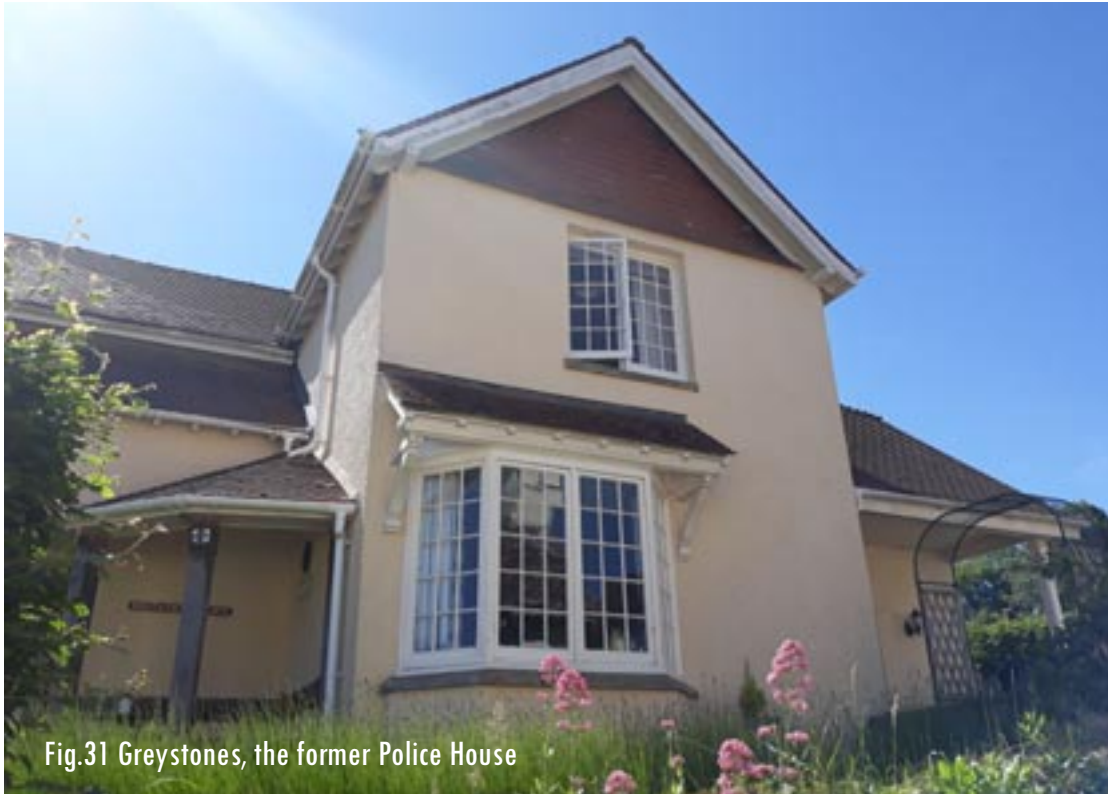
Fig.31 Greystones, the former Police House

The former **Police House** (now Greystones) contains small pane timber windows that imitate those found in the Royal Oak. The elevations were formally slate hung as a reference to other Exmoor buildings but this has now unfortunately been removed. Winsford had a village policeman until after the Second World War. The Police Station was moved from Pitt Cottage to Greystones in the 1930s.

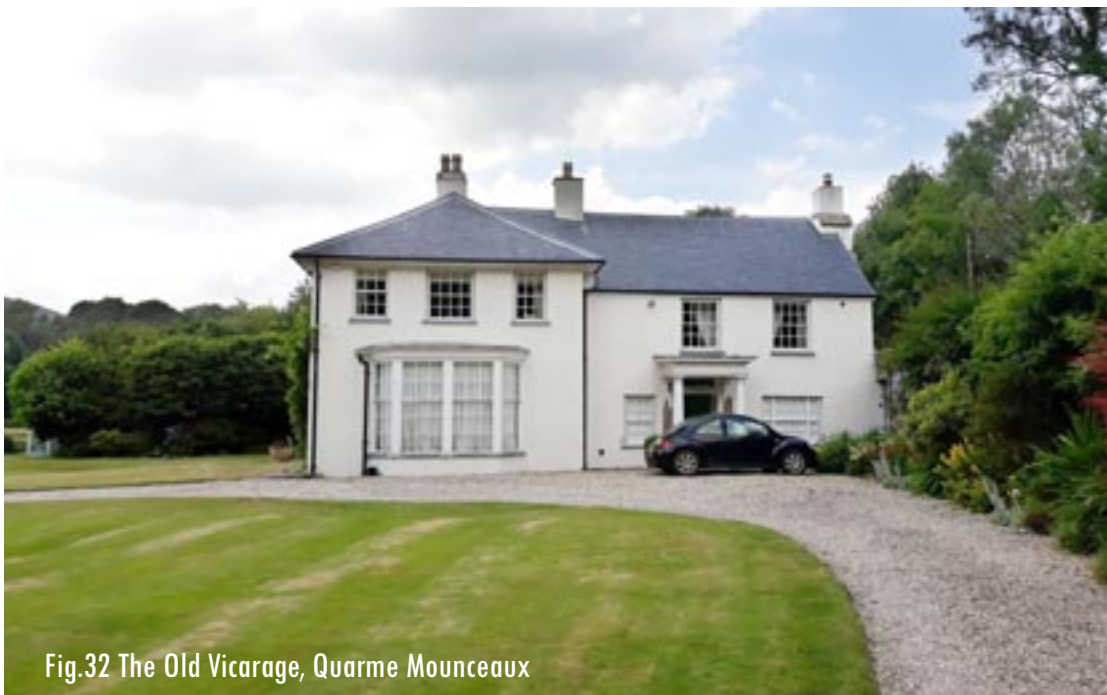
Fig.32 The Old Vicarage, Quarme Mounceaux

The Old Vicarage, now a private dwelling named **Quarme Mounceaux**, has 16th-17th century origins and was substantially enlarged in the early-mid 19th century. Built of roughcast over rubble with asbestos slate roof, the present L-plan consists of the original building, which was probably two cell with cross passage (there are said to be surviving moulded ceiling beams). The shouldered external stack set axially in the blind gable adjoining the highway is typical of the 17th century. The new wing with hipped roof, overhanging eaves on paired brackets and with 12, 15 and 16-pane sash windows, including one tripartite to the right of the six-panelled entrance door, with panelled reveals are typical late Georgian/early Victorian features. Pevsner describes the building as being stuccoed, late Georgian hip roof addition to an earlier house.

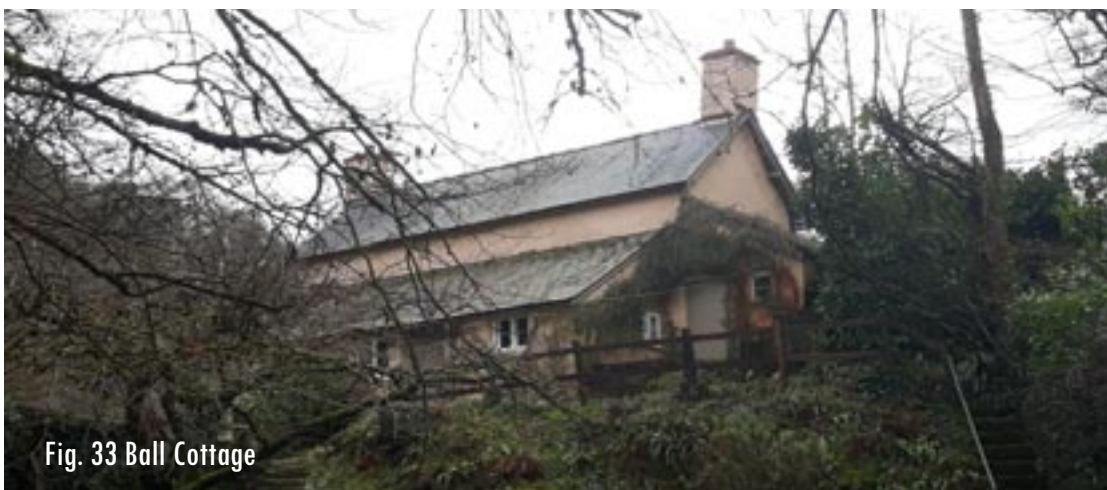
Fig. 33 Ball Cottage

At the northern end of the village, **Ball Cottage** outwardly of late 18th century or early 19th century date but possibly of earlier origin, is an unspoiled cottage, with plank doors and timber casement windows. Built on a spur of underlying rock with end gable and projecting stack facing the highway, it fully retains original character of colour-washed stone rubble, and slate roofs including the added lean-to rear extension. Also in this part of the village the **former Vicarage stables** is two storey and stone built with half-hipped slate roof, and is probably contemporary with the early 19th century extension having shallow segmental arched openings and six-pane sash windows. Also at this end of the village, **Pitt Cottages** rendered with slate roof and brick stacks, have low gabled dormers and timber casement windows, and are probably early 19th century. Beyond is a corrugated iron garage/store.
