Exmoor National Park
Historic Environment Report Series No 28

WINSFORD CONSERVATION AREA: APPRAISAL DOCUMENT

CONSULTATION DRAFT

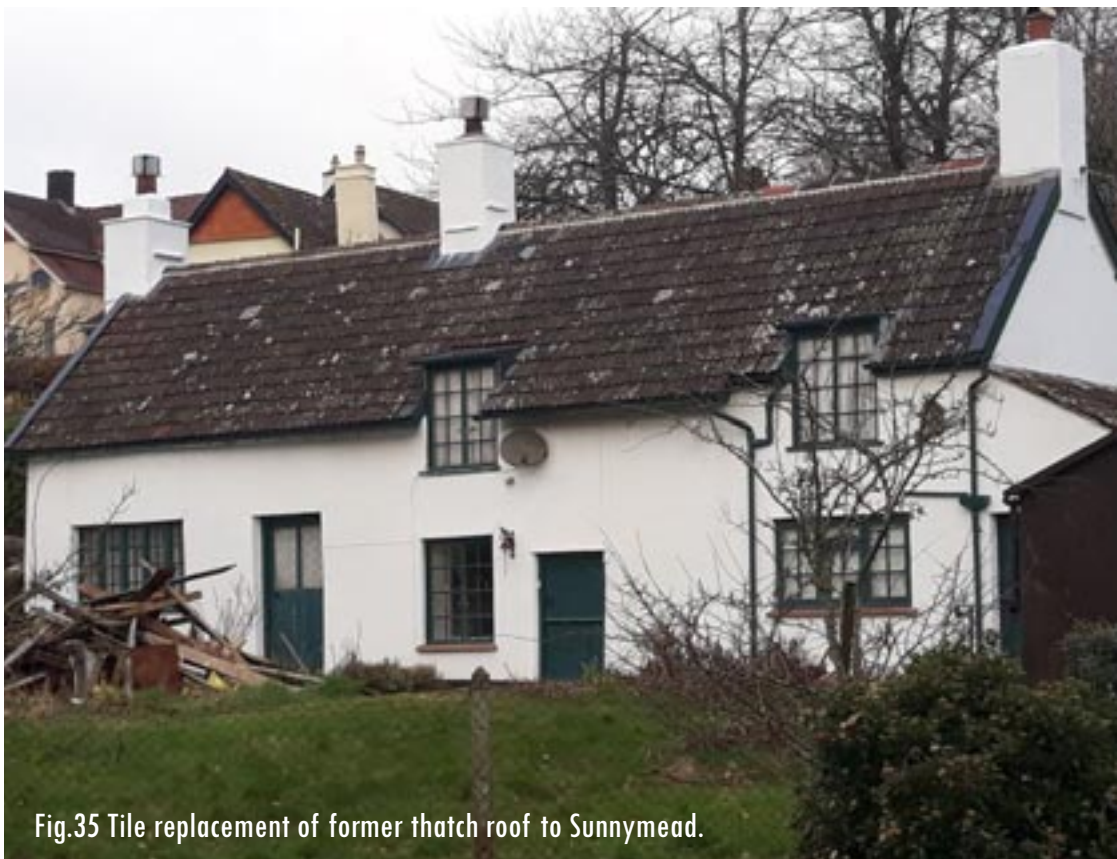
The high cost of transportation meant that imported slate only became readily affordable from the mid 19th century. Cheaper transportation also brought costs down for Bridgwater tiles, double and single Romans and similar variants and meant they could be utilised on cottages and these newly obtainable materials replaced the existing thatch on many cottages over the next century (Fig.35). Tiles were also utilised on new buildings of the period, for example The Close where the 'fish-scale' variety is evident.

Thatch was originally the predominant roofing material, with several good examples of its use surviving, especially The Royal Oak and adjoining cottages. Elsewhere clay pantiles from the Bridgwater area of Somerset have replaced thatch. Up until the later 19th-century thatch would have been the only available roofing material for all but the highest status buildings. Traditionally, thatch was combed wheat reed. In recent years, this tradition has been under threat from the non-indigenous water reed, much of which is now imported from Eastern Europe.

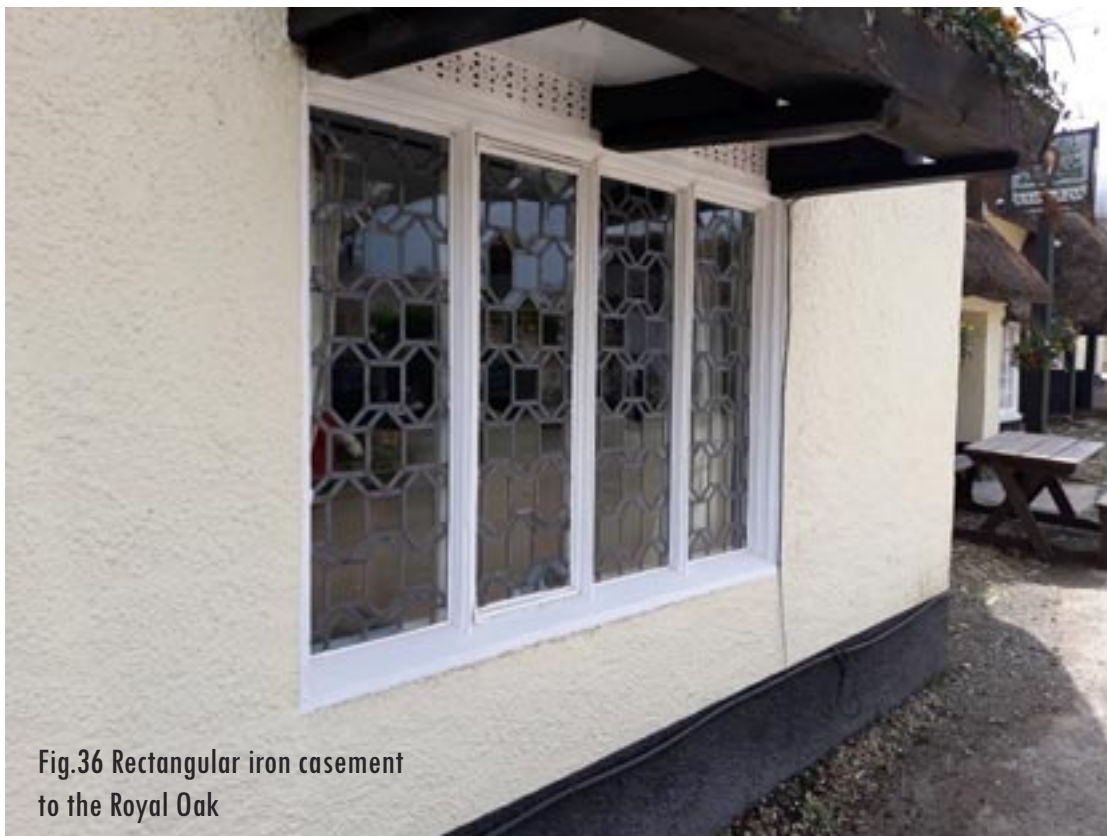
Historic windows in the conservation area are mainly a mixture of timber and metal casements. Although this has long been the traditional local vernacular pattern, there are also good examples of sash windows, for example, the former Vicarage and Karlake House where the pattern is of narrow glazing bars, indicating Georgian or early Victorian origin. A good later 19th century example with fewer glazing bars can be seen at Bevin's Cottage. There are a few examples of forged iron frames, and of decorative glazing patterns, as in the ogee-arch pattern windows at the Tea Room, a "trademark" feature of cottages once part of the Acland estates. Elsewhere, small pane timber or leaded light glazing patterns, mainly plain rectangular are evident, as at the Royal Oak Inn. Interestingly, this pattern is imitated at the former police house. This imitation of earlier patterns is typical of the Arts & Crafts tradition, which flourished from the late 19th century until c.1930

**Fig.36 Rectangular iron casement
to the Royal Oak**

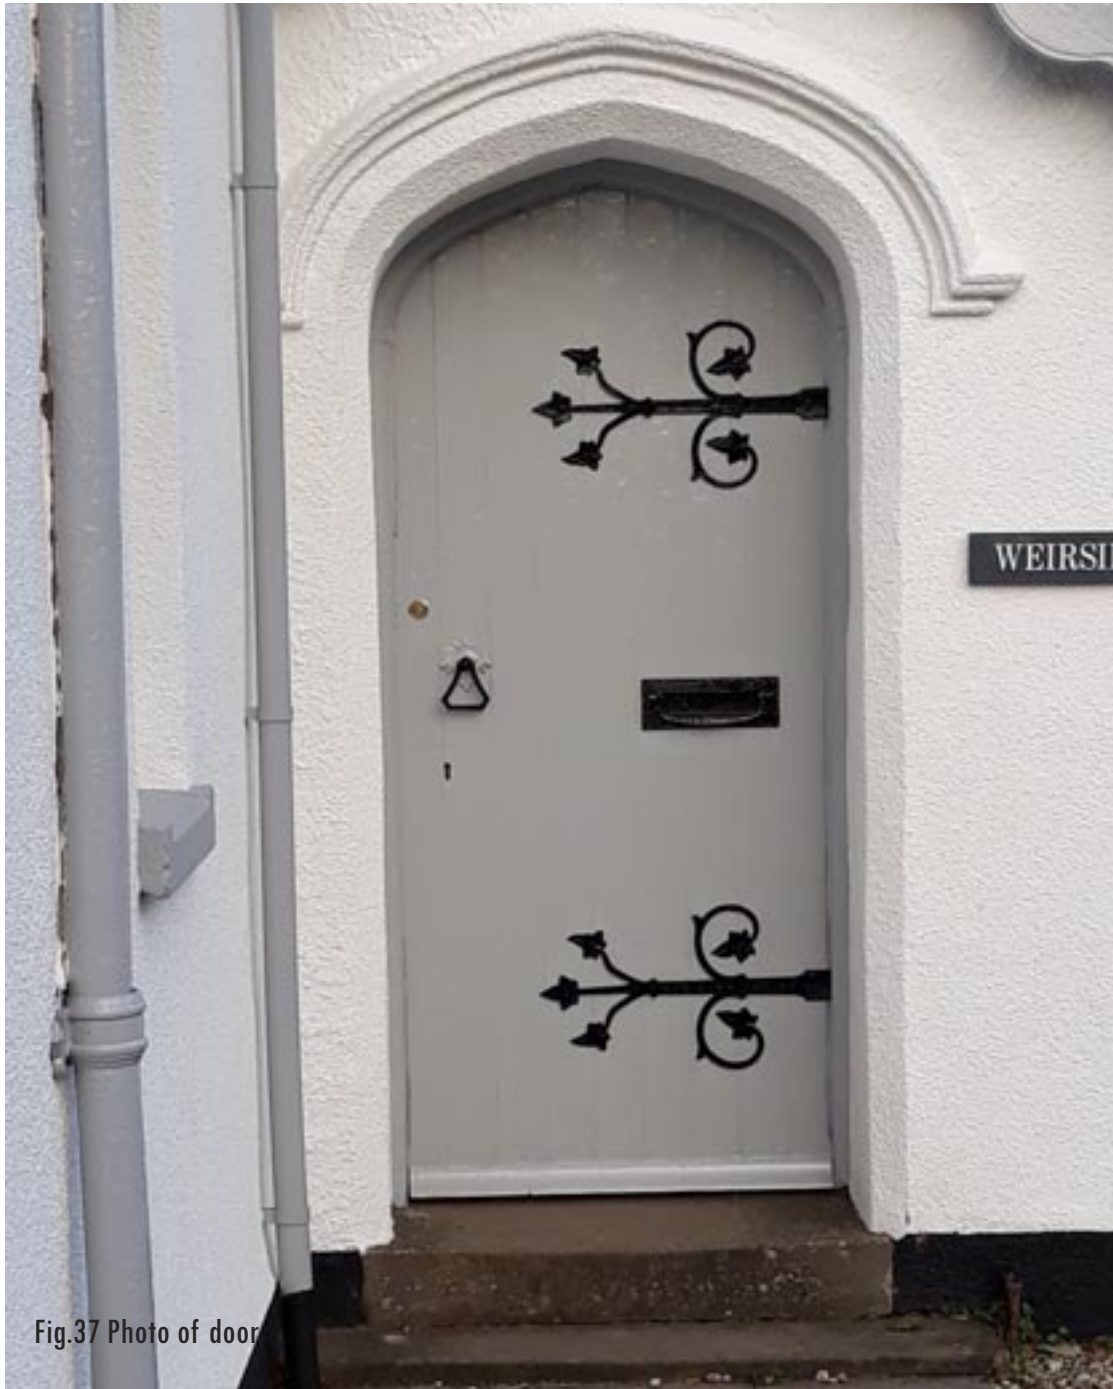
Many doors are constructed in a traditional plank and ledged form, some incorporating fixed lights. In some of the grander domestic buildings these are panelled, some with glazed panels or with over-lights. There is little obvious ornament, but a number of cottages have small front porches with gabled roofs and a variety of sometimes ornamental detail, mainly dating from the 19th century.

Fig.37 Photo of door

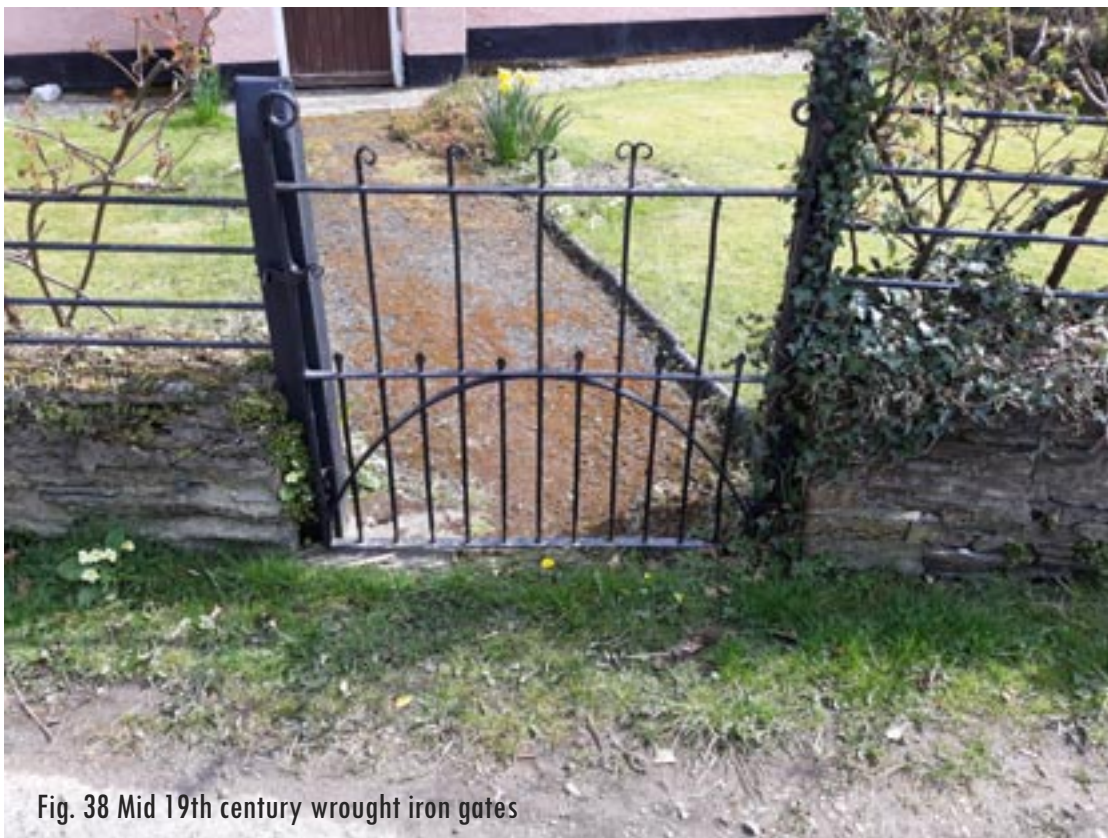
There are a few good examples of ironwork, most notably wrought iron gates, as at the entrance to the Old Vicarage, and to a number of garden gates, as well as some boundary railings, for example to the north of Karlake House.

Fig. 38 Mid 19th century wrought iron gates

- The conservation, and where necessary, the repair of walls and/or historic railings, and timber fencing is considered important. Where appropriate consider using additional timber or ironwork that reflects the local craft traditions.

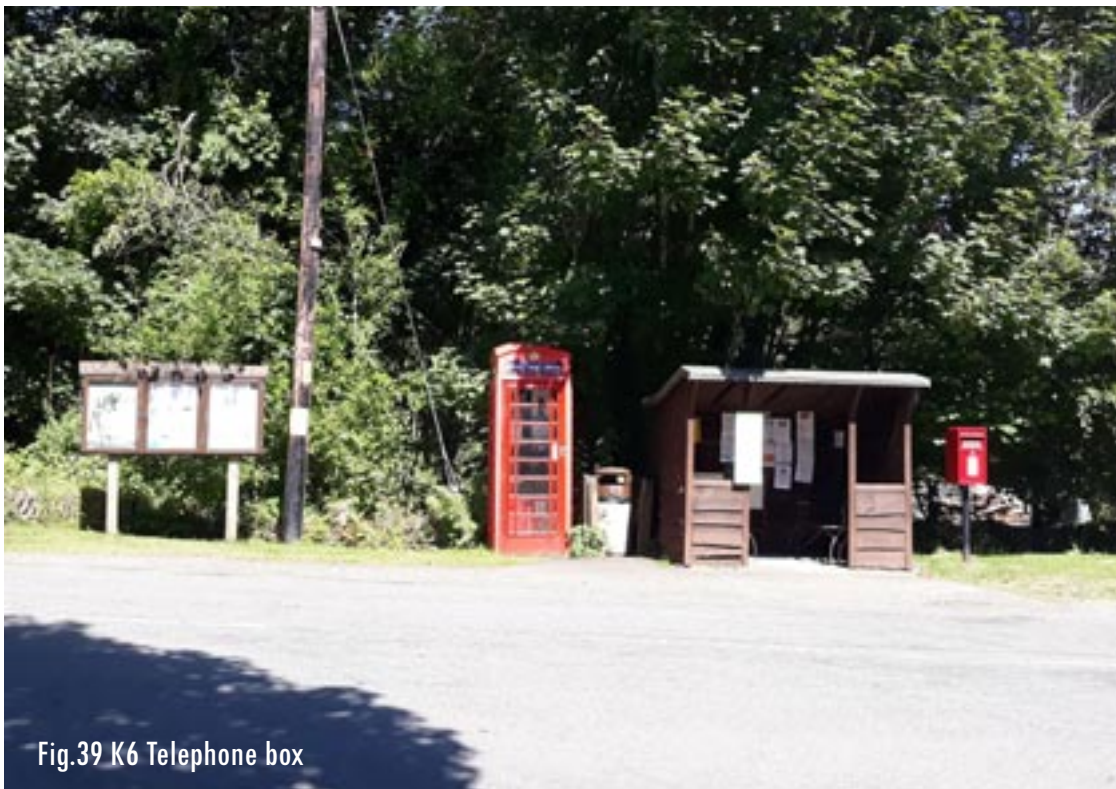
Fig.39 K6 Telephone box

The earliest piece of street furniture identified is the cast iron red telephone kiosk known as “type K6” and designed by Sir Giles Gilbert Scott in 1935. This is grade II listed.

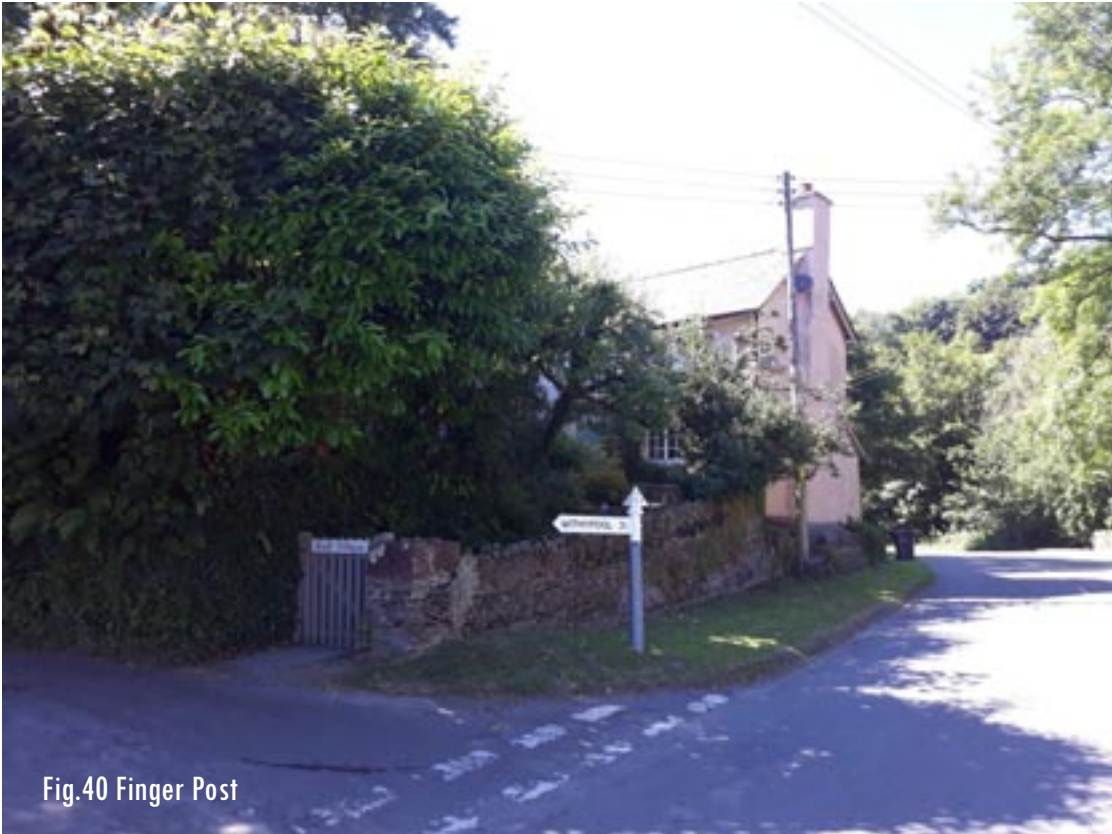
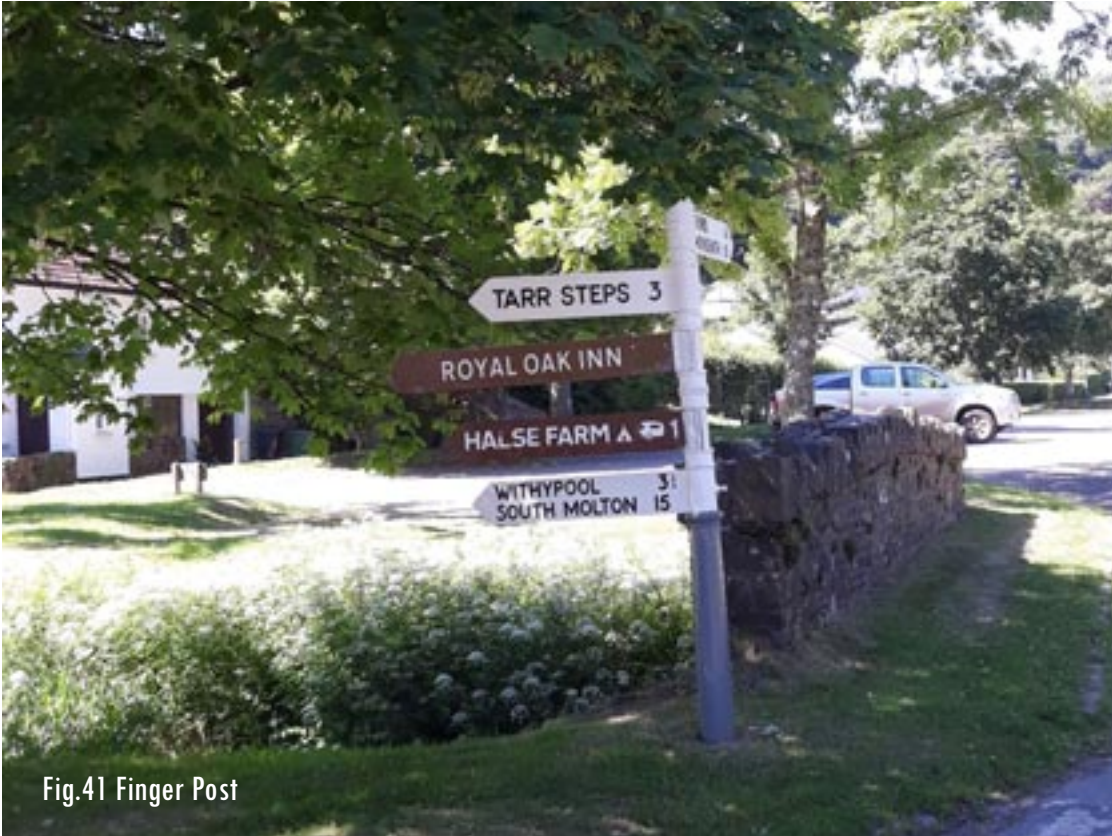
Fig.40 Finger Post

Fig.41 Finger Post

There is a mid 20th century cast iron Somerset County Council guidepost adjacent to the Old Winn Bridge and a second near Ball Cottage both of which have recently been refurbished.

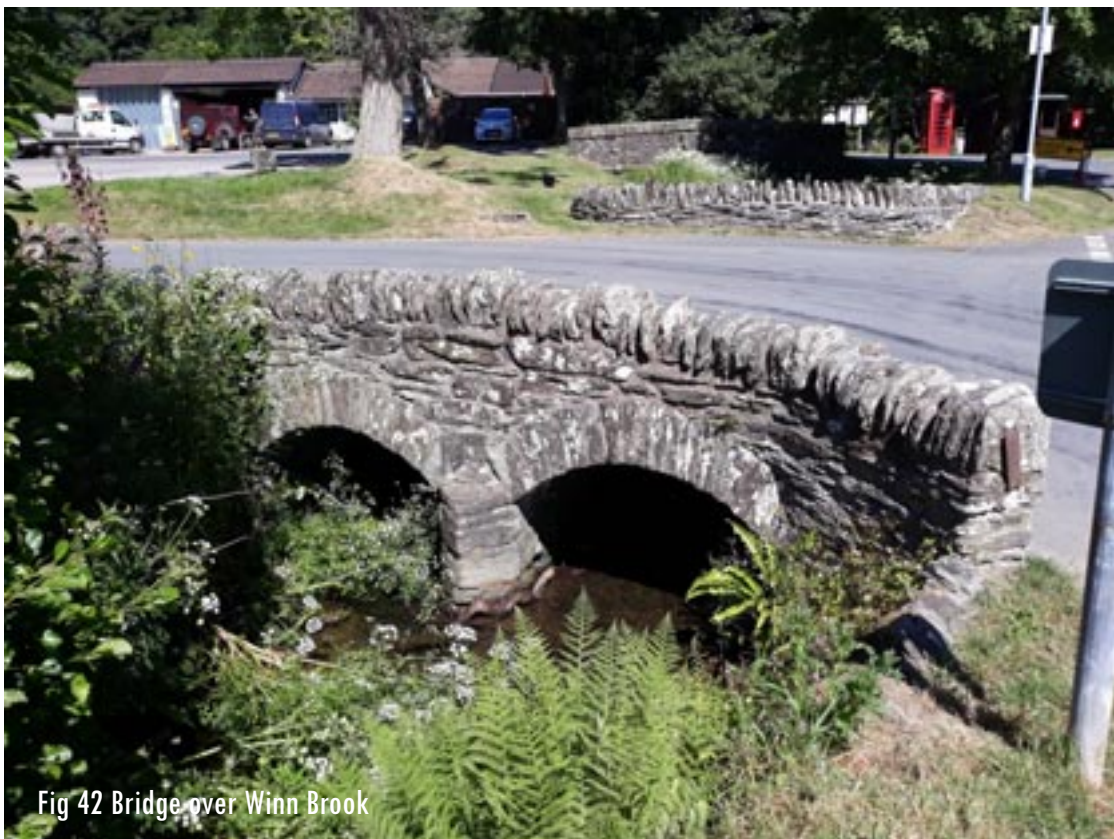
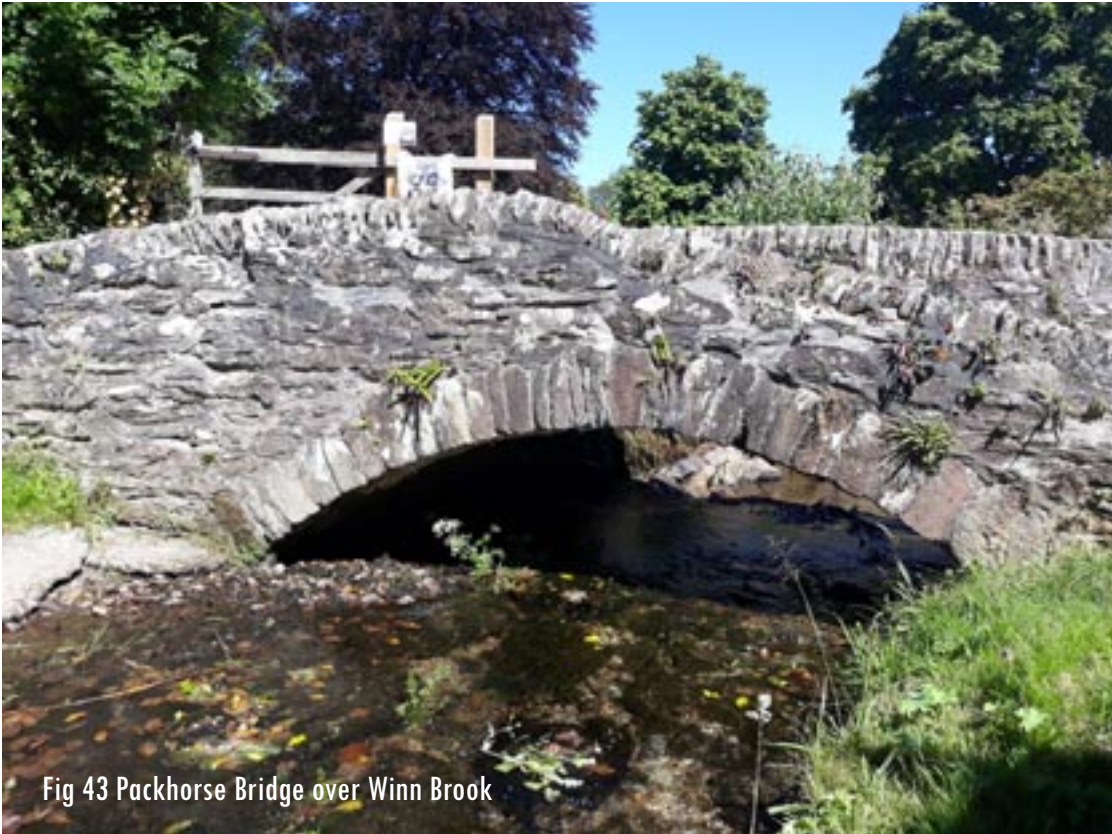
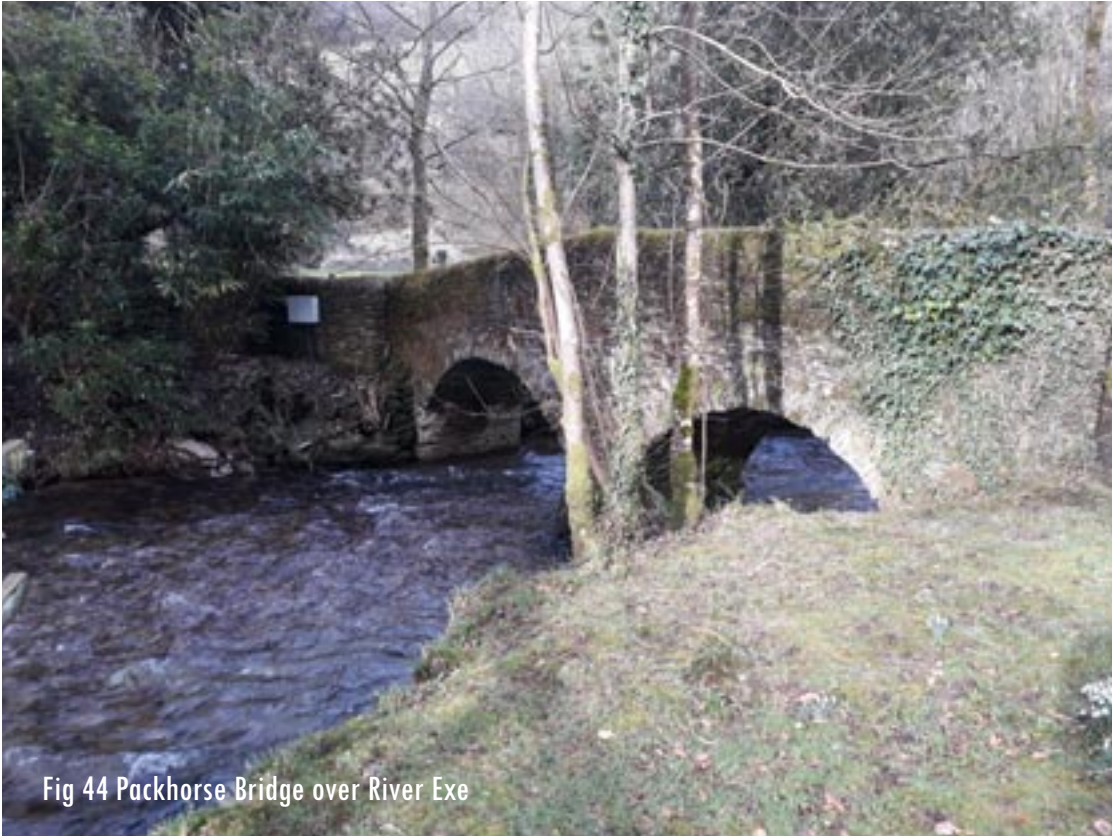
The streams flowing through the Winsford contribute greatly to its character and appearance. Winsford has a number of bridges of different dates and constructions including two stone footbridges both restored in 1952. The **Packhorse Bridge crossing the River Exe**, a Scheduled Ancient Monument and Grade II* listed, is medieval in origin and has a two-arch span with random-rubble voussoirs and small cut water on upstream side. It is mainly built of flat-bedded slate, vertically aligned as coping and was restored in 1952. In the village centre is another **Packhorse Bridge crossing the River Winn** of similar date and also an Ancient Monument, but much smaller and lower with shallow arched single span, mainly of red sandstone rubble with end-on bedded coping, and some dressed stone to abutment and voussoir. **The Old Winn Bridge**, Grade II Listed, was the only road crossing in the village centre prior to the 1920s. The road bridge across the River Exe, known as **Vicarage Bridge**. It is recorded as originally built in 1835, although appears older, and was widened in 1928.

Fig 42 Bridge over Winn Brook

Fig 43 Packhorse Bridge over Winn Brook

Fig 44 Packhorse Bridge over River Exe

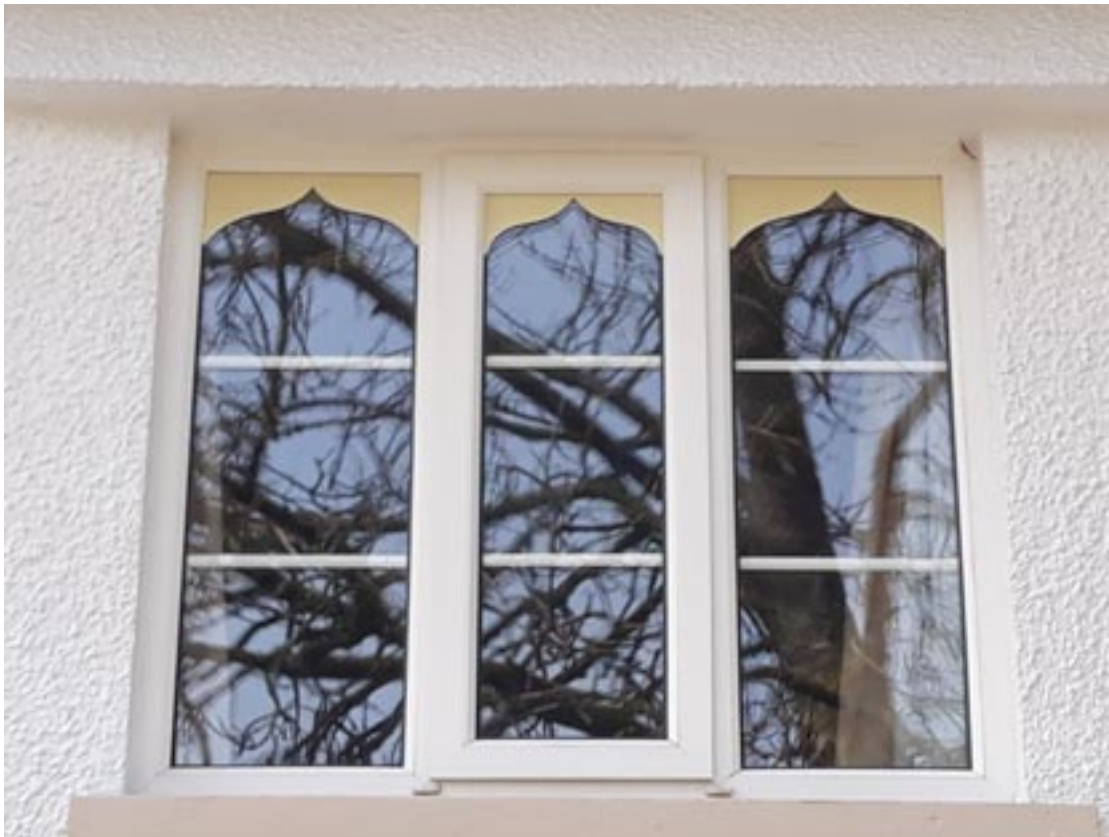
Most historic buildings, both listed and unlisted, are generally well maintained. Some former farm outbuildings both within or on the borders of the village, although inherently structurally sound, appear to be suffering some neglect or under-use. A large proportion of timber windows and entrance doors survive in their original form, or where replacements have been made, these have tended to closely match the traditional form and still predominate. Even so, PVCu replacement windows and doors are starting to make inroads into the village and are most evident when installed within the close-knit pattern of early development. Such replacements, even where they closely match the traditional glazing and joinery patterns, inevitably introduce an artificial product that in a historic setting can all too easily destroy the visual integrity of even the most modest of traditional buildings.

Fig. 46 Plastic windows fitted to the tea-rooms
