Exmoor National Park
Historic Environment Report Series No 18

LYNMOUTH CONSERVATION AREA: APPRAISAL DOCUMENT

Adopted 2018

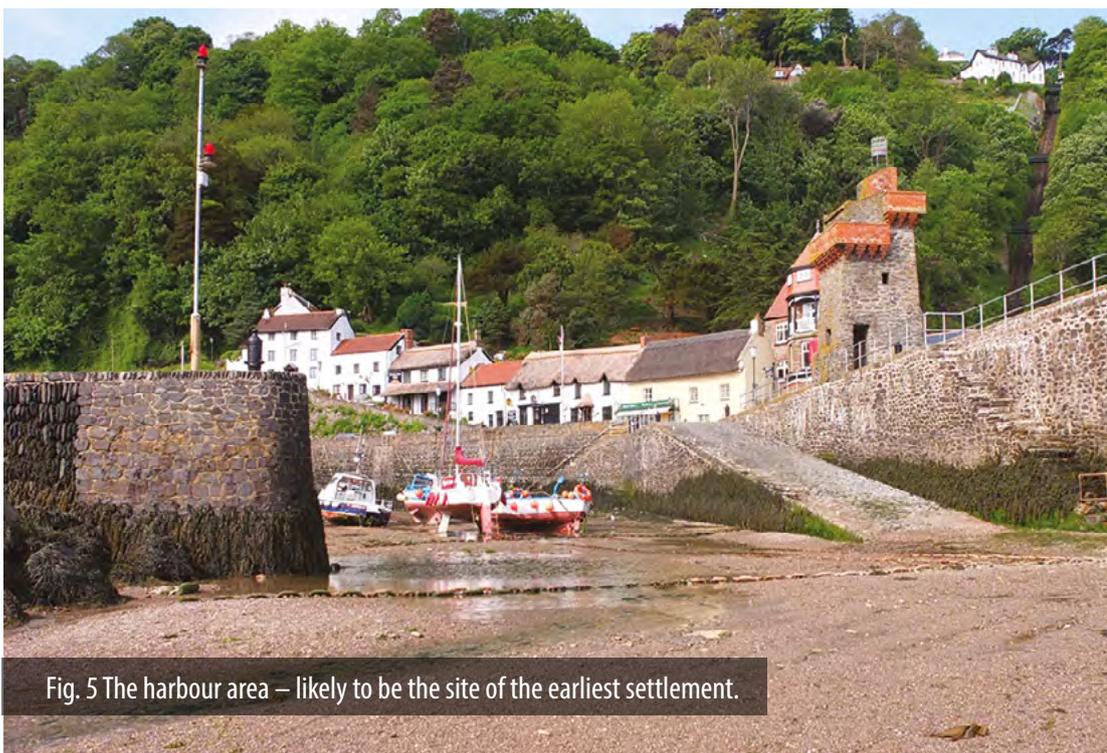
Fig. 5 The harbour area – likely to be the site of the earliest settlement.

There are early mentions of Lynmouth in the Assize Rolls of 1282 and in the Subsidy Rolls of 1330. The name is probably derived from the Old English hlynn meaning 'torrent.' The original settlement owes its existence to fishing and is likely to have developed immediately around the present harbour area (Fig. 5). With the exception of Mars Hill, there are, however, few buildings dating to before the 19th century, many being lost in the flood of 1607.

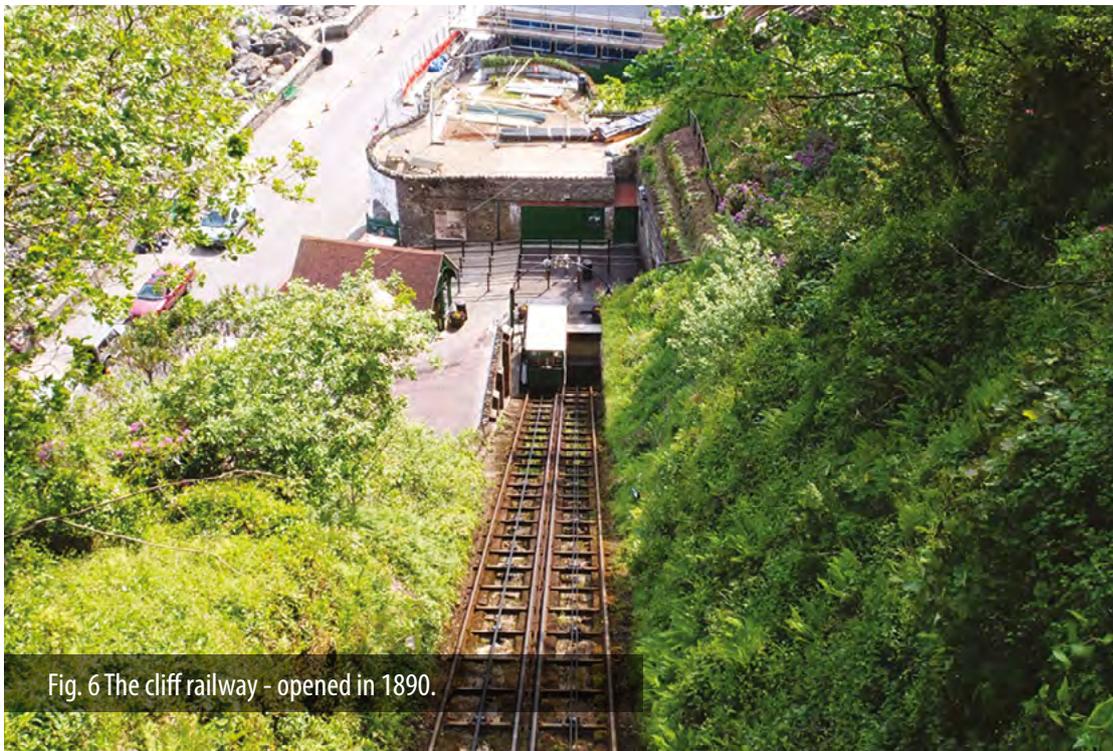
Fig. 6 The cliff railway - opened in 1890.

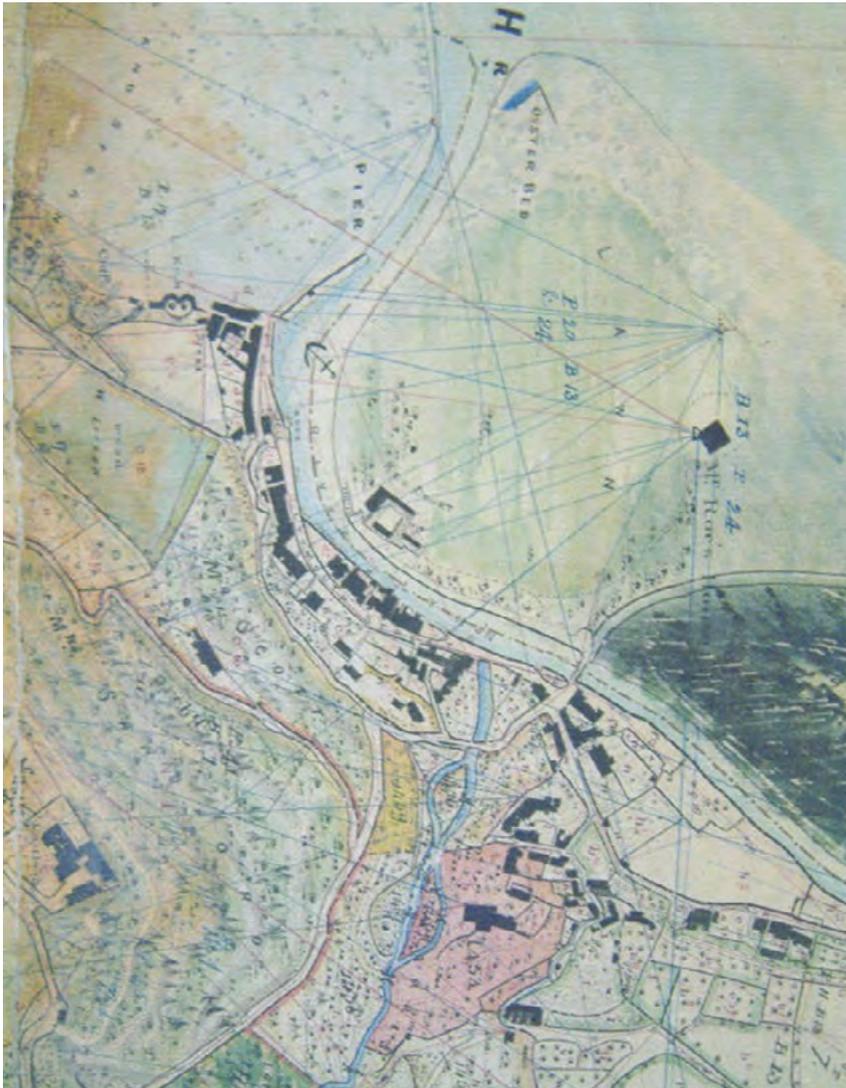
Fig.7 Extract from
Tithe Map c.1840 for
Lynmouth.

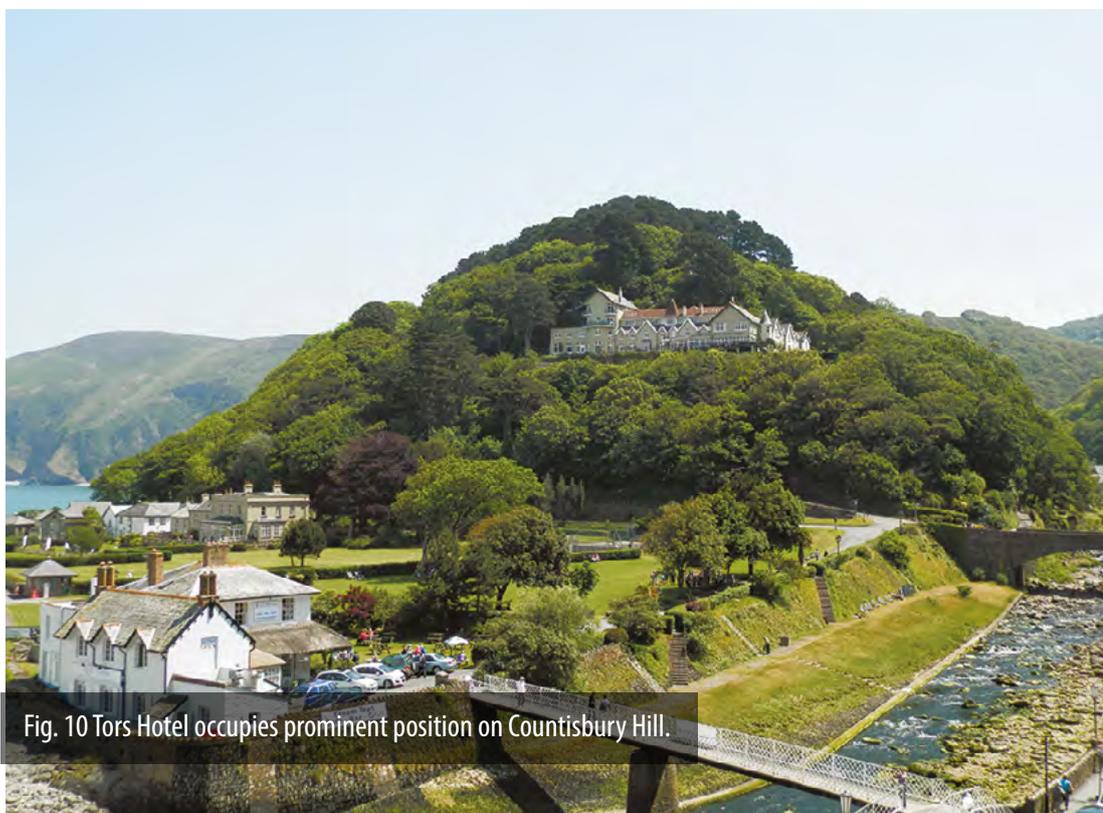
Fig. 10 Tors Hotel occupies prominent position on Countisbury Hill.

The narrow tarmac lane winds up from Tors Road through woods, occasionally branching off to one of the large detached late 19th-early 20th buildings set high on the hill, before connecting with Countisbury Hill. These are now mainly hotels and are well spaced, maintaining the impression of a wooded hill. The exception is Tors Hotel, which is very visible and occupies a commanding position on the west side of the hill. (Fig. 10)

Tors Park has a collection of large late 19th-early 20th century villa style buildings, most of which were probably built as hotels. None have a standardised plan-form but all are detached and most two-three storey, with the exception of the Tors Hotel, the largest building in Lynmouth, which rises to four storeys on its north side.

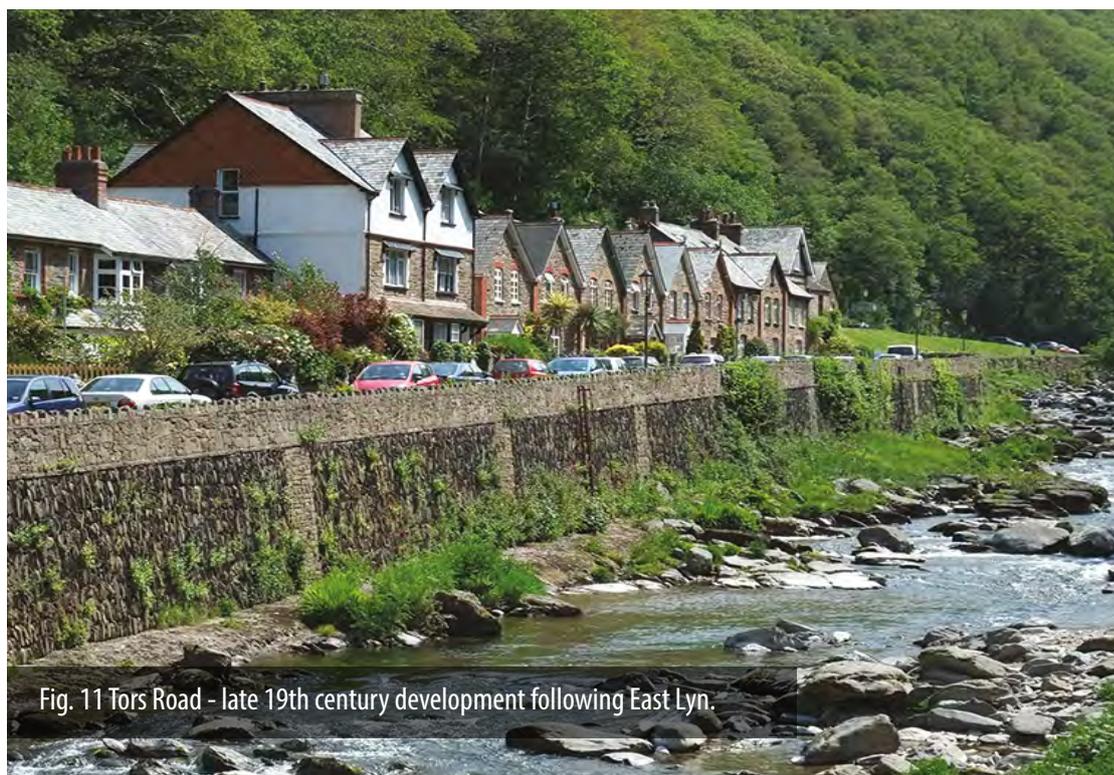
Fig. 11 Tors Road - late 19th century development following East Lyn.

A late 19th century addition to Lynmouth, extending alongside the north bank of the East Lyn, it comprises a long line of terraced cottages, with occasional narrow breaks between, set slightly towards the back of their plots to give small front gardens divided from the river below by the road.

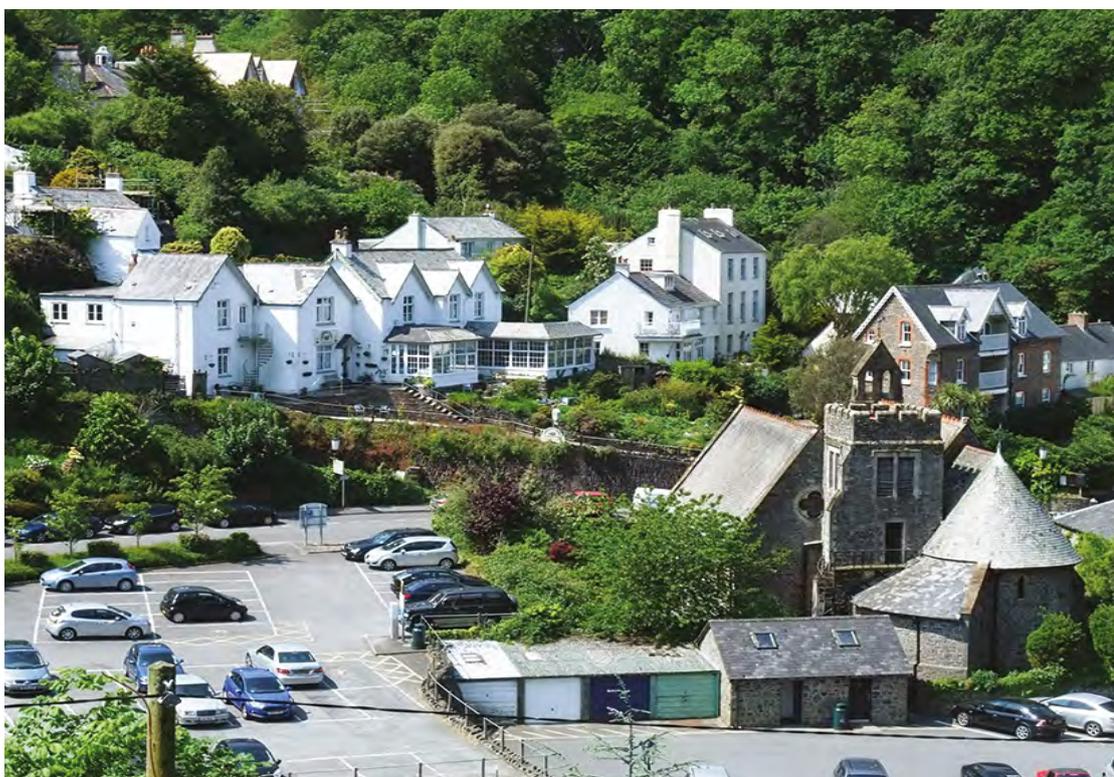
Fig. 12 Watersmeet Road – densely spaced buildings on south side of road with church car park in foreground

The road follows the valley of the East Lyn. On the south side close to West Lyn, the properties along the narrow Summerhouse Path are set back off the street, tightly spaced and seem to jostle for position in an apparently random fashion. Further west, the buildings become more orderly and are built right up to the street frontage of their small plots. The north side of the road has two car public car parks that result in significant gaps in the building line.

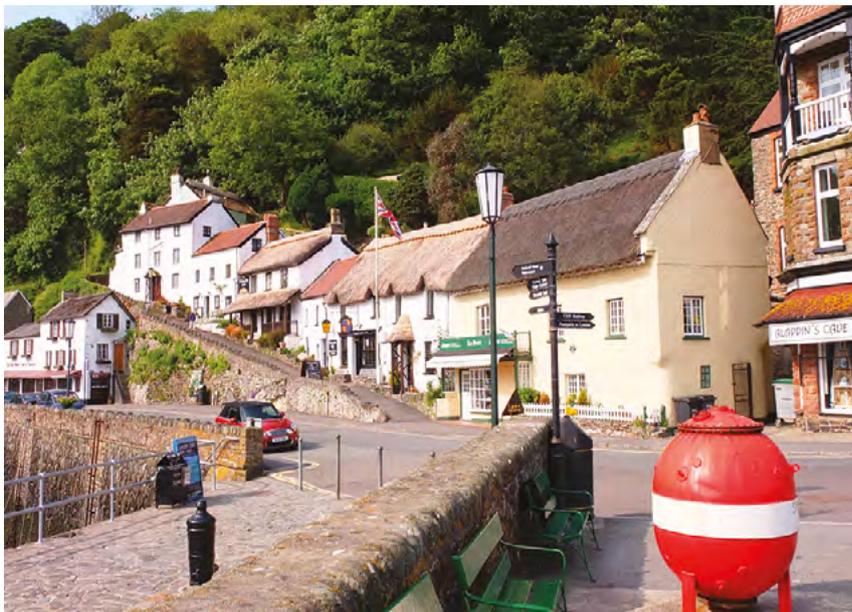
Fig. 13 Mars Hill – stepped terrace of 17th and 18th cottages.

On Lynmouth Street, the buildings are mainly three-storey, or two-storey with attics, with ground floor shops and narrow frontages, those on the west side are mainly higher in a effort to gain a river view. Most are attached, the Bath Hotel is detached and part four-storey. Mars Hill has a stepped terrace of two-storey cottages, with the end building being three-storey. (Fig.13)

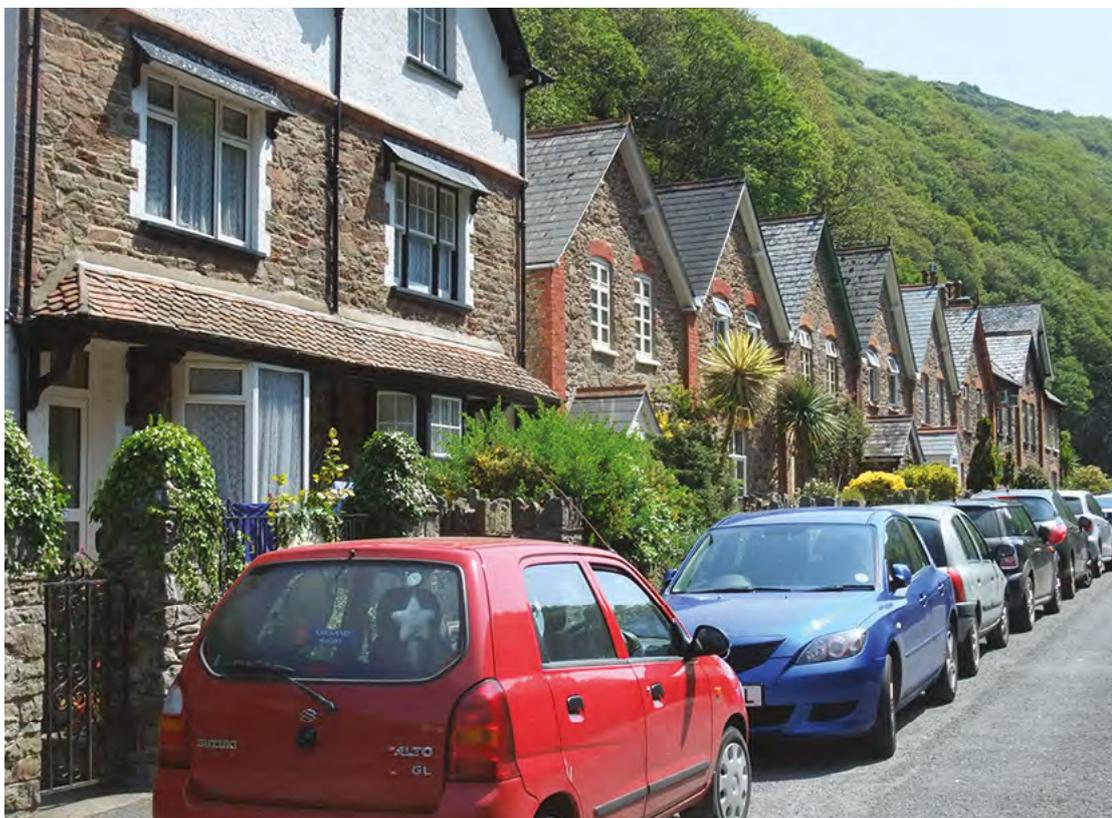
Fig. 14 Tors Road - row of late C19 cottages

At its west end Tors Road has two pairs of what were probably once matched semi-detached two-and-a-half storey villas, but have been much extended. The remainder of the road is characterised by a line of attractive terraces of small two-storey artisan late 19th century cottages facing the river with a semi-detached three storey pair of a later date a little way to the east.

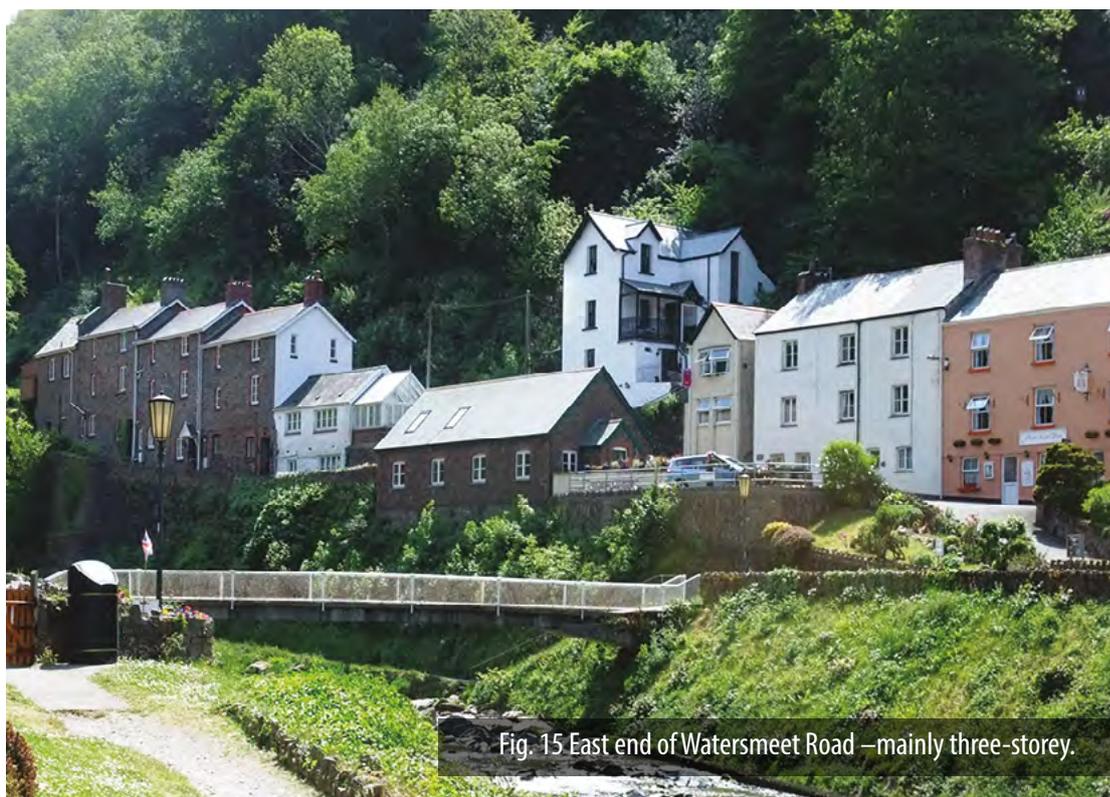
Fig. 15 East end of Watersmeet Road – mainly three-storey.

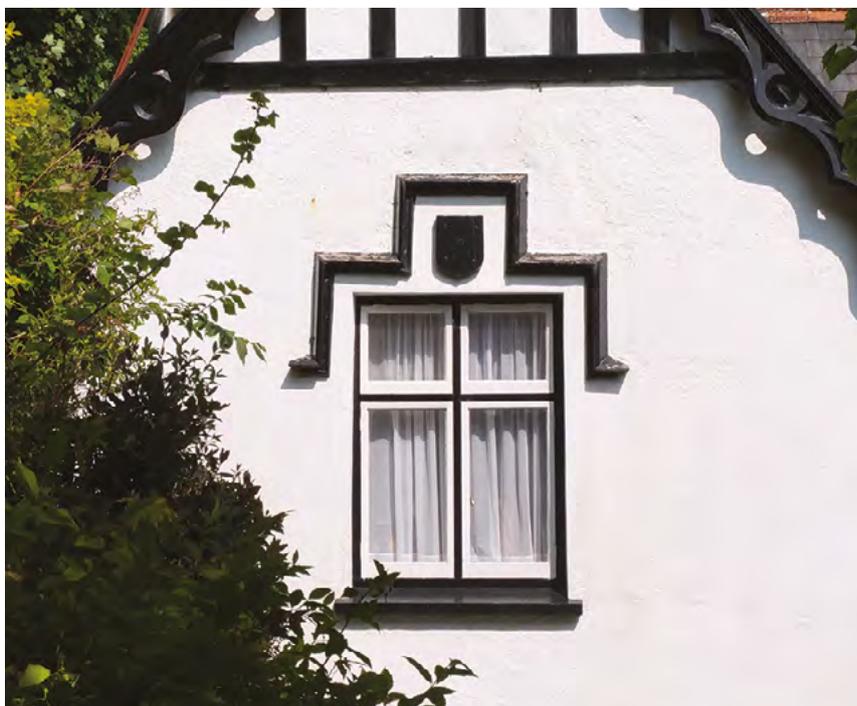
Fig. 19 Late 19th century decorative detailing.

On closer inspection, individual buildings and building groups, display a wealth of period detail, albeit of several different periods, and not in any particular concentration. Although now a century or more old, much remains in good condition, and makes an immense contribution to the character of the Conservation Area. There are good examples of ornate gable detail, including barge-boards and some timber-framing as well as timber and cast-iron detail to balconies and balustrades. Some original casement and sash windows survive, although rather fewer authentic entrance features, which include wood panelling, overlights and colour-patterned glass to some entrance doors.

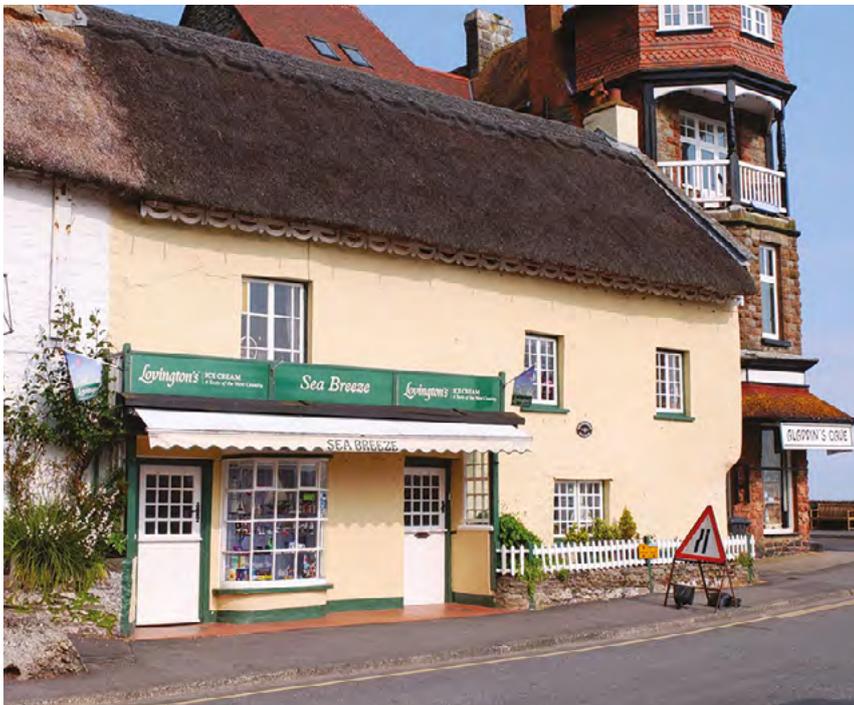
Fig. 20 Seabreeze Cottage, 19th century or earlier.

Among the earliest listed buildings are in the stepped terrace at Mars Hill. This group also contains **Seabreeze Cottage** (no. 1 Lynmouth Street) (Fig. 20), which the listing details describe as early-mid 19th century, but is possibly of earlier origin. It is thatched and rendered with a variety of frontage detail, including first floor French window with margin panes on to a balcony with timber balustrading. The ground floor has an early shop window of 20 panes with curved glass returns.

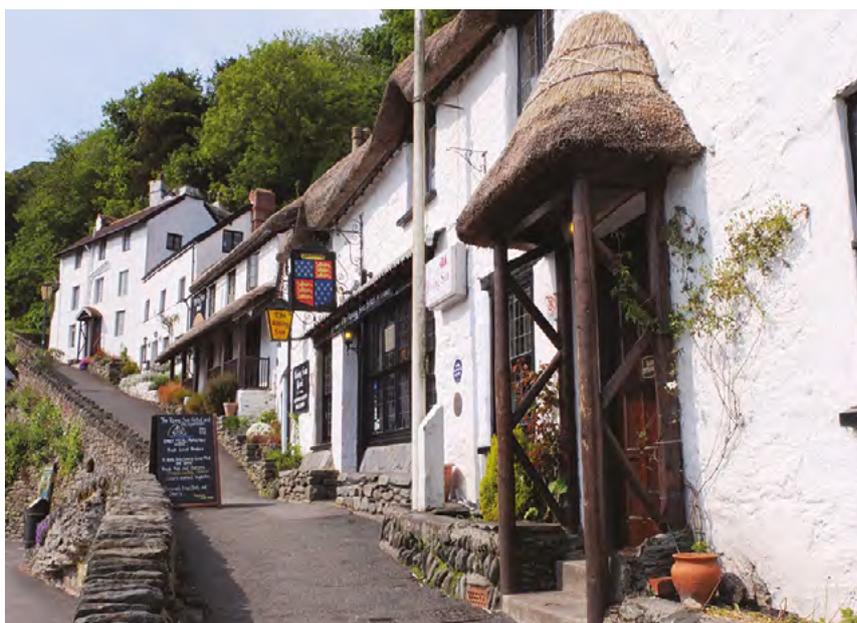
Fig. 21 The Rising Sun, attractive row of cottages.

Much of **Mars Hill**, formerly seven separate cottages, now comprises the **Rising Sun Hotel** (Fig. 21). The main part, of three former houses, date from the early-mid 18th century or earlier and are stone-rubble built with render and limewash, and roofs are mainly thatched. At the top of the row the detached **Shelley's Cottage** (Fig. 22) faces away from the sea and is probably 17th century. Much of the interior was destroyed by a fire in 1907. Externally the building is notable for its large lateral stack with bread oven. The roof is thatched at the front with Roman tiles to the rear elevation.

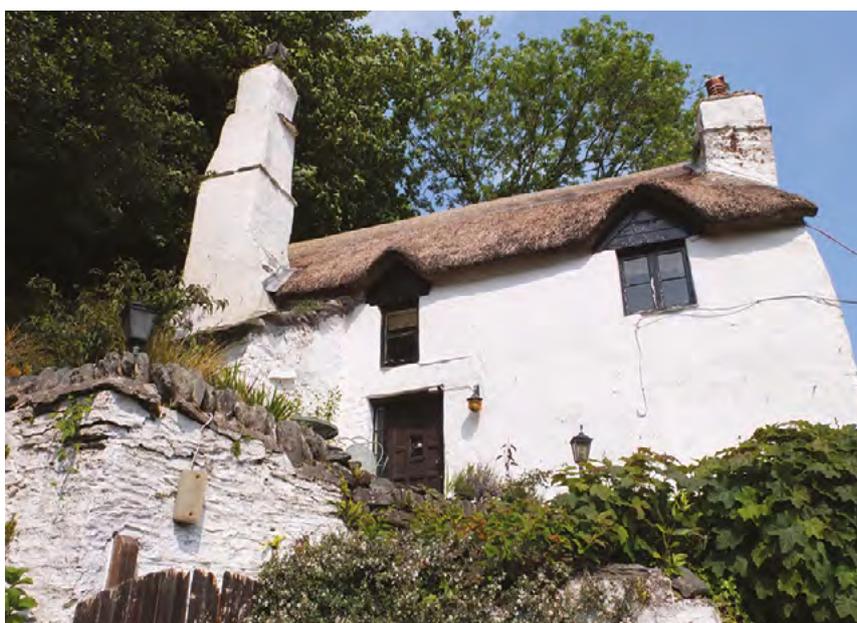
Fig. 22 Shelley's Cottage- possibly lodged the poet.

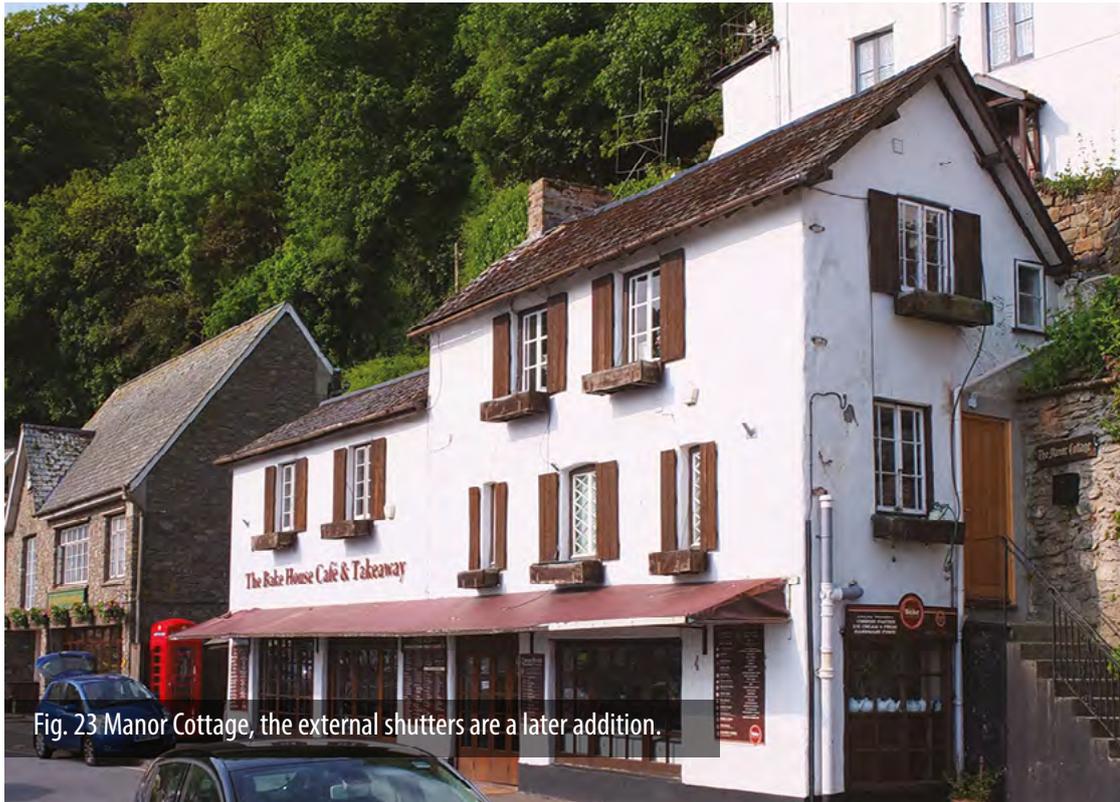
Fig. 23 Manor Cottage, the external shutters are a later addition.

Below Mars Hill is **The Manor Cottage** (Fig. 23) damaged in the 1952 floods, but rebuilt. There is a right hand three-storey range dating from the early 19th century, whilst the left-hand range is two-storey and probably mid 19th century. The earlier part has first and second floor casement windows, the former with diamond panes in cast iron the latter with timber margin pattern glazing - the external shutters and window boxes are not original features.

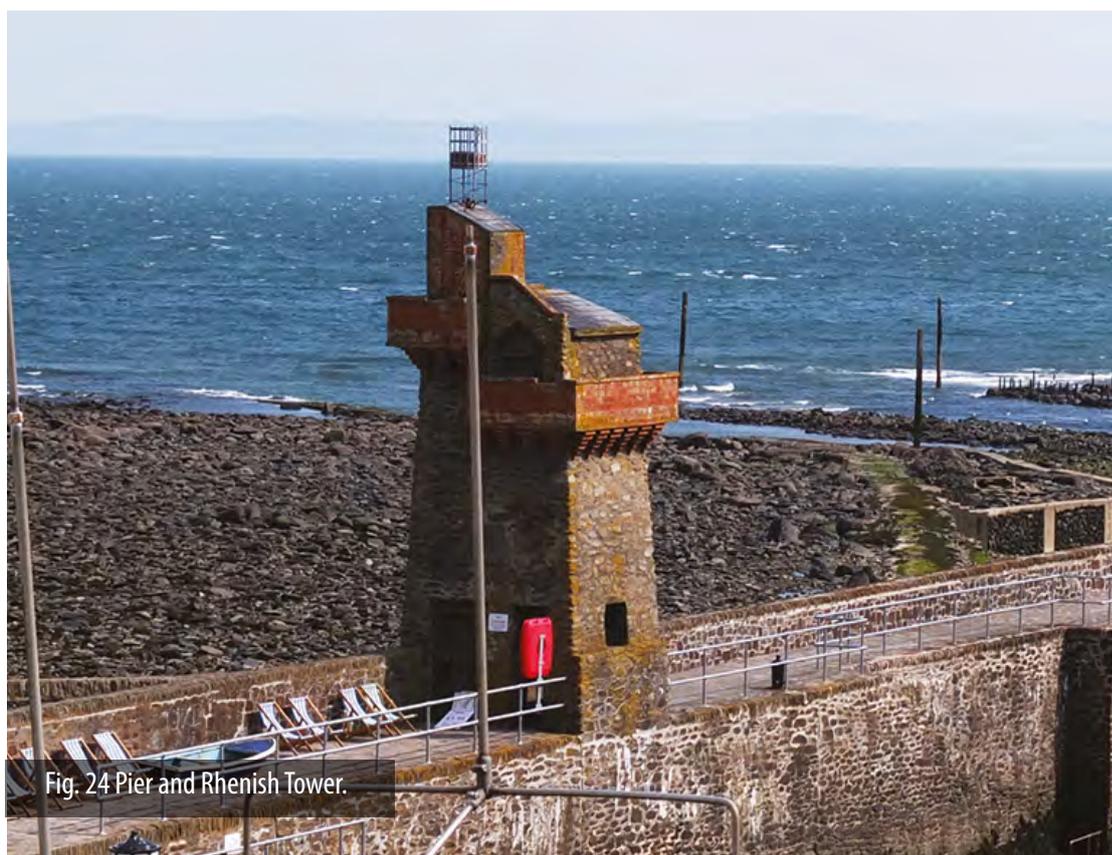
Fig. 24 Pier and Rhenish Tower.

Opposite is the **Pier** (Fig. 24), probably late 18th or early 19th century. It is largely built of large roughly squared granite blocks with a rounded, flush granite parapet. Photographs from the 19th century show the east end of the pier as lower forming a ramp and it is likely that the current guise is as rebuilt following the 1952 flood. Halfway along is the **Rhenish Tower** (Fig. 24) a square stone tower, tapered with two balconies in brick, carried on brick machicolations – added at a later date. It is supposedly an imitation of one on the Rhine, built by General Rawdon and is likely to date to the 1820s to 1830s. Its original function is unclear, the list description describes it as a folly but other purposes put forward include a means of providing sea-water for indoor baths and a light to mariners and fishermen,

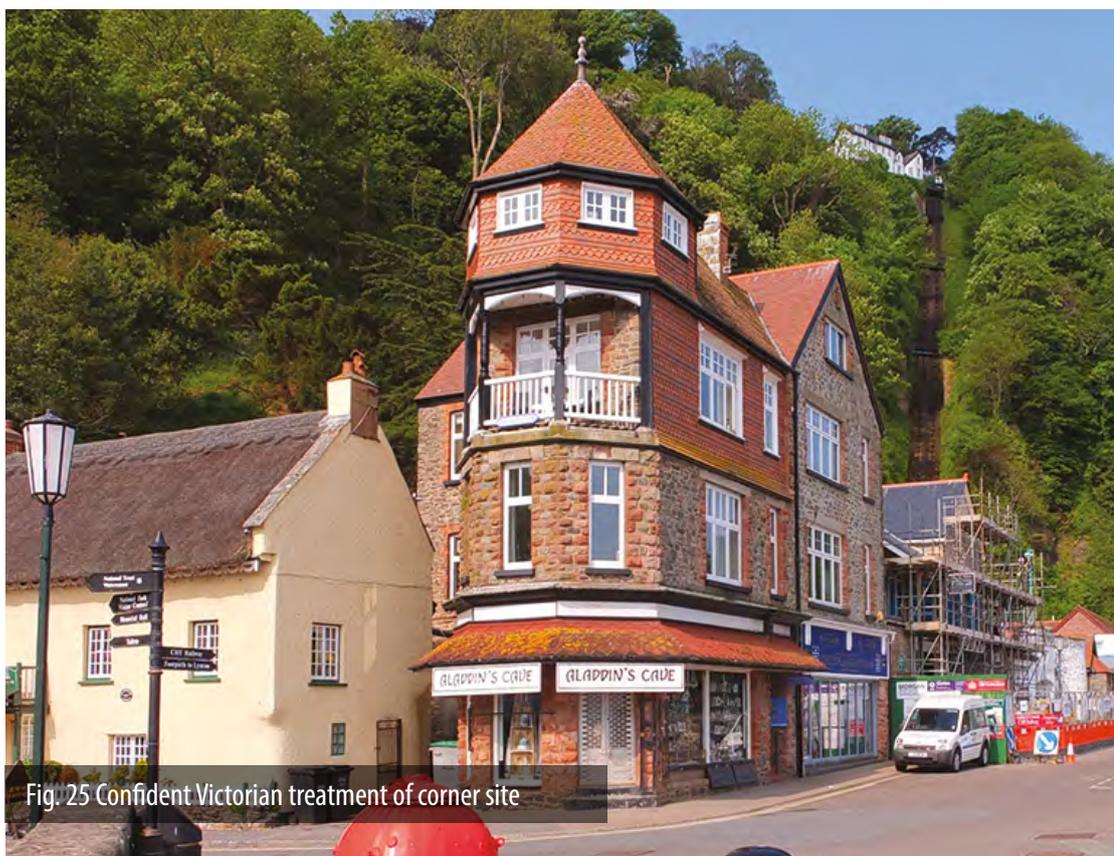
Fig. 25 Confident Victorian treatment of corner site

At the **Esplanade** corner with **Lynmouth Street** there is a 19th century group built of stone with brick dressings and plain tiles used for the roof and as tile hanging. At the corner is an octagonal third floor turret (Fig. 25). It is hardly surprising that the extraordinary contrast in scale, style and use of materials to the adjoining older buildings drew adverse comment at the time, a guide book of 1899 commenting that 'The builder has done his best to spoil Lynmouth [...] nothing could be worse than the erections at the corner of the esplanade.'

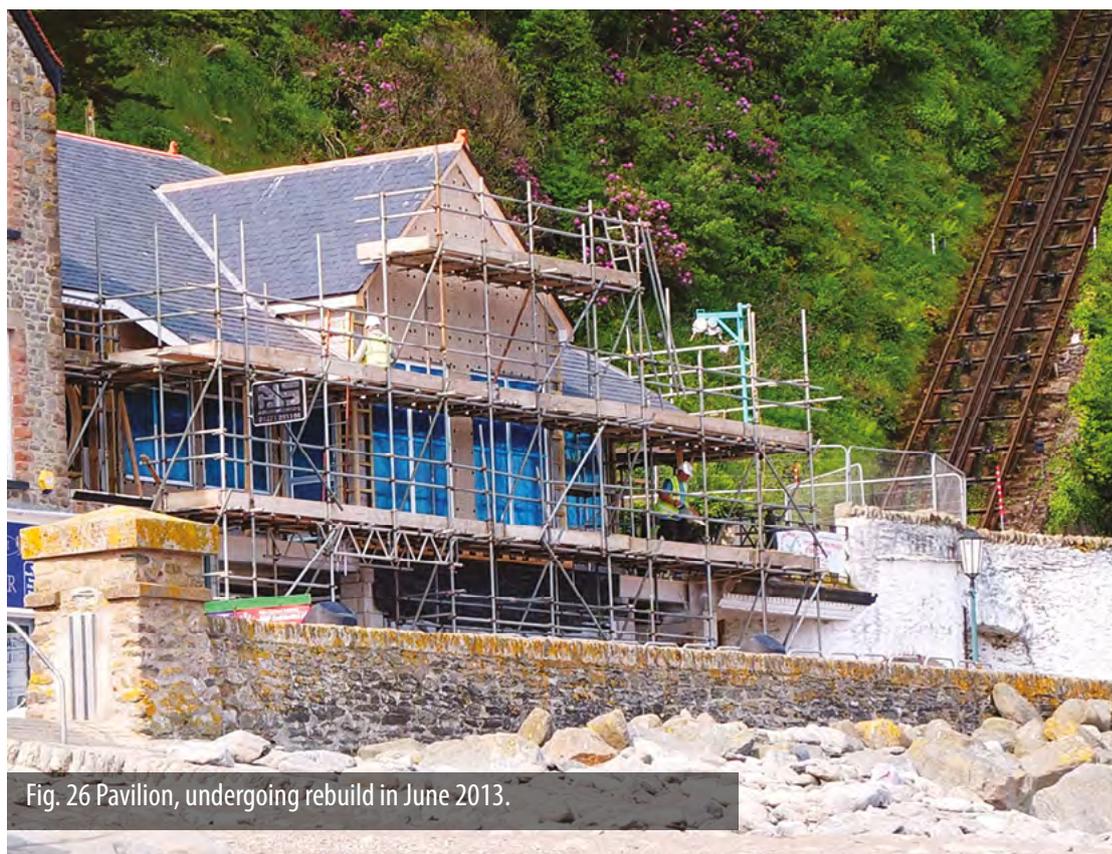
Fig. 26 Pavilion, undergoing rebuild in June 2013.

The adjoining **Pavilion** (Fig. 26) fronting the Esplanade is located in a prominent position on the quayside. It was constructed in 1931 for the town council to a design by A J Gibbs, using steel framed construction. It is of two stories with a hipped roof and a gabled central bay flanked by an open veranda to the first floor. The original structure escaped the floods of 1952 but has recently been rebuilt as a visitor centre for Exmoor National Park.

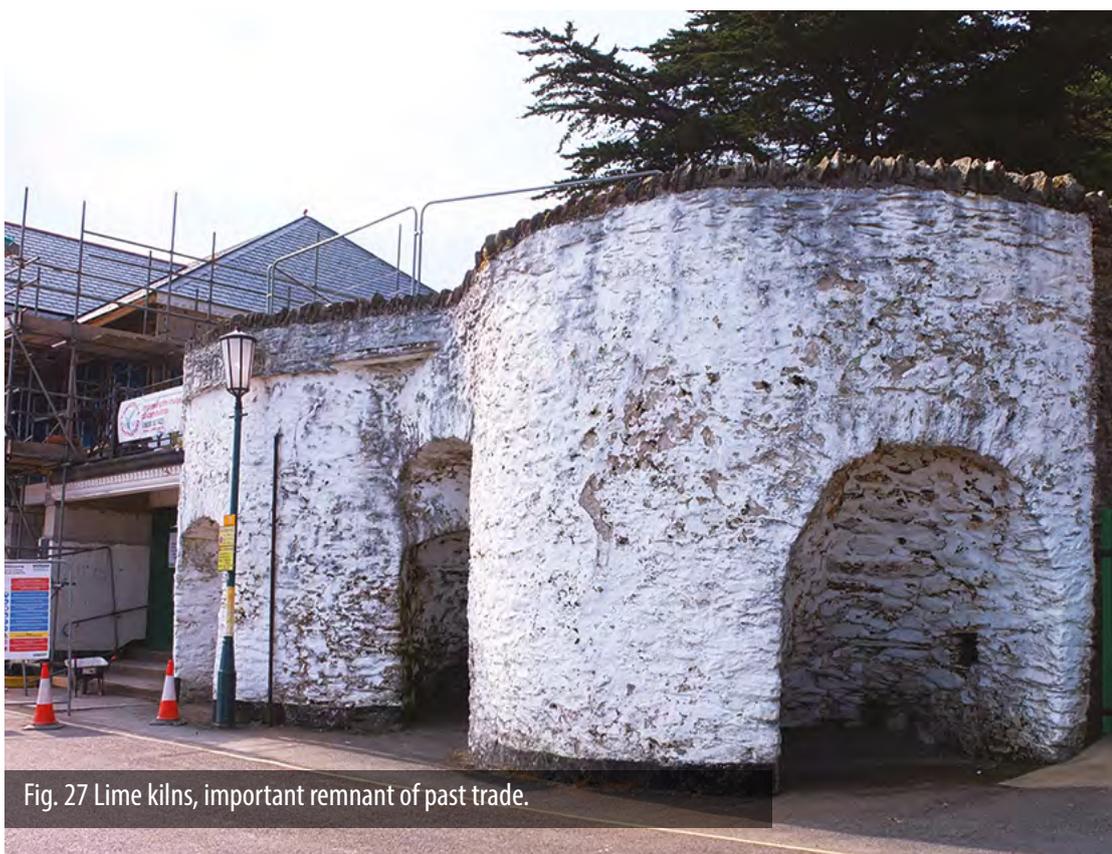
Fig. 27 Lime kilns, important remnant of past trade.

Attached to the Pavilion are the remains of **lime kilns** (Fig. 27), probably dating from the late 18th Century, although one reference mentions a grant of 1698. They are built of stone rubble whitewashed over. They are now partially infilled with an earth-covered roof, the top forming part of a promenade, enclosed by the upper walls of the kilns. They served a demand for lime to be added to the local acid soils and for building and are a testament to the a regular trade in limestone across the Bristol Channel.

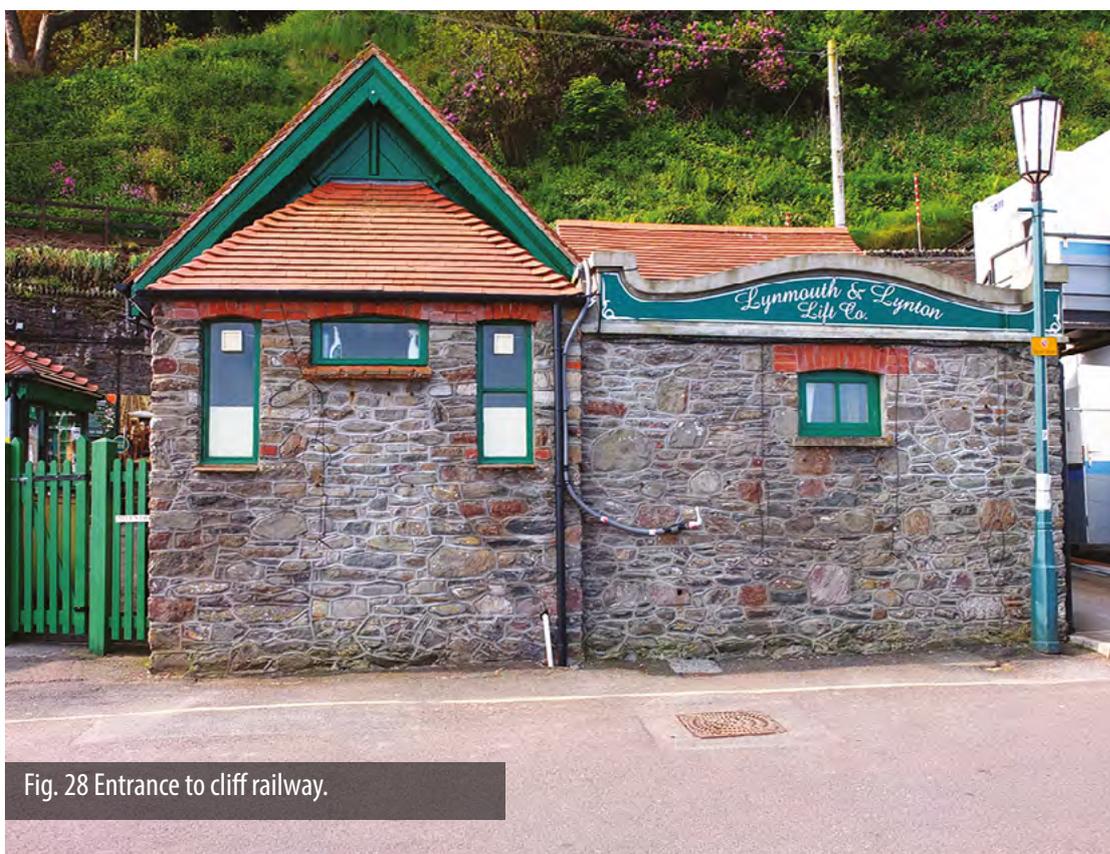
Fig. 28 Entrance to cliff railway.

Nearby, is the **Lower Waiting Room** (Fig. 28) of the **Cliff Railway** with an attached workshop, built in 1890 by local builder Bob Jones, and paid for by George Newnes. It is constructed of stone rubble with timber framing, and diagonal boarding, it is a rectangular pavilion with a deep projecting decorative gable to the south side. The original frontage is partly obscured by a later service block. The roof is tiled and is supported by a king-post roof truss with cross-bracing. The listing details record a comment made by the builder's grandson, who was at the time still working for the railway that 'Newnes' money and Jones' brains built Lynton and Lynmouth.' It is little changed from the original cable driven water displacement method of operation. Black's Guide of 1898 feared 'it would flood the place with a class of excursionists for whom there is little accommodation, and on whom, for the most part, its characteristic beauties would be thrown away'. In fact, it has long provided an essential link between the twin settlements and is used by both residents and visitors.

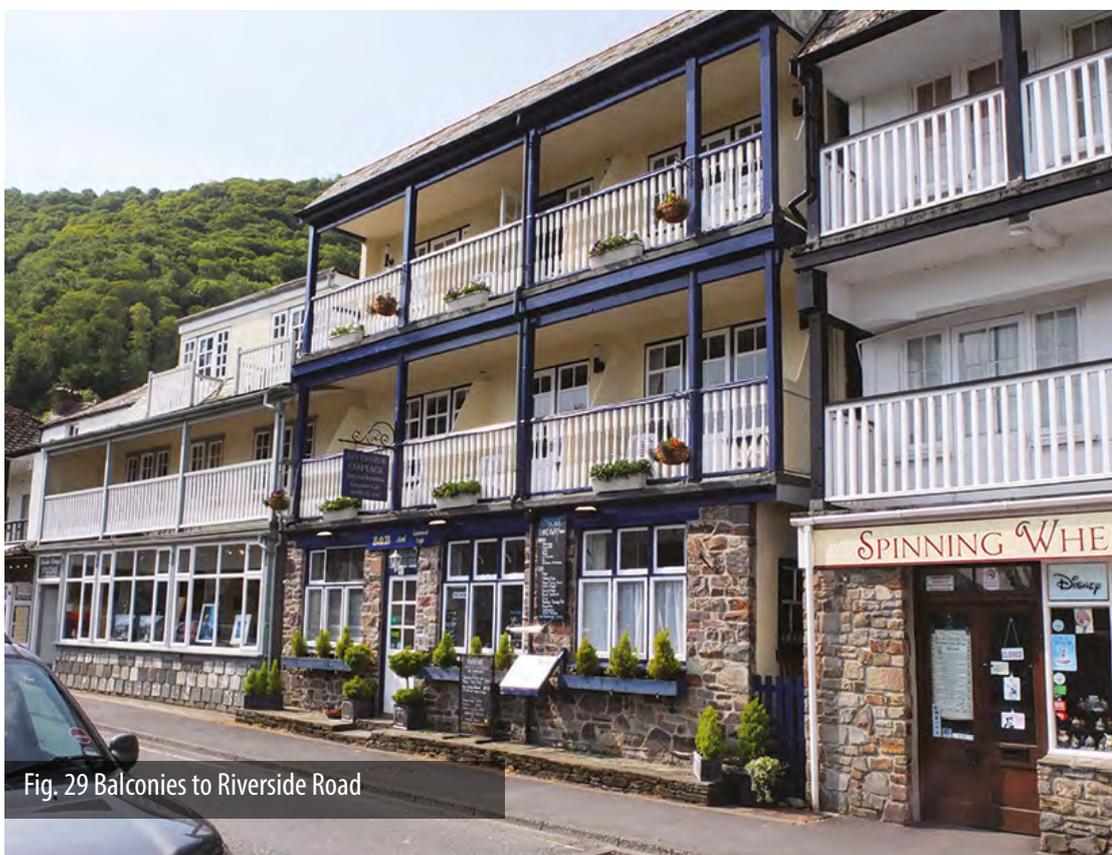
Fig. 29 Balconies to Riverside Road

Riverside Road was created following the 1952 flood leading to the Janus nature of the 19th century buildings on the east side of **Lynmouth Street**. The first and second floor balconies with timber balustrading are a distinctive feature of the river frontage (Fig. 29). The side fronting the north side of Lynmouth Street tends to be less satisfactory and there is an eclectic mix of materials and styles (Fig. 30). At the south end, the **Lynmouth Bridge Hotel** (Fig. 31) is a former early 19th century rendered villa with slate roof, having a typical symmetrical front forming a good visual stop of the island group between Lynmouth Street and Riverside Road. There are both plain and small-pane sash windows with a later gabled porch. The central bay is slightly brought forward with scalloped barge-board and drop finial on a hipped roof.

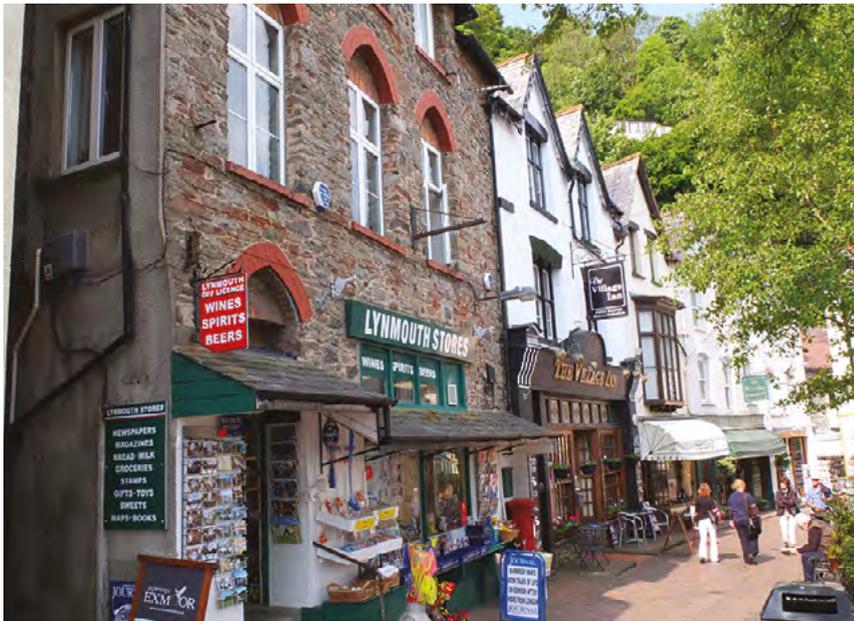
Fig. 32 West side of Lynmouth Street.

On the west side of the Lynmouth Street the buildings are also 19th century and later and form a more cohesive group, some gable end on to the street constructed of brick or stone and some with decorative detail, such as the pierced barge boards to the **Village Inn** (Fig. 32).

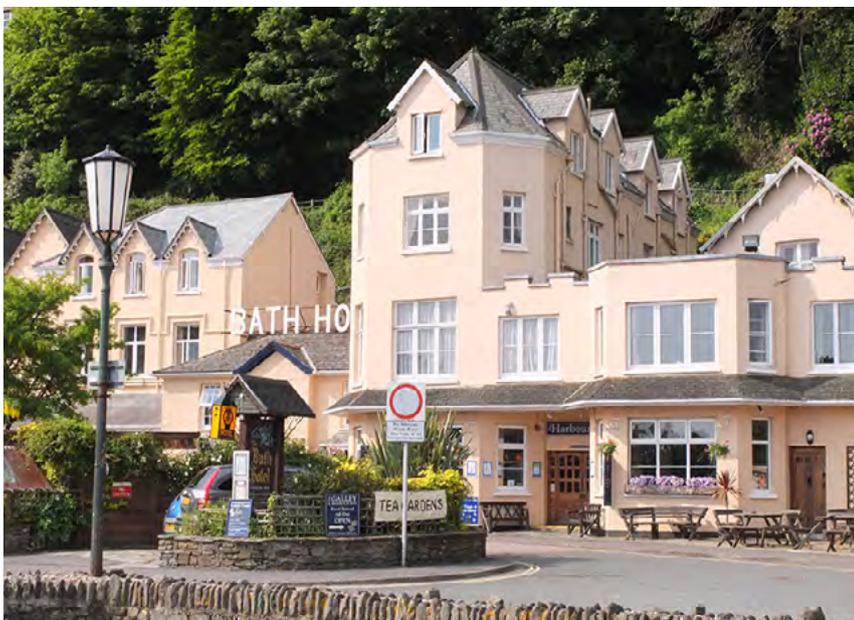
Fig. 33 Bath Hotel, the earliest part is to the left.

Lynmouth Street contains several listed buildings of mainly mid 19th century date. At the north end is the **Bath Hotel** and **Pixie Dell** (now part of the former) (Fig. 33). Originally a late 18th to early 19th century villa, it was considerably extended in the late 19th century. The listing details refer to the original building ‘as representative of the early scale of hotel development in Lynmouth’. This part of the hotel retains sash windows with narrow glazing bars, and ground floor canted bays with French doors. Pixie Dell was reputedly a bath house built as part of the estate of Rev. W. Halliday, who was responsible for much of the early 19th century development of Lynmouth.

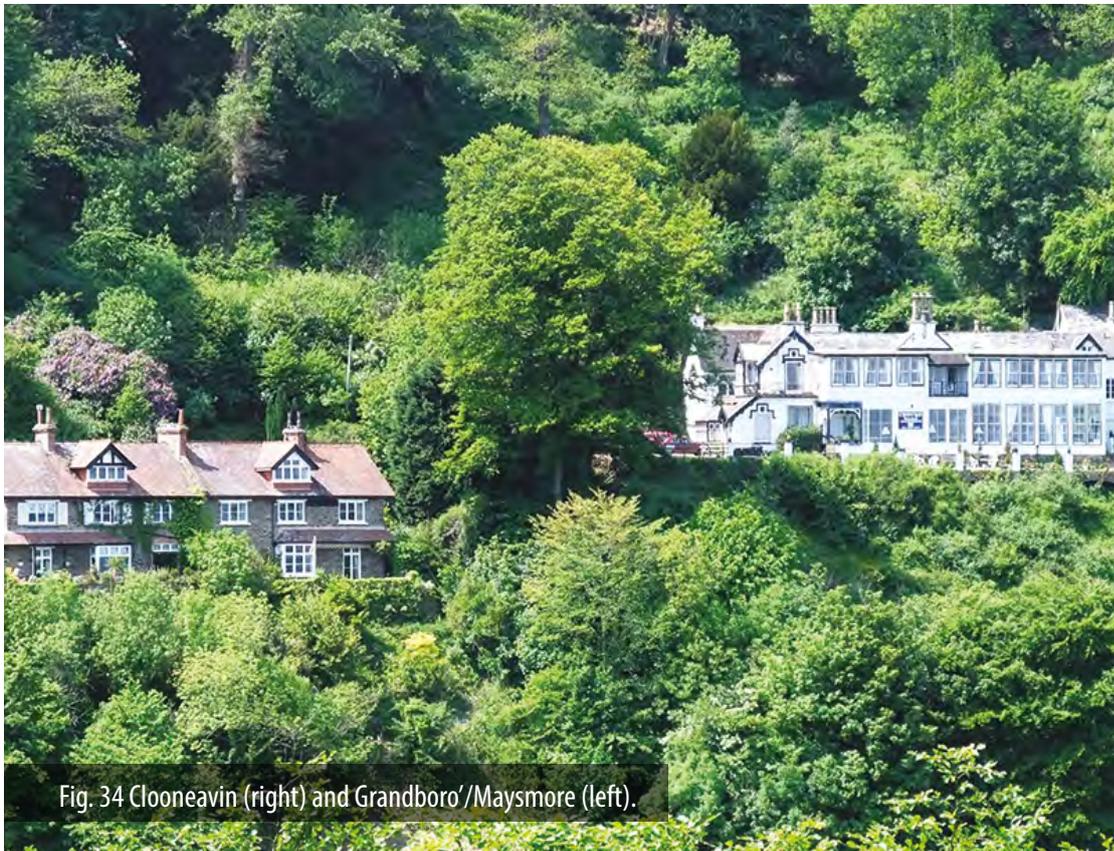
Halliday's original house, **Clooneavin** (Fig. 34) survives on the hill high above Lynmouth Street. It retains original features including, for example, some sash windows and decorative chimney pots, but a large mid 20th century forward projecting extension obscures the profile of the earlier building. Just to the south **Grandboro'** (Bay View House) and **Maysmore** (Fig. 34) a semi-detached early 20th century pair, chalet style with deep eaves at each gable end and other timber-framed gables, typical of the period.

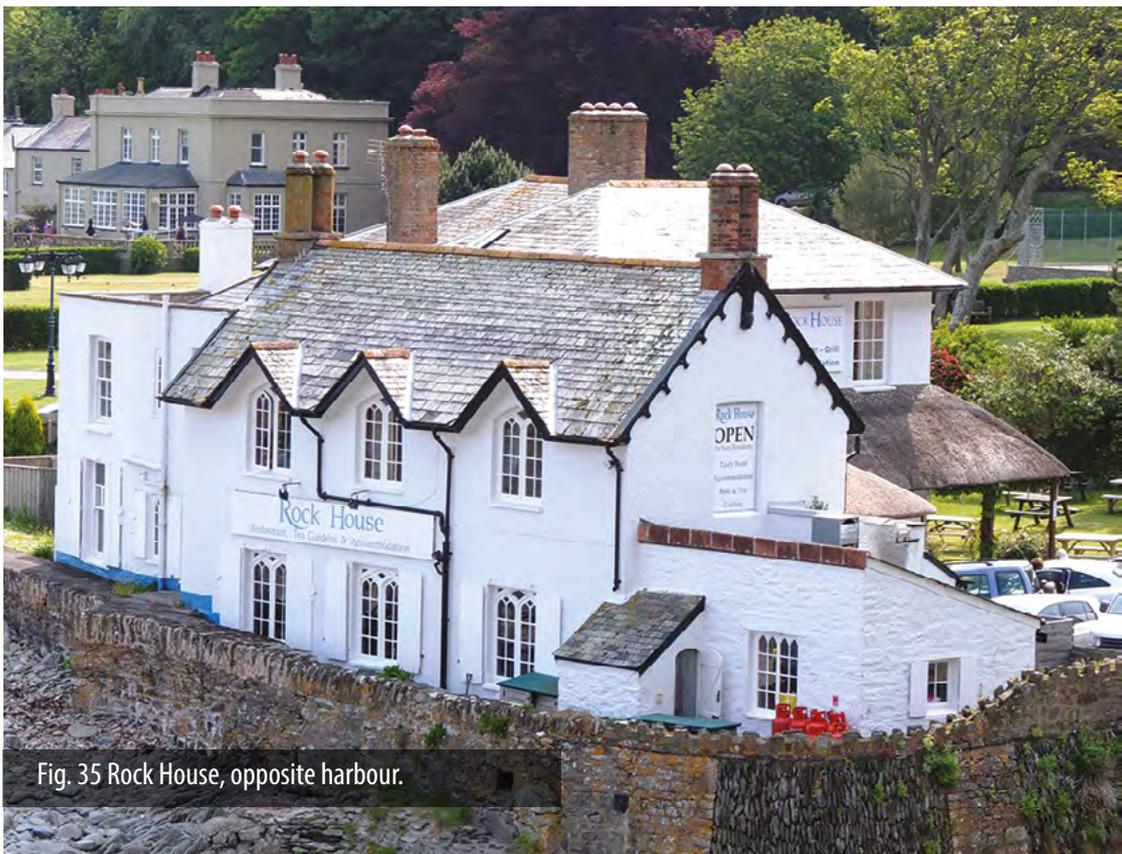
Fig. 35 Rock House, opposite harbour.

Directly opposite the harbour, **Rock House Hotel** (Fig. 35) is one of the more prominent and attractive buildings in Lynmouth. It dates to the early 19th century, L-shaped with some cottage ornee features including a thatched veranda on tree-trunks and light gothic style frontage detail.
