Exmoor National Park
Historic Environment Report Series No 18

LYNMOUTH CONSERVATION AREA: APPRAISAL DOCUMENT

Adopted 2018

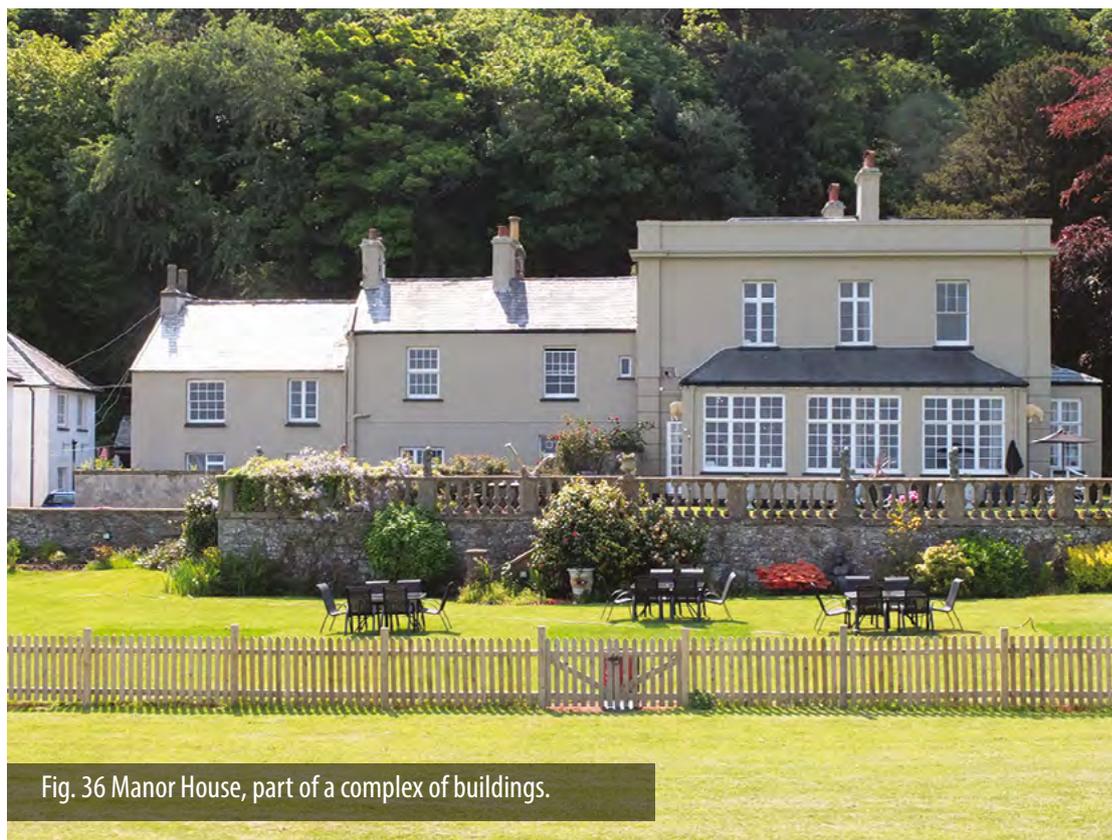
Fig. 36 Manor House, part of a complex of buildings.

The **Manor House** (Fig. 36) is of a similar date but without the gothic influences. The main house sits compact, plain and square facing the sea, rendered with slate roof behind a parapet. It appears to have been built as a hotel, but has until recently been used as a nursing home. A good collection of service buildings, including stables, extend to the north, mainly rendered with slate roofs.

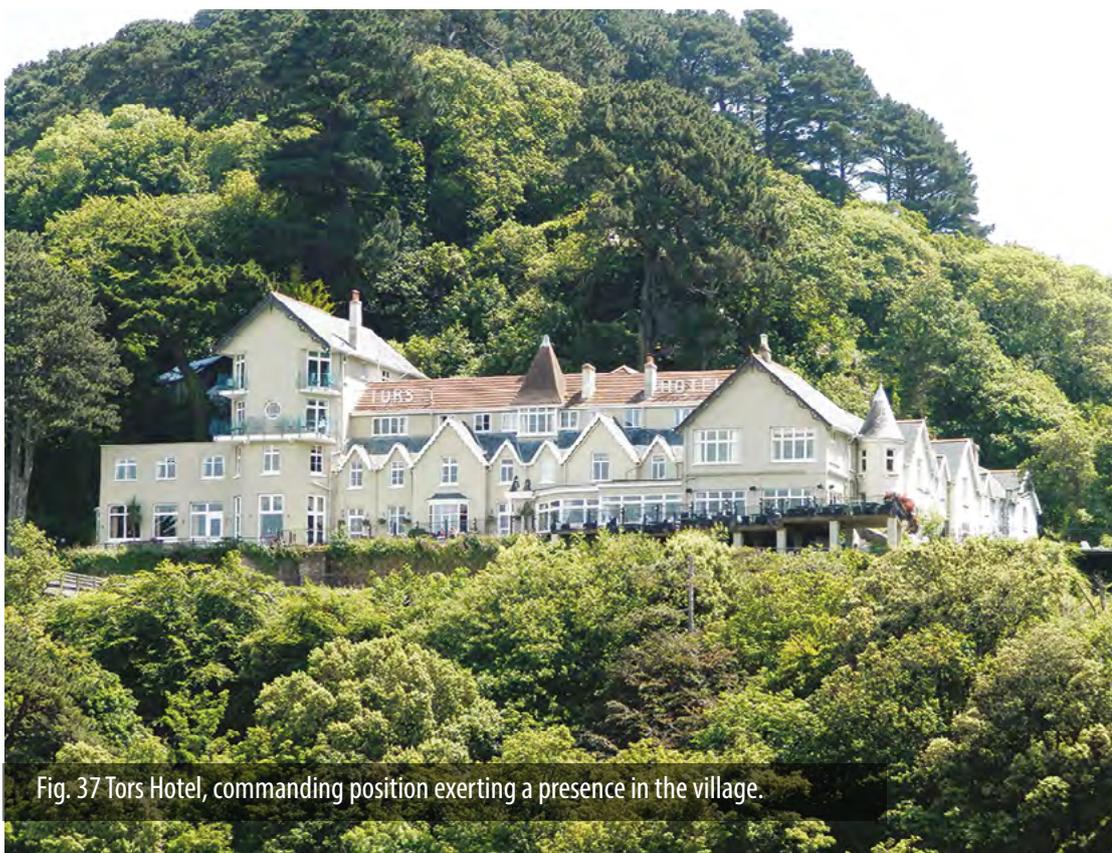
Fig. 37 Tors Hotel, commanding position exerting a presence in the village.

Perched on the hill above Eastern Beach, the **Tors Hotel** (Fig. 37) opened in 1886 but has been vastly extended to form the largest hotel in Lynmouth. It is rendered with slate and plain tile roofs and encompasses a wide range of styles, including a circular corner turret with conical roof, early 20th century half-timbered gables and decorative bargeboards.

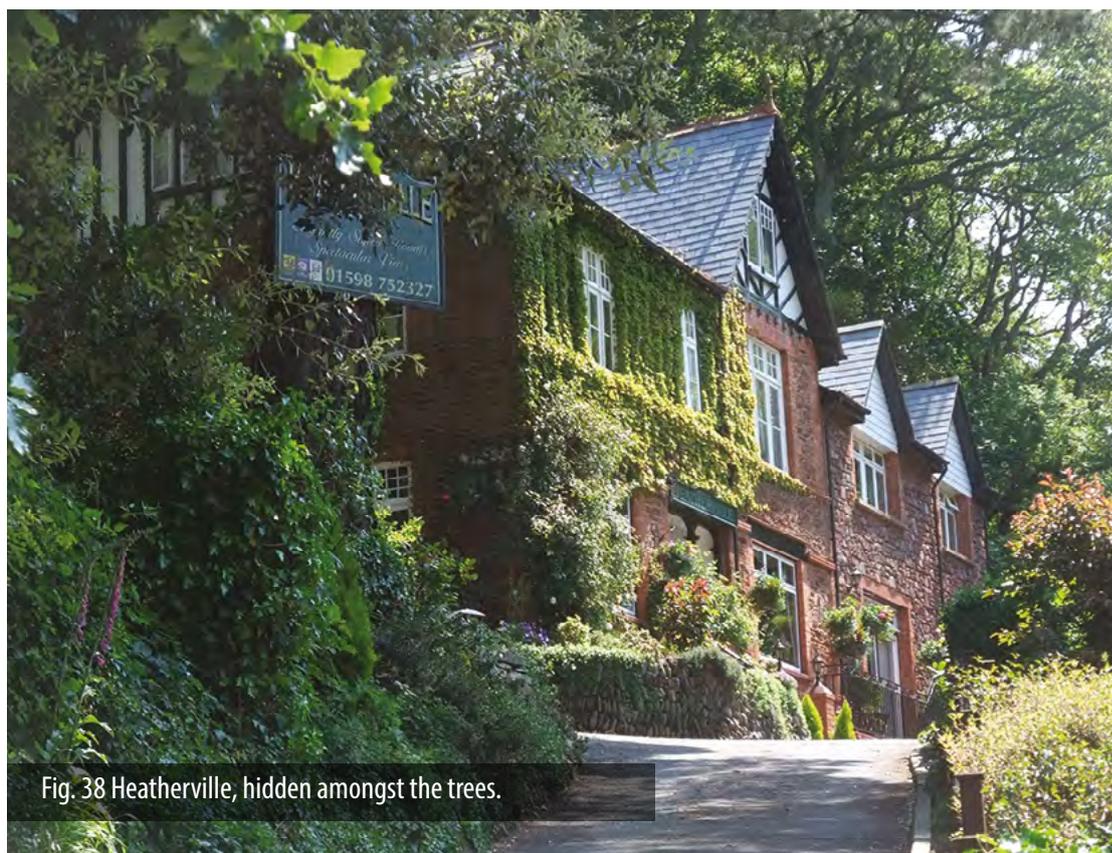
Fig. 38 Heatherville, hidden amongst the trees.

Other notable buildings on this hillside, **Cliffe House**, **Countisbury Lodge**, **Heatherville** (Fig. 38), and **Aberlyn** (Fig. 72), are partly hidden among trees. They are mostly late 19th to early 20th century stone-built houses and villas, many with Arts and Crafts details such as shaped brick drip-stones, deep timber gables and small -pane top vents.

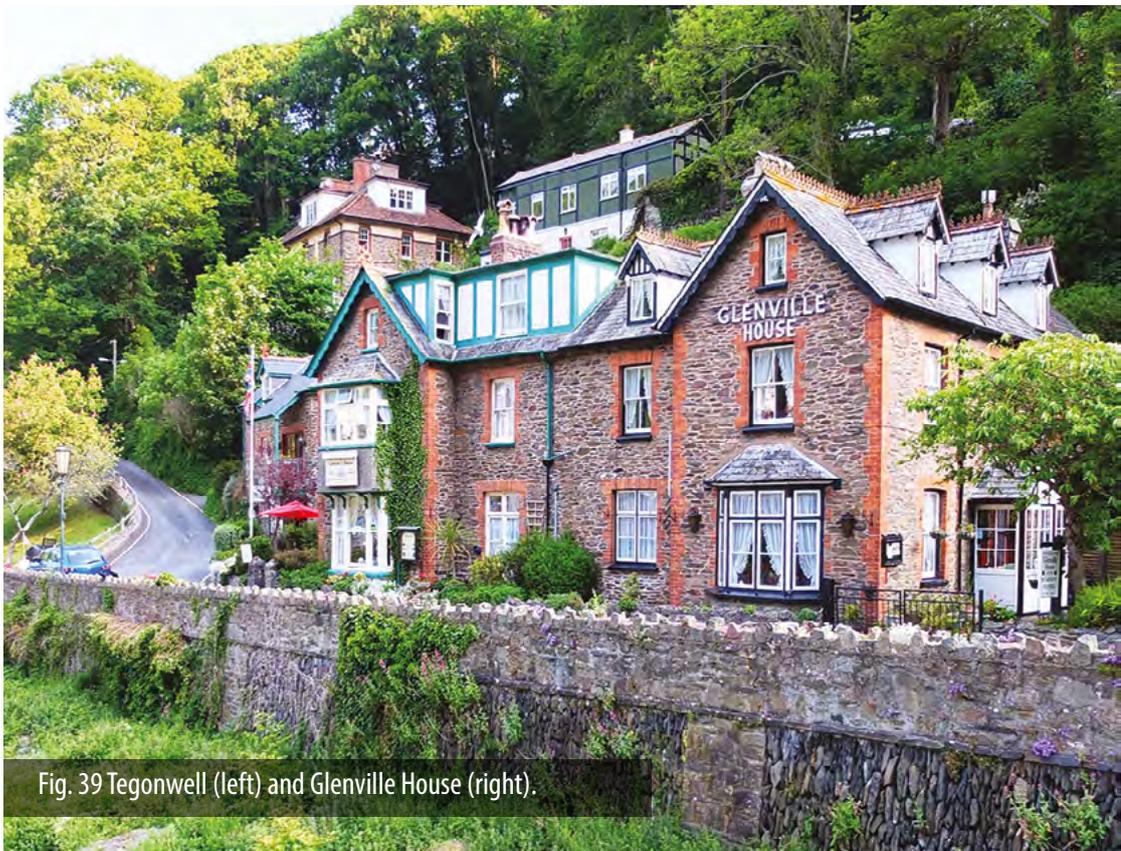
Fig. 39 Tregonwell (left) and Glenville House (right).

Tors Road is wholly late 19th century in character and forms an attractive group. At the west end are small hotels or guest houses including **Oakleigh, Riversdale and Clovelley House, Glenville House** and **Tregonwell** (Captain's House) (Fig. 39). These are three-storey, stone-built with brick dressings and slate roofs and are mainly semi-detached. They retain a wealth of original detail, including timber verandas, cast iron balcony, canted bay windows, some with French doors.

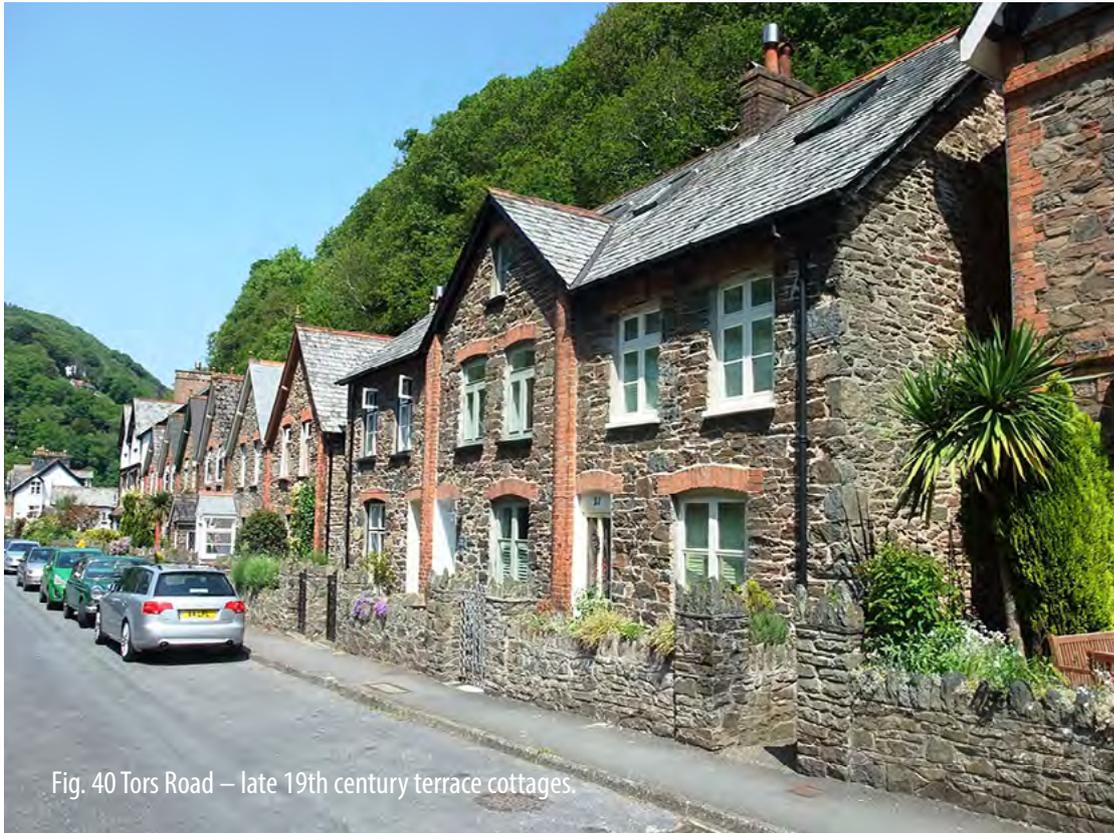
Adjoining are some 20, mainly two-storey in height houses, though some have a second floor attics. The frontages are built of exposed stone rubble with brick dressings and slate roofs. They have well preserved frontage detail, and include mainly timber casement windows, some ground floor square or canted bays, a few half timbered gables, and several original panelled doors. 25 Tors Road is a later addition, but in the same style, with the ruins of the former Coastguard Station now forming part of the garden.

Fig. 40 Tors Road – late 19th century terrace cottages.

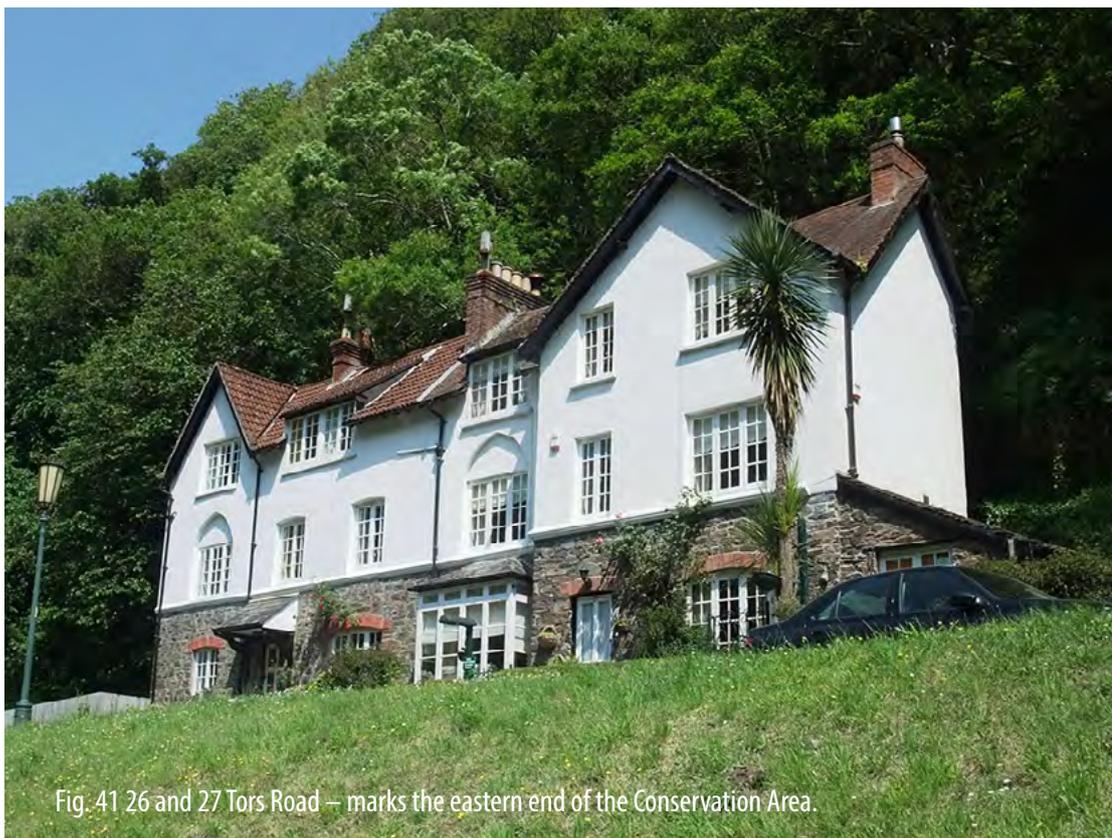
Fig. 41 26 and 27 Tors Road – marks the eastern end of the Conservation Area.

Further up the valley, **No. 26** and **27** (Fig. 41) is an asymmetric pair of houses, probably built c.1920 of three storeys, the ground floor of exposed stone rubble with brick segmental arched lintels, the upper floors rendered, with two first floor windows set in recessed arches. The roof is plain tile with gables and split eaves.

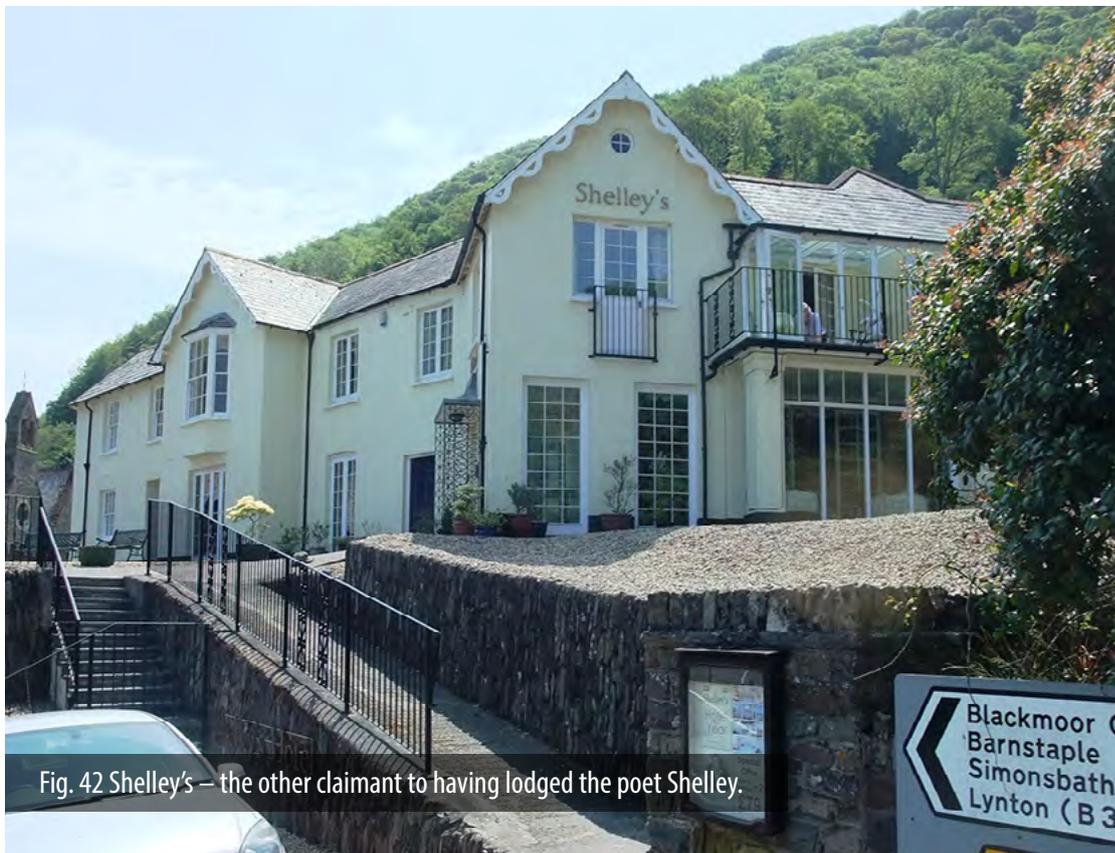
Fig. 42 Shelley's – the other claimant to having lodged the poet Shelley.

The beginning of Watersmeet Road is marked by **Shelley's Hotel** (Fig. 42), which occupies the prominent corner site. It is a mid-19th century building with recessed two-bay centre, and projecting gabled wings facing east. There are some contemporary external features including small-pane sash and casement windows with thin glazing bars, canted oriel above French doors with side-lights and iron trellis work flanking the six-panel entrance door. The right hand wing was badly damaged in 1952 and has been removed with the north-facing range, almost all rebuilt since the flood.

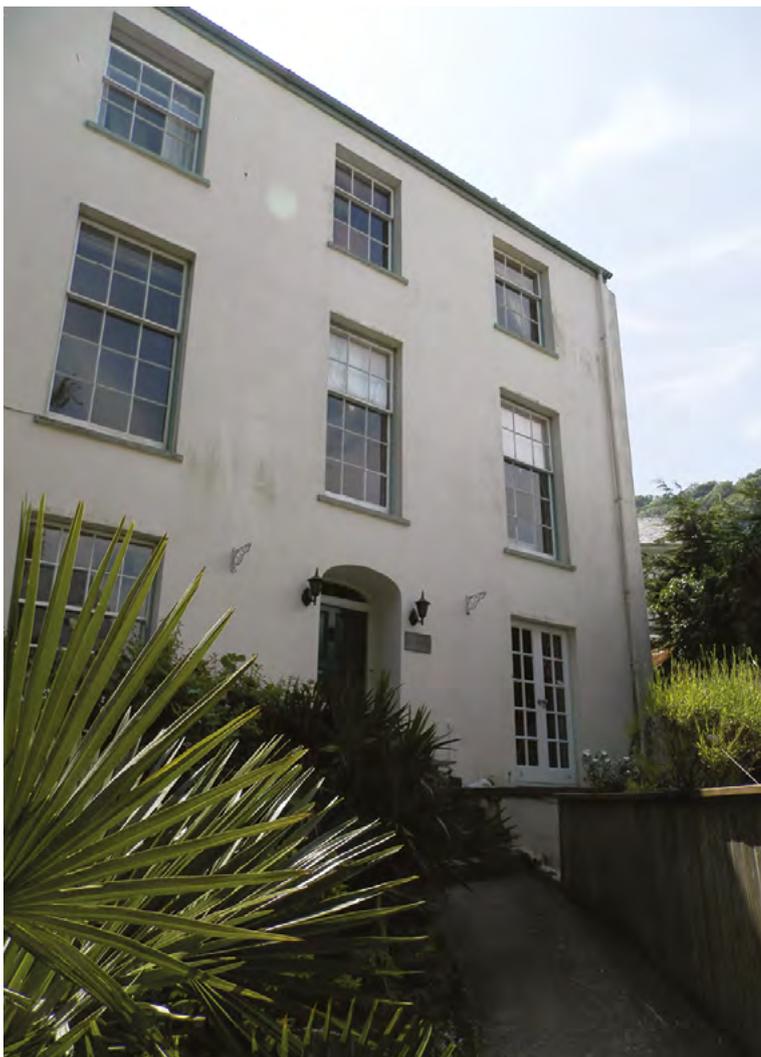
Fig. 43 Seaview Villa, Summerhouse Path

To the side of Shelley's, **Summerhouse Path** rises steeply. On the right is **Seaview Villa** (Fig. 43) a three-storey late 18th - early 19th century house with symmetrical plan, sash windows with narrow glazing bars and elliptical arched entrance with plain reveals, panelled door and fanlight.

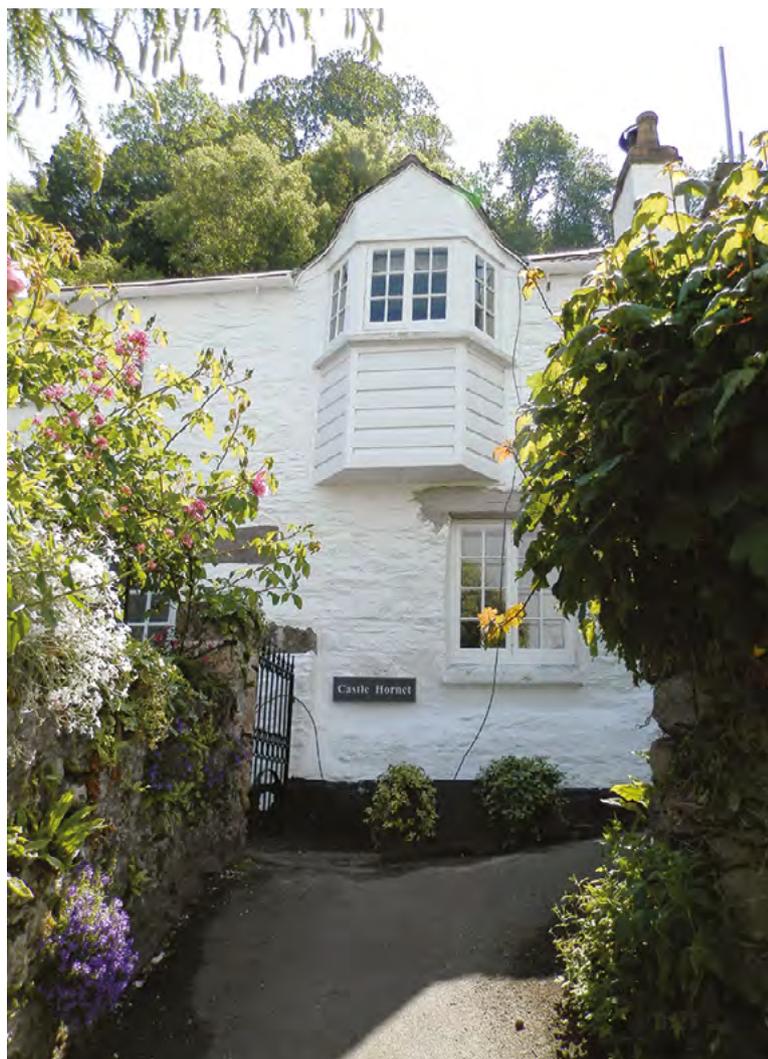
Fig. 44 Castle Hornet, Summerhouse Path

Higher up to the left, and to the rear of Bonnicot, is **Castle Hornet** (Fig. 44) a small L-plan 18th – early 19th century cottage of whitewashed rubble with external axial stack. Windows are casement with two oriels, and the 19th century entrance door has an over-light with oval glazing bar.

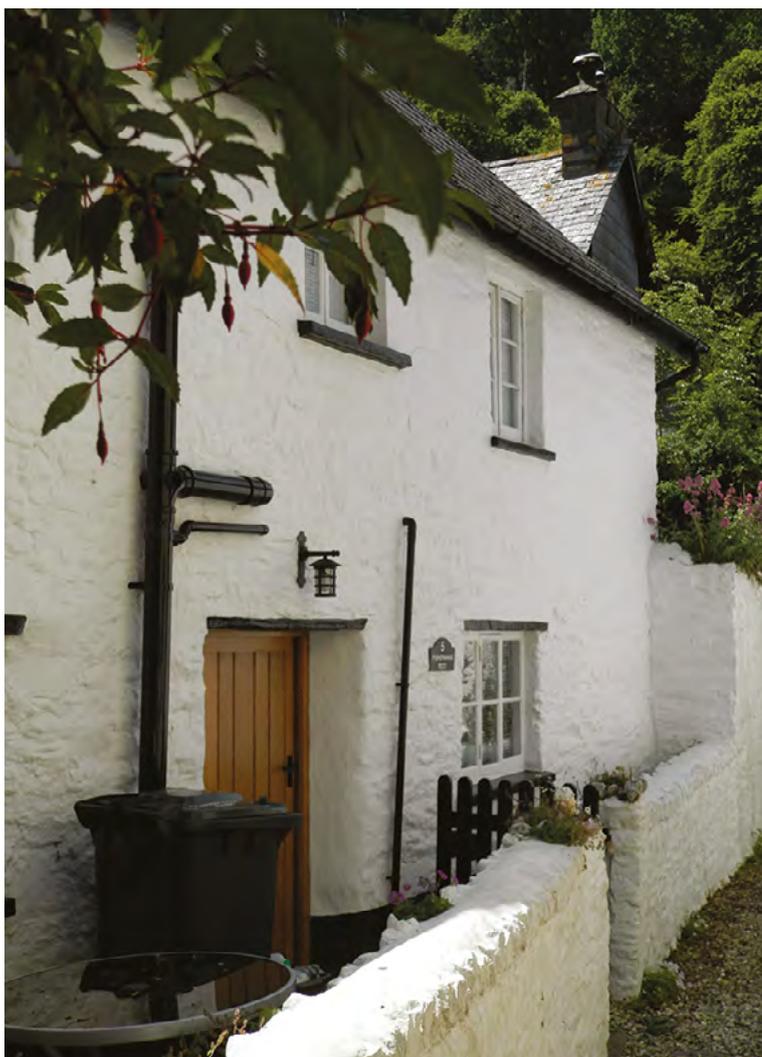
Fig. 45 Fisherman's Rest, Summerhouse Path

A narrow path extending east from Summerhouse Path leads to two buildings of interest. **Sea Fern** is probably late 19th century, stone built and with brick dressings, **Fisherman's Rest** (Fig. 45) is one of a smaller scale group of whitewashed stone or render buildings with slate roofs, and appear to have originated as pre-19th century former fishermen's cottages.

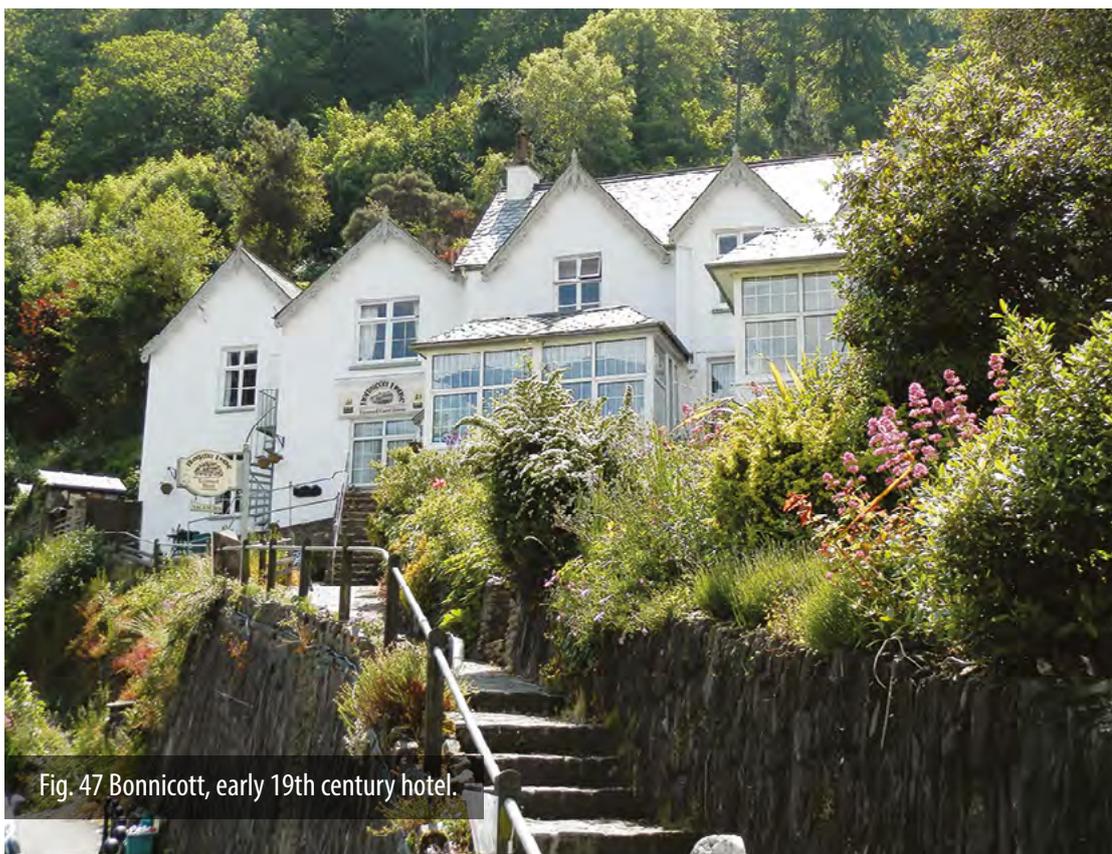
Bonnicott (no.10) (Fig. 47) is dated 1820 (from the deeds) and has a symmetrical main range of central gable of three stepped forward, all having decorative barge boards with dropped finials. In spite of late 20th century external modifications, much detail is original.

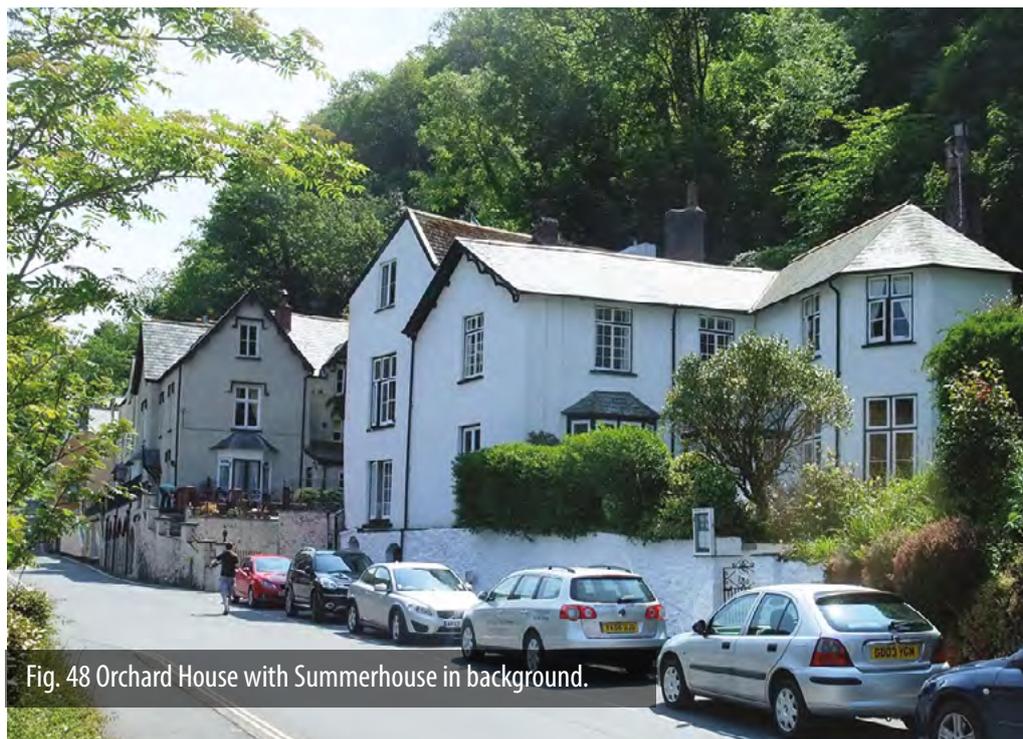
Fig. 48 Orchard House with Summerhouse in background.

Orchard House (no.12) (Fig. 48), also probably early 19th century and rendered with slate roof is L-plan with the gable end of the long wing fronting the street. An adjoining front gable to the left is set back with the entrance in the internal angle. Windows are mainly timber casement with mullions and transoms, some with small-pane glazing.

Summerhouse (no. 14) (Fig. 48) has a retaining wall, and terrace with railings included in the listing details. This hotel dates from the first half of the 19th century, and the main range has a left gable slightly brought forward. Windows are mainly two-light mullioned and transomed casements, some with drip courses, and all the gables have decorative barge-boards.

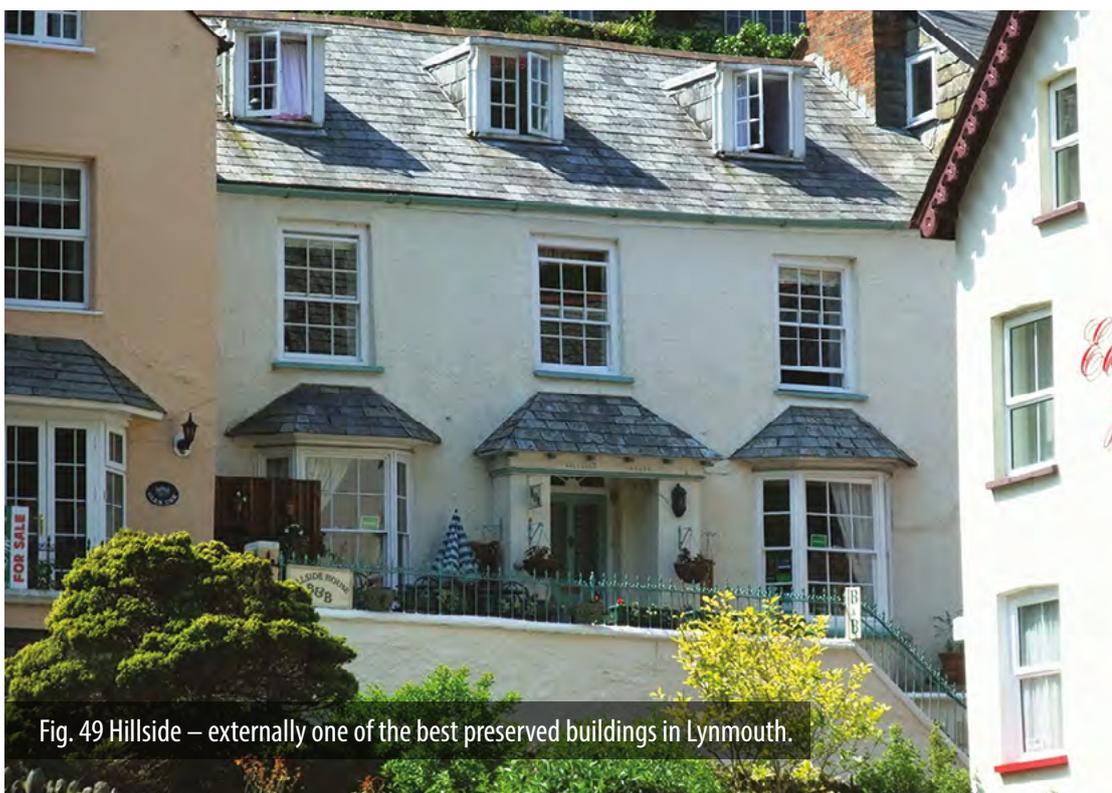
Fig. 49 Hillside – externally one of the best preserved buildings in Lynmouth.

Hillside House (no. 22) (Fig. 49) also includes in the listing the front terrace, wall and railings. This is again early 19th century with symmetrical central stair hall plan set on a high plinth a storey height above the road. It has a central porch under a hipped roof and part glazed twin panelled entrance doors with radial fanlight above. Its exterior is one of the best preserved in Lynmouth.

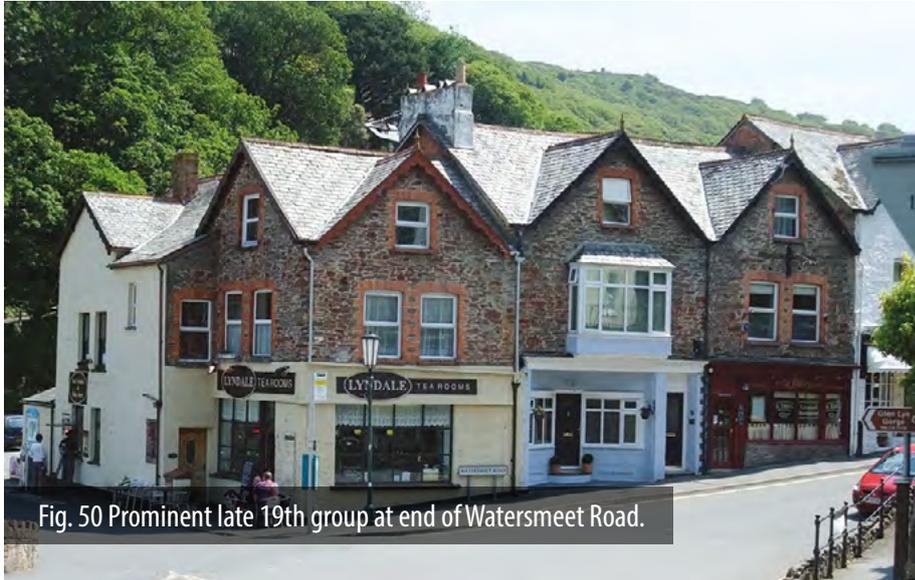
On the north side of Watersmeet Road, **nos 3 -9** (Fig. 50) is a good late 19th century three-storey stone built terrace with decorated bargeboards, 5-9 have traditional shop fronts.

Fig. 50 Prominent late 19th group at end of Watersmeet Road.

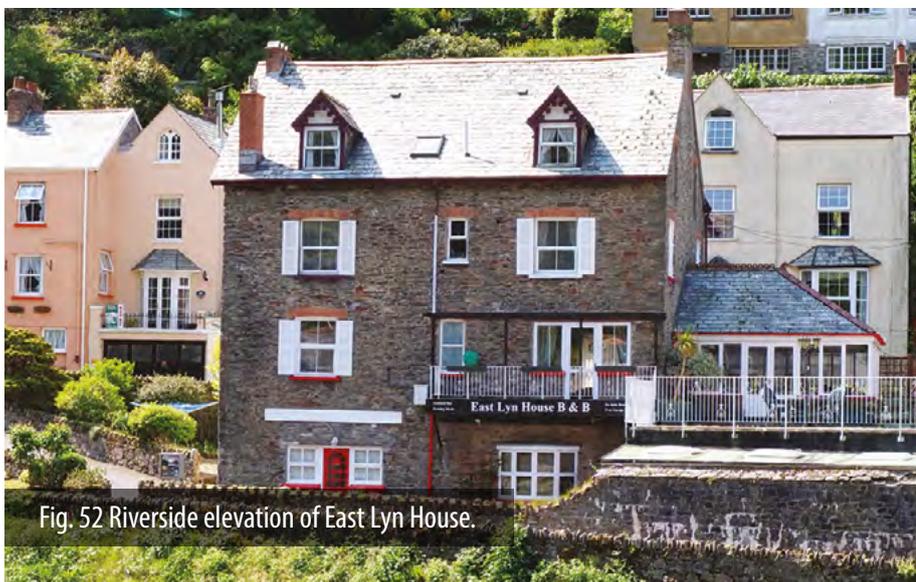
Fig. 52 Riverside elevation of East Lyn House.

East Lyn House (no. 17) (Fig. 52) is a tall late 19th century building, random rubble with brick detailing, slate roofs and decorative barge boards.

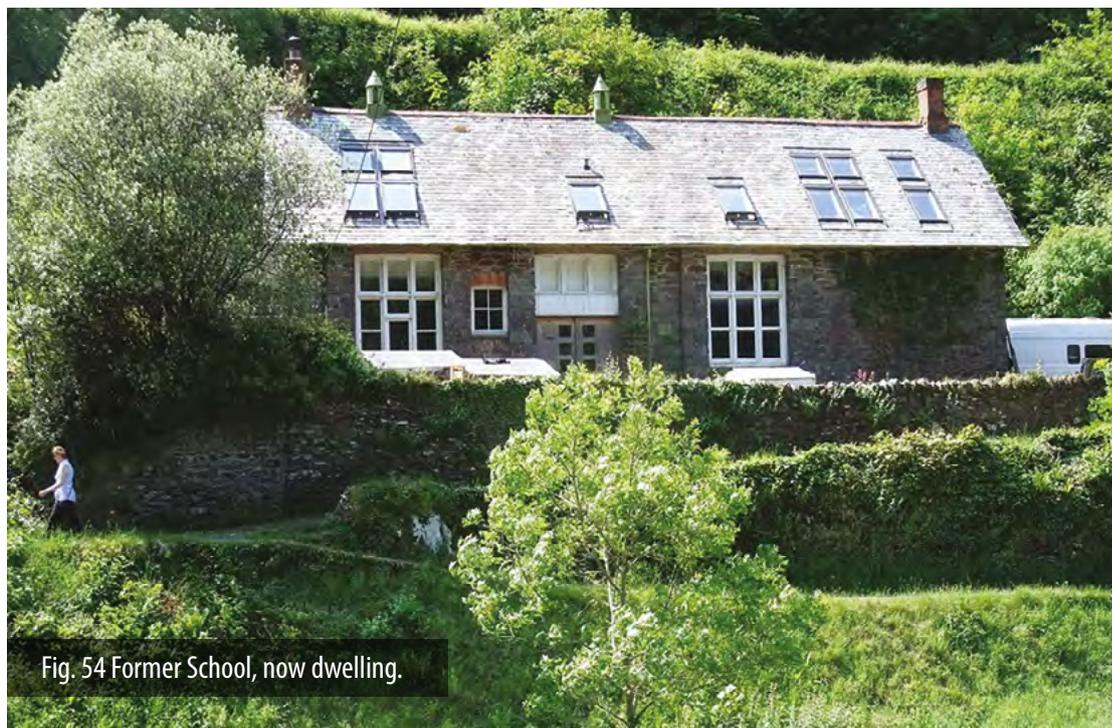
Fig. 54 Former School, now dwelling.

The Old School House (Fig. 54) is set down near the river bank and is a long single storey stone building, possibly extended on its west side, with a number of rooflights puncturing its slate roof. Now converted to a dwelling it was formerly Middleham School and would have served the small hamlet largely swept way in 1952.

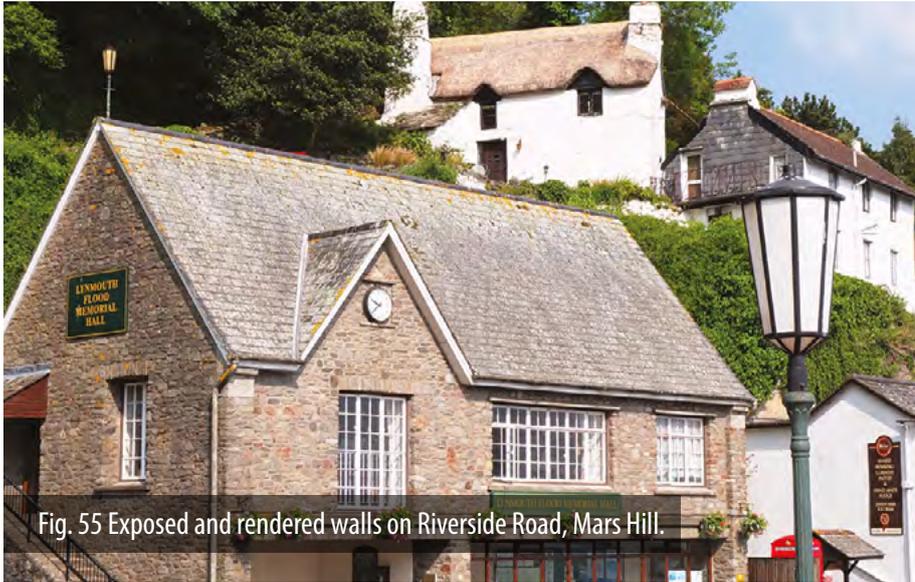
The majority of early buildings are stone-built. The stone used in buildings is mainly from the Old Red Sandstone series, and much is in shale form. It is hard, with distinct bedding planes and not readily worked. It is normally laid as roughly coursed stone rubble. Most walls of dwellings have subsequently been colour-washed or rendered in white or pale pastel shades.

Fig. 55 Exposed and rendered walls on Riverside Road, Mars Hill.

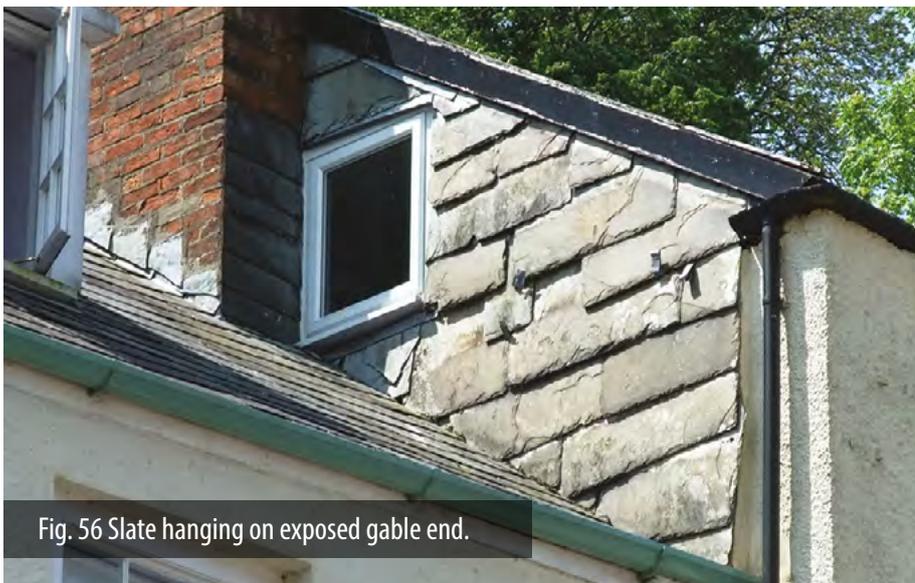
Much of the stone used is probably from small local quarries and originally, where rendered, lime wash or lime mortar would have been applied. Lime is likely to have been imported from Wales arriving as limestone and being burnt in the harbourside lime kilns. The building work that took place between the latter part of the 19th century and first two or three decades of the 20th century uses a much more eclectic mix of materials and in a number of instances is quite ornate. Many have exposed stone walls with red brick dressings and as is common in coastal locations there is slate and tile hanging on end elevations.

Fig. 56 Slate hanging on exposed gable end.

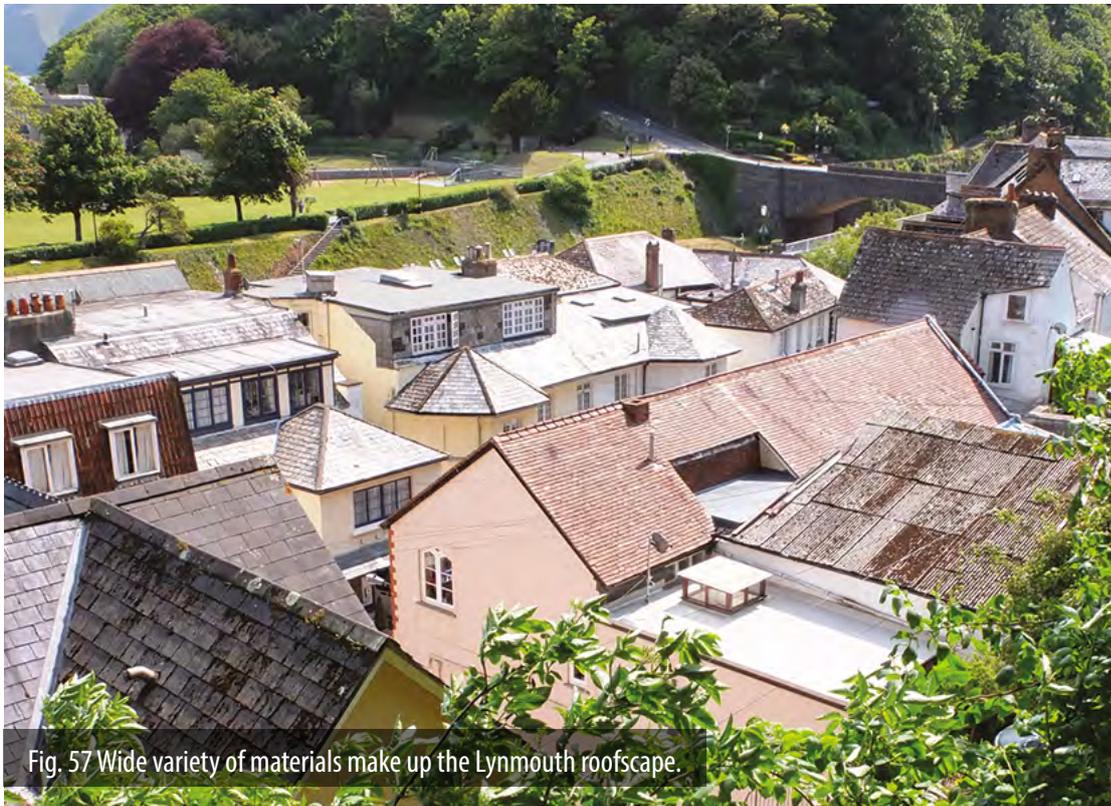
It would be expected that most of the cottages would have originally have been thatched and there remain examples in the Mars Hill area. Today the roofs of Lynmouth are predominantly slate. Almost all would have arrived by sea from Cornwall and Wales but there were also more local slate quarries such as Treborough in the Brendon Hills and Chibbet Ford near Exford. Much of this local slate was of a somewhat inferior 'rag' material compared to slate from Cornwall or Wales but would have still been available in the early 20th century. From the later 19th century clay tiles were also available and these occur on some Arts and Crafts influenced buildings. There are good examples of ornate gable detail, including barge-boards and some timber-framing.

Fig. 57 Wide variety of materials make up the Lynmouth roofscape.

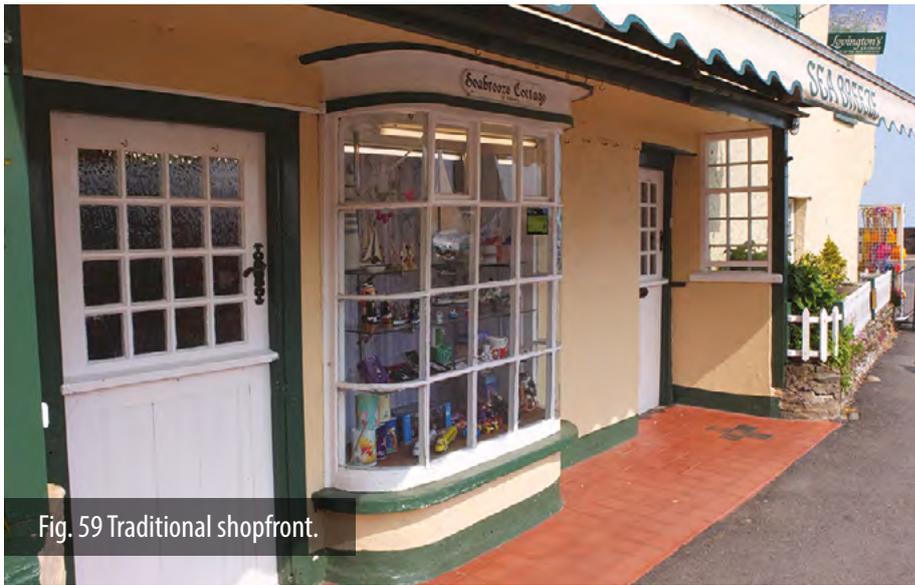
Fig. 59 Traditional shopfront.

There are some good quality shopfronts remaining which while not necessarily earlier than the 20th century are traditional in design (Fig. 59).

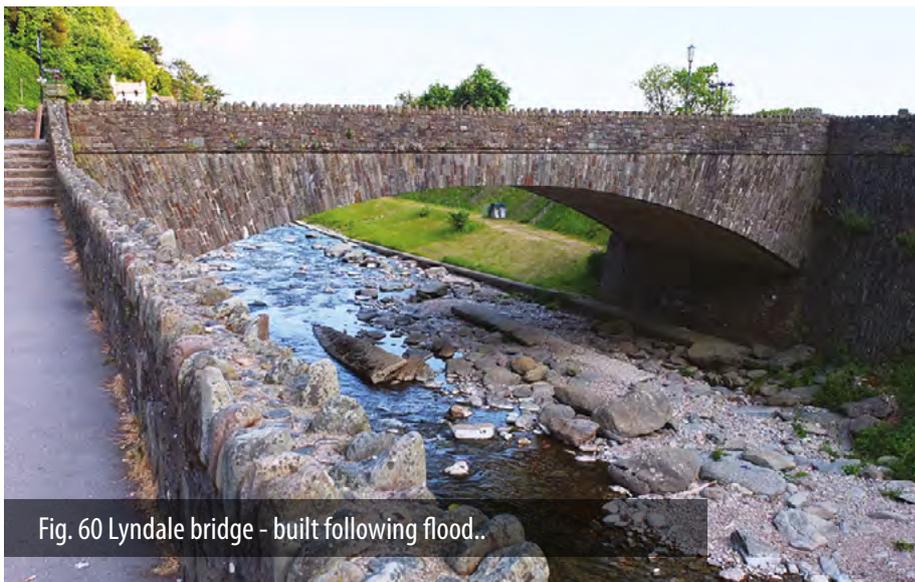
The Conservation Area boasts five bridges, although all post date the 1952 flood. Lyndale Bridge (Fig. 60) over the East Lyn is a prominent landmark, a largely stone-built, shallow arched single-span structure, completed in 1954. It is angled to enable maximum unimpeded flow of floodwater.

Fig. 60 Lyndale bridge - built following flood..

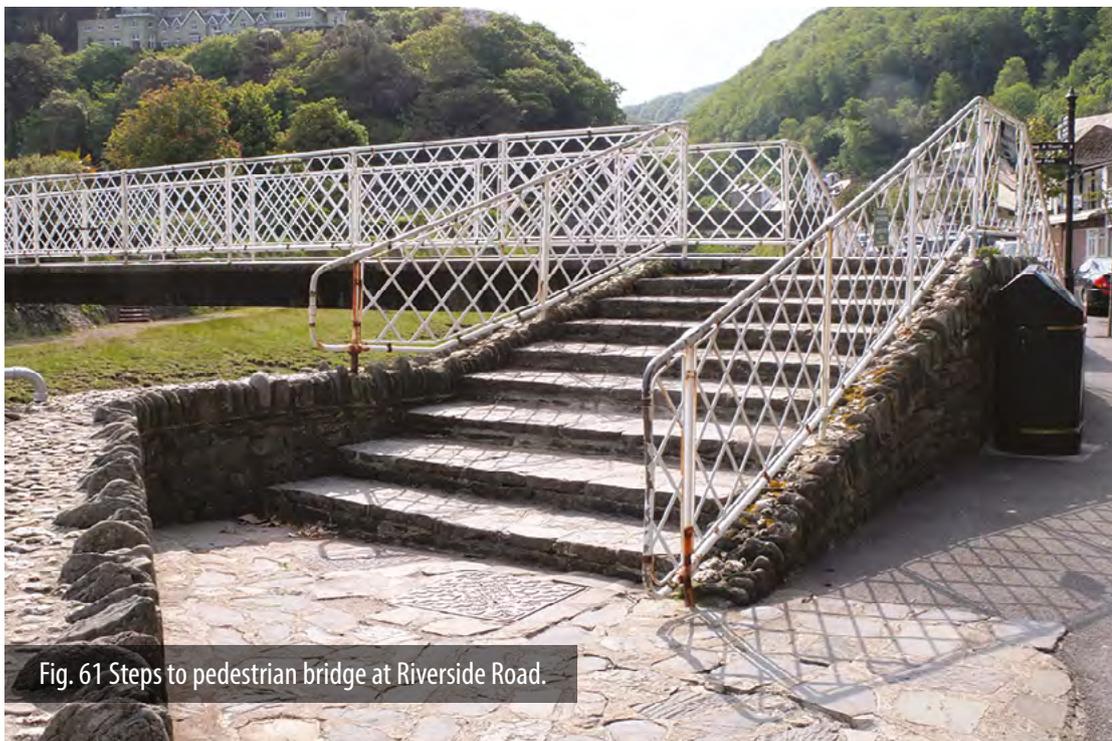
The other four, two pedestrian and two road, are concrete beam construction and of less note although their white painted railings do contribute the character and appearance of the Conservation Area.

Fig. 61 Steps to pedestrian bridge at Riverside Road.

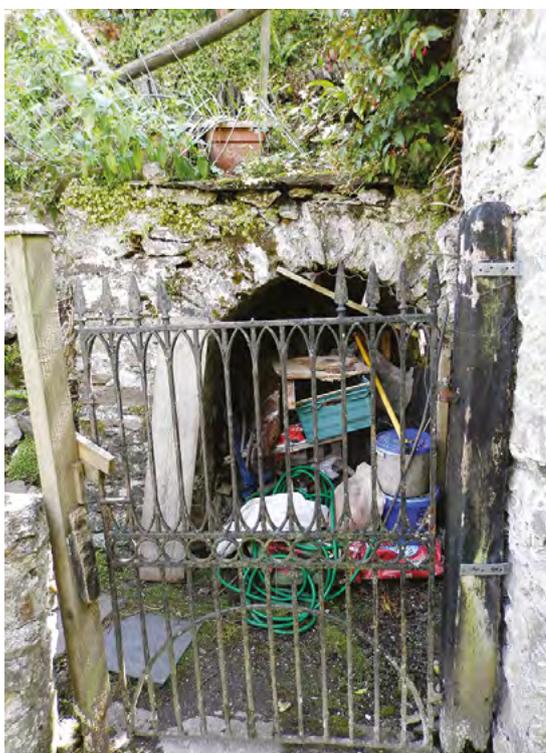
Fig. 64 19th century iron gate.

Lymouth also has a good collection of 19th- early 20th century ironwork, which as well as forming railings and gates is used as architectural decoration around balconies, notably in the Watersmeet Road/Summerhouse Path area.

- The conservation and repair of historic railings and associated ironwork is essential. Where appropriate consider using additional ironwork that reflects the local tradition of cast and wrought iron.

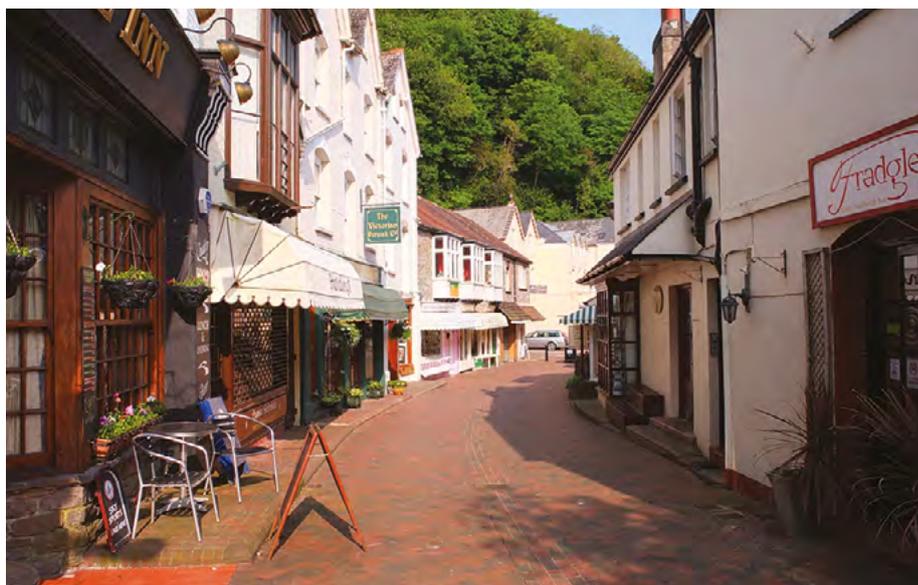
The modern red block paving in Lynmouth Street (Fig. 66), is a modern addition.

Fig. 66 Paving at Lynmouth Street - could have been more effective if natural stone paving or cobbles had been used.

- poor condition of some road and footpath surfaces and use of non-traditional materials, such as the red block paving in Lynmouth Street;
- the dilapidated state of some buildings and empty properties;

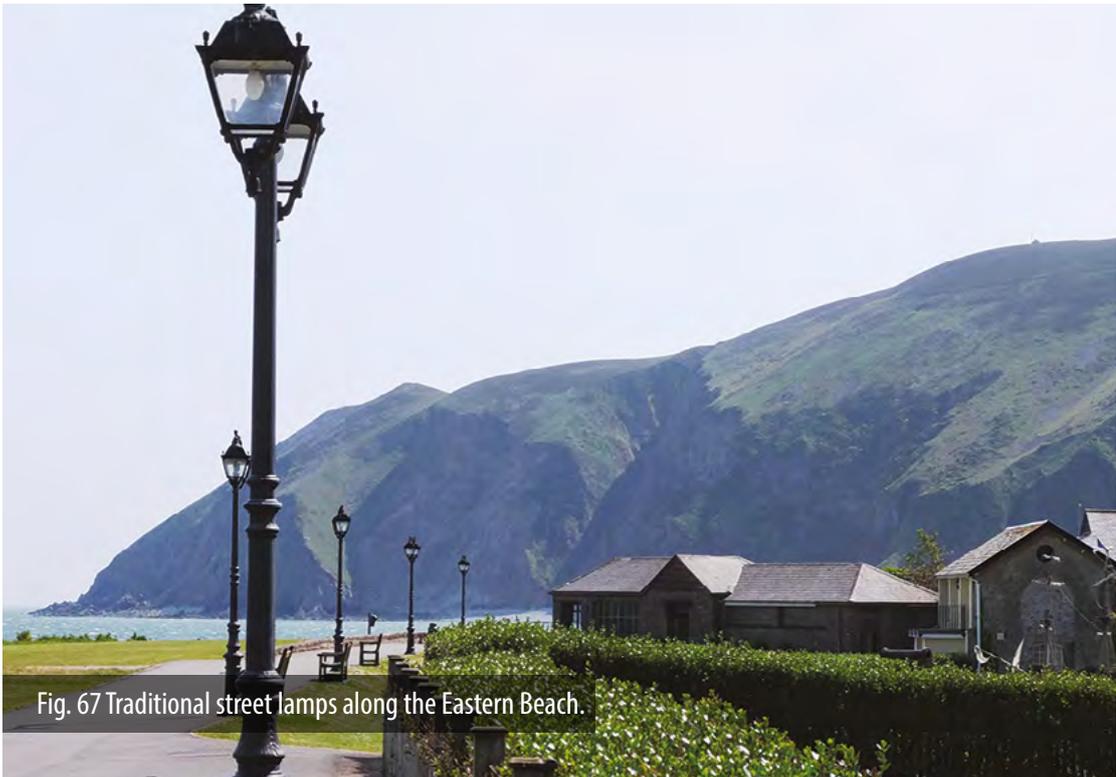
While of no great age, the street lamps throughout the Conservation Area are of a traditional design and in-keeping (Fig. 67). The solar powered lamps along the cliff paths behind Lynmouth Street are of a more contemporary design. There are cast iron benches at the end of Lynmouth Street dated 1985 and of a conservative design inkeeping with the late Victorian surroundings.

Fig. 67 Traditional street lamps along the Eastern Beach.
