Exmoor National Park
Historic Environment Report Series No 18

LYNMOUTH CONSERVATION AREA: APPRAISAL DOCUMENT

Adopted 2018

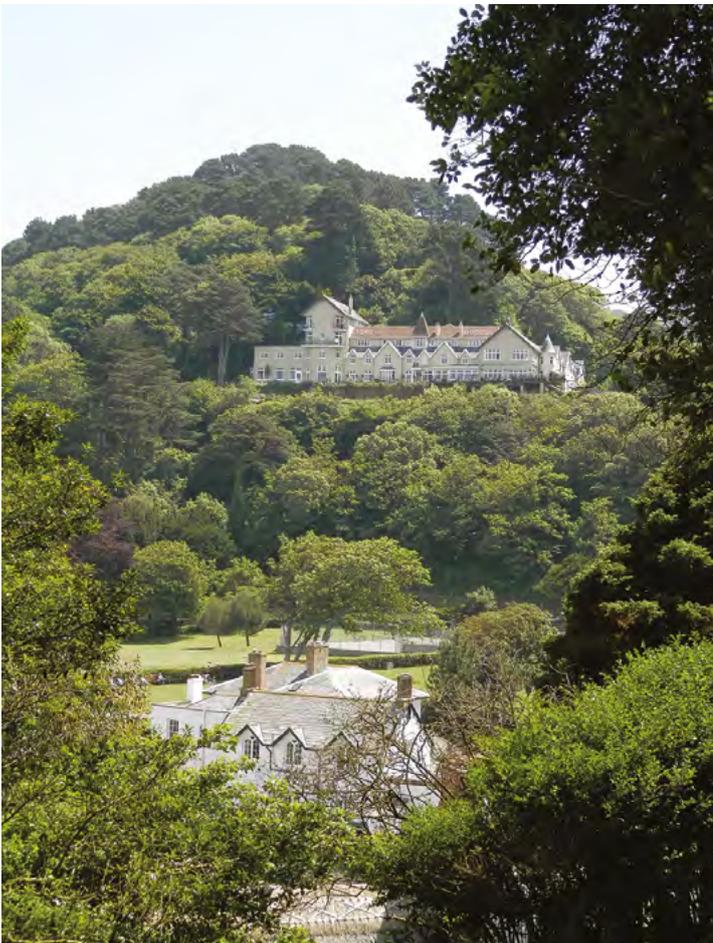
Within Lynmouth itself, mature trees provide an essential element of townscape in several locations, with prominent small groups, mainly evergreen, including what appears to be a stone pine. There is a row of yews along the drive to Manor House, and a short row of silver birch flanking the northern part of Lyndale car park. Elsewhere, trees mainly form woodland which virtually encircles the built-up area. Among the main deciduous species represented is oak, beech, sycamore, and evergreens include, holm oak, yew, holly and Monterey pine. Many of these were probably planted in the late 19th century and have grown to over 30 m in height and are a prominent feature of the hillside above the Tors Hotel (Fig. 69).

Fig. 69 Tree cover plays an important role in framing and screening buildings.

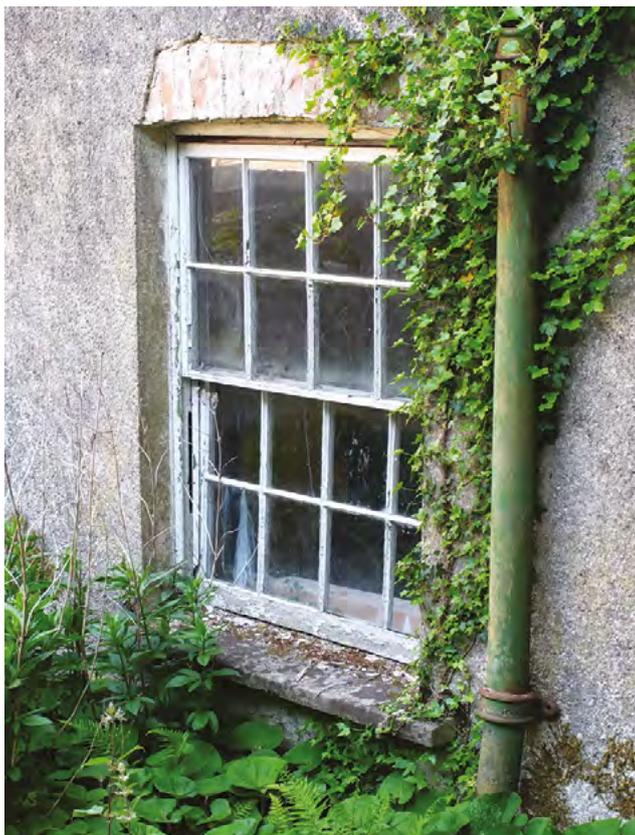
Some original window frames and sills are in somewhat poor condition, and because of the steep slopes, tend to be relatively inaccessible, but the majority are still sound, and mostly distinctive and well crafted. Where replacements are required, they need to be in timber and utilise traditional joinery. Unlisted buildings are especially vulnerable, yet their group value is often of vital importance in the street scene.

Fig. 70 Traditional sash window – worthy of repair.

A further detraction is the tendency to replace original timber windows and doors, many of which are capable of restoration, with PVCu replacements. This is a trend identified in the last Appraisal in 2003 and is continuing. It has resulted in a considerable loss of historic character. It is acknowledged that repair or restoration of period features, especially timber joinery, ornate glazing detail and cast or wrought ironwork, can be costly and time consuming, and may require specialist advice, but it invariably repays the effort involved.

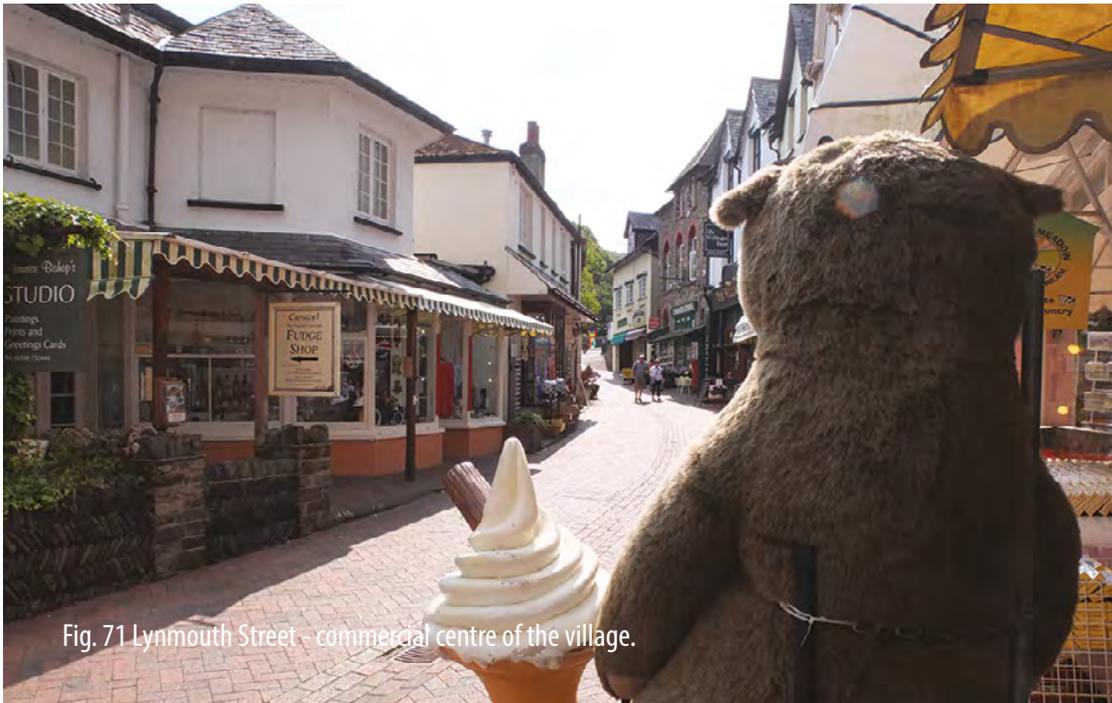
Lynmouth owes its development and continuing prosperity to the tourism so it is not surprising that there are some instances of less than satisfactory signage as businesses try to attract trade. On the whole, however, this is not excessive and can be regarded as a minor detraction from the Conservation Area.

Fig. 71 Lynmouth Street - commercial centre of the village.

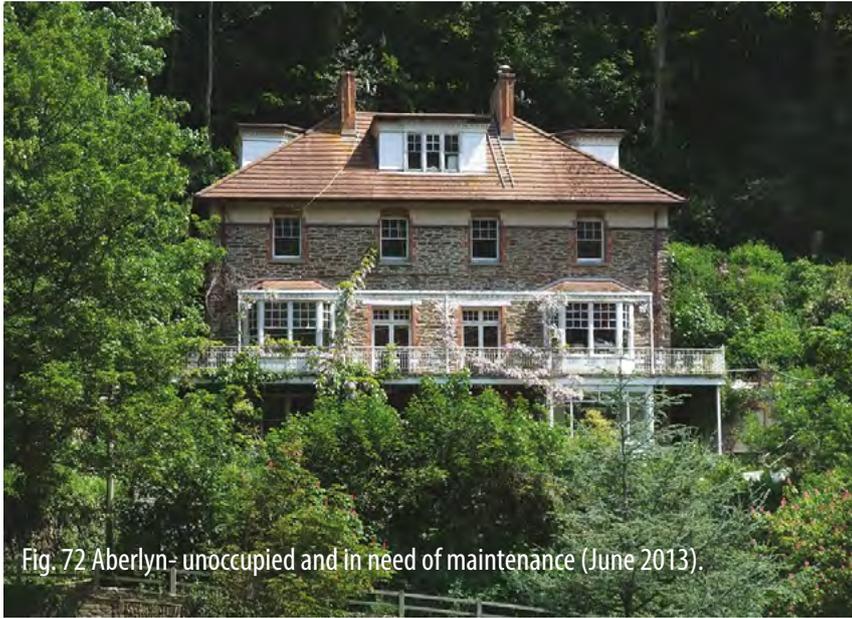
Fig. 72 Aberlyn- unoccupied and in need of maintenance (June 2013).

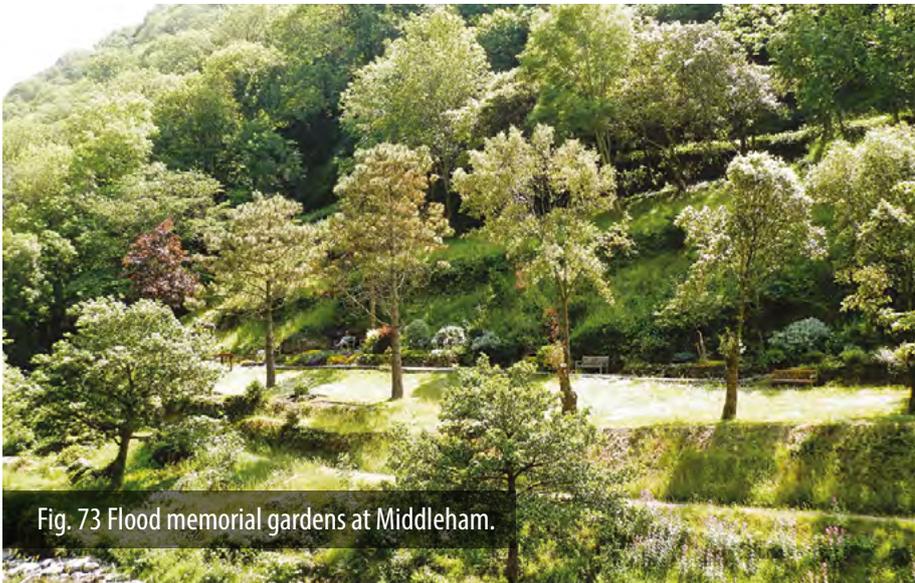
At the east end of the Conservation Area, close to the site of the small settlement known as Middleham swept away in 1952, there is a memorial garden. This pleasant terraced garden is outside of the current Conservation Area (Fig. 73).

Fig. 73 Flood memorial gardens at Middleham.

- At the east end of the Conservation Area, on the site of the small settlement known as Middleham swept away in 1952, there is a memorial garden. This pleasant terraced garden has no buildings but is of historic interest and would make a positive contribution to the Conservation Area.
- To regularise the boundary north of Midhills it is proposed to extend the Conservation Area to the cliff railway line.
- For consistency, it is proposed to continue the line from No.21 Tors Road and for the Conservation Area east of here to follow the rear property boundaries.
